Field report from the journey to North-East Greenland 2014

Sverresborg resurrected!

Field report for the North team 2014

Field report for the South team 2014

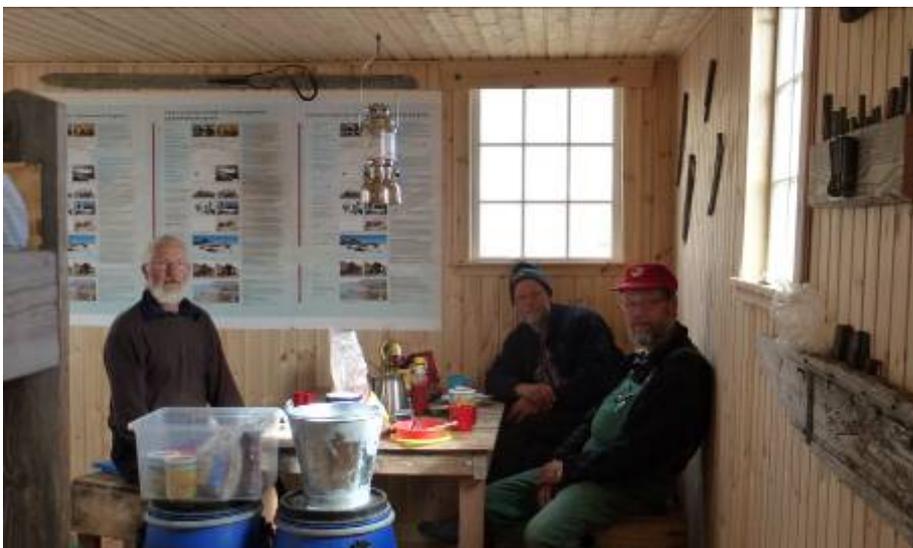
The North team in the fully renovated house in Dødemandsbugten.

The attic and inside walls of the house have been covered with rustic boards. Posters with local historical information in Greenlandic, Danish and English respectively, have been put up.

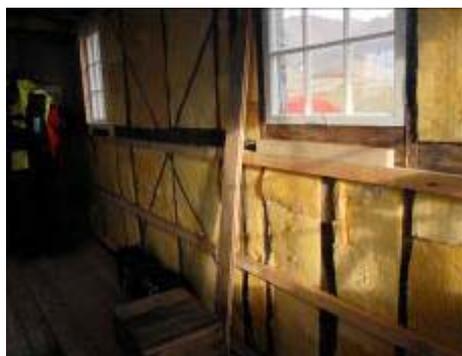
Isolation and laths attached as sheathing.

All outer walls are isolated with 100 mm. No vapour barrier, so the materials can breathe. Every 50 cm laths are put up horizontally to which rustic boards are attached.

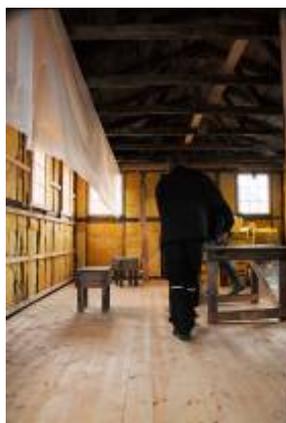
Isolation of attic.

The attic is slanting, so we have to detach several of the rafters. Pliers are loosened from the end of the rafter, which is straightened, so we are able to put up the rustic boards in an acceptable craftsman-condition. We isolate with 145 mm. A vapour barrier is put up, however not completely in accordance with the demands to contemporary building. Mostly, it is put up to help us walk below the isolation, while fixing the attic boards. Rustic boards are also fixed to the entrance to conceal the wind support wire.

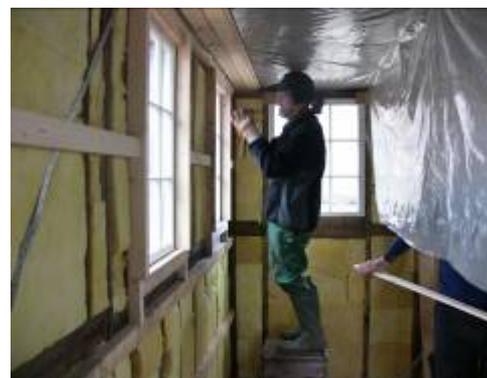
Attic boards are put up.

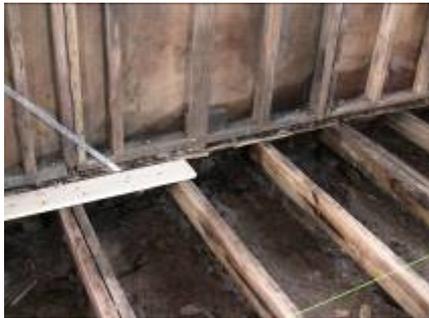
*Walls and ground are very damp.
The condition of the wood is OK.*

Good advice is hard to come by. All experience say that for this floor to dry, it needs air, a lot of air, and time that we do not have. The risk that dry rot and permanent dampness will occur, if we block with isolation, is an immediate problem that has to be calculated. It will cause that the floor beams would be infected with rot to a degree that can only be prevented with the

option of air circulation. Furthermore, the outer walls are sealed with roofing felt in the same height from where the peat has been stacked last year. Therefore it is not an option to use a base to make air circulation below the isolation.

Owing to the building style and lack of time, we decide to lay the floor without isolating. Also, this style is in accordance with the original building style of the hut.

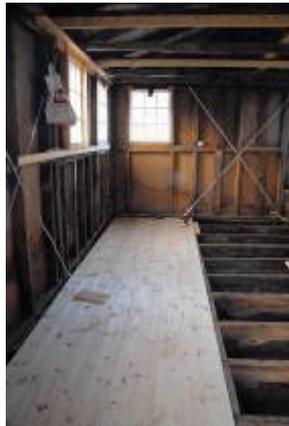
New floor.

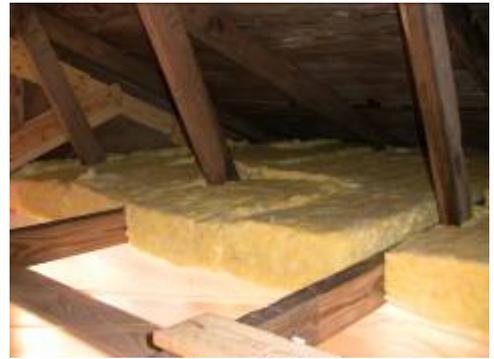
Isolation of attic.

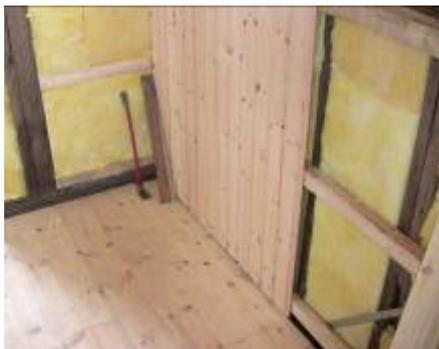
Wall is boarded.

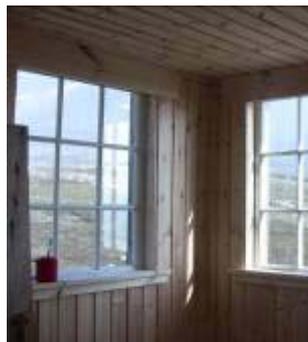
Lists are formed.

With handsaw we adjust the attic sections, wall bases, shadow list and architrave and do modifications to ensure the final result.

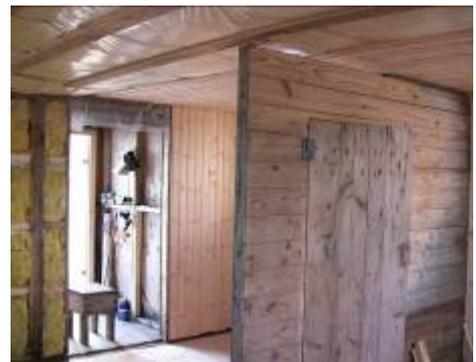
Old partition wall put up.

We carry everything out of the hut except the partition between the rooms, which we have to reposition until later, when it can be installed as directed. Soon we realise that the hut is very damp. The undersides of the boards that are lying on the floor beams are soaked in water, and the ground is so slushy that we are slipping.

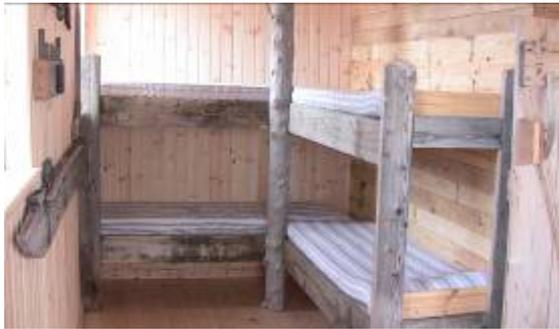
Bunks made from old boards.

The bunks are made from old wood, and the bed boards from new wood. The new mattresses are put in place.

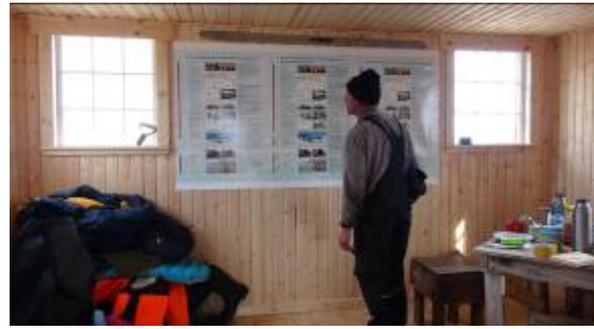
Information posters put up on the wall.

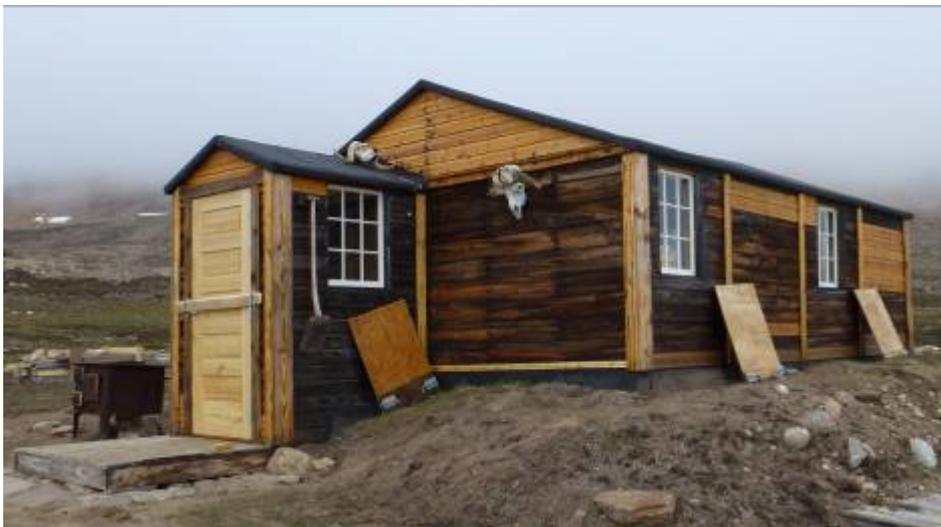
Dødemandsbugten at our departure. The house is now fully renovated with a new door and new windows. It was a conscious choice to keep the fine, rustic board facade and to exchange only the rotten boards.

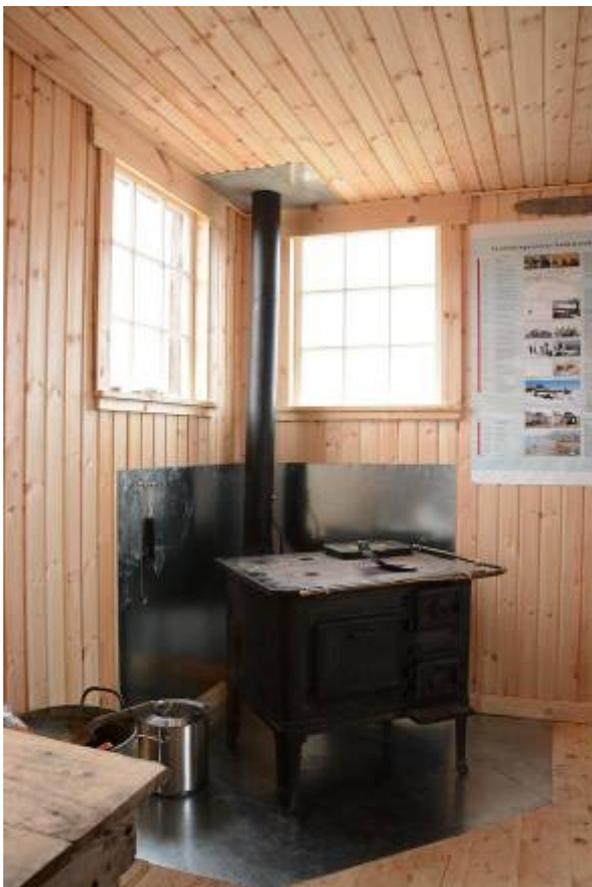
The new coal stove put up by Sirius after the Nanok team's departure.

A very impressive, newly renovated coal stove with all equipment was delivered with the ship. For the sake of the possibilities of navigation and the scarcity of time, we agree with Sirius that they on a later occasion will bring and install it on the spot, where all the preparations have been made. We make a hole in the roof for the lead-in of the

chimney and attach all plates and lead-in components, so the stove only has to be put in place, and the chimney pipe lowered to its place. We seal with roofing felt around the metal plate. The plates to protect the wood are installed onto the floor and walls.

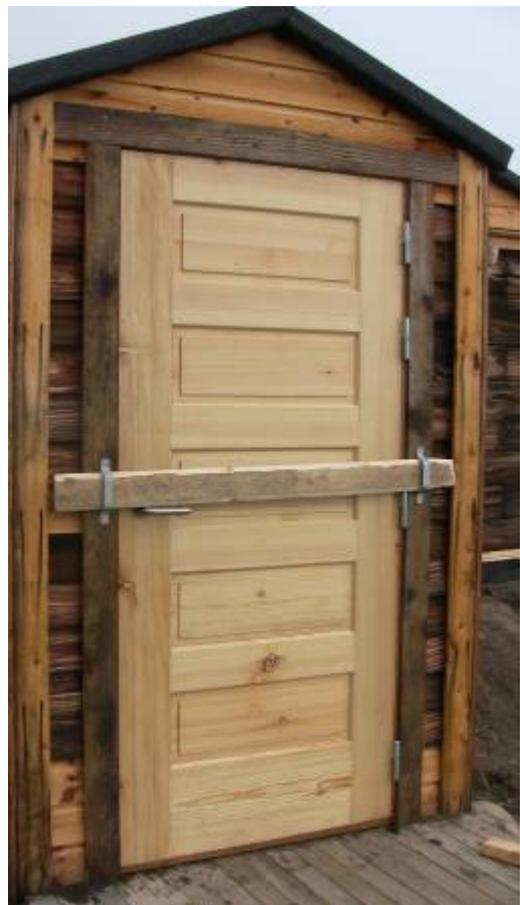
The new outer door.

Also new doors have arrived with the ship. The front door and the door inside are installed. They fit the old measurements of the hut. A door handle is installed, it works perfectly. The door in the old partition, consisting of old, broad, vertical boards, is kept and restored according to original style.

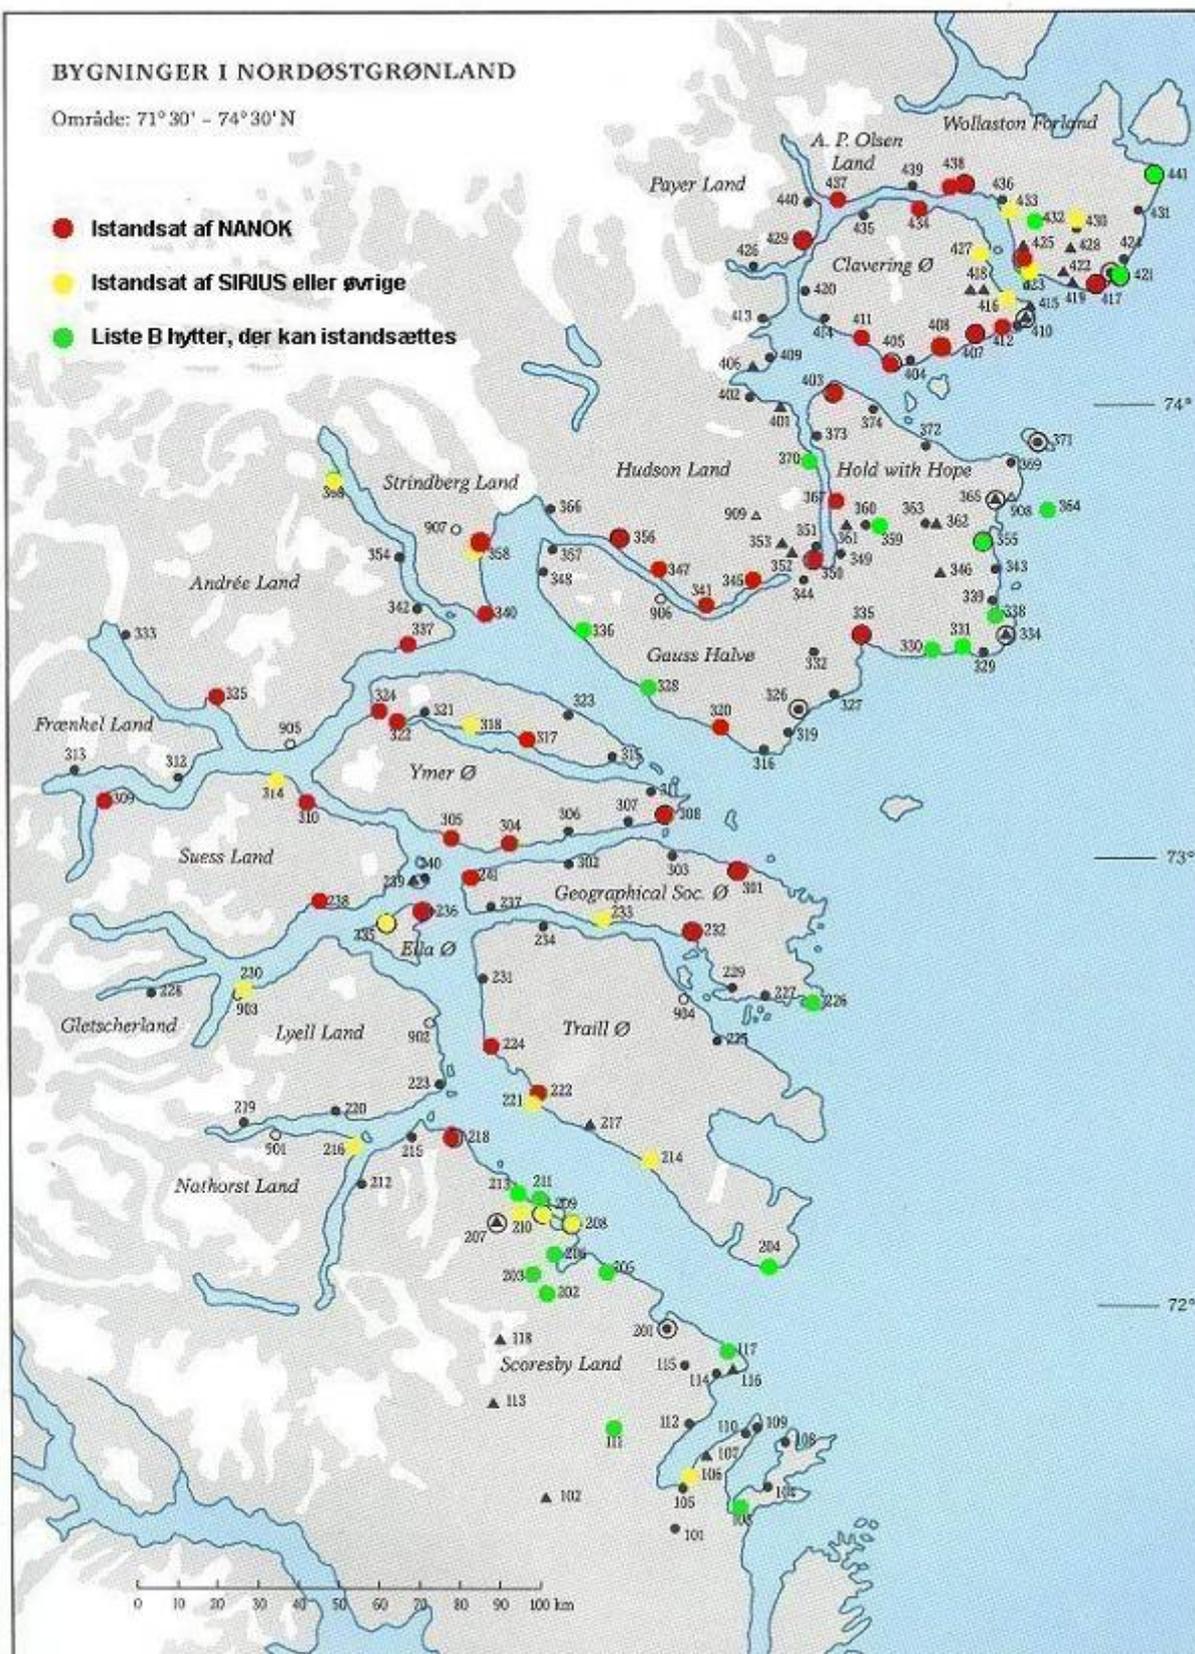
Område: 71° 30' - 74° 30' N

The maps on this and opposite pages show the maintenance status for the old huts, houses and stations in North-East Greenland. The sites marked red or yellow can be expected to be in reasonably usable condition. Other sites, however, cannot be expected to be usable. Sites marked green are other huts with the classification B, which Nanok may renovate and maintain in the coming years.

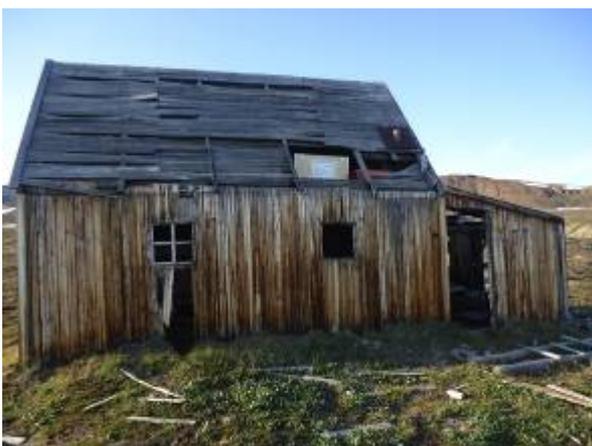
First impression of Sverresborg.

pictures of the condition of Sverresborg. For one thing, it was ascertained that the outside walls could not be brought back to original condition with red paint, but were to be covered with felt. This was partly due to the lack of tongue and groove boards, partly to the general decayed condition of the walls.

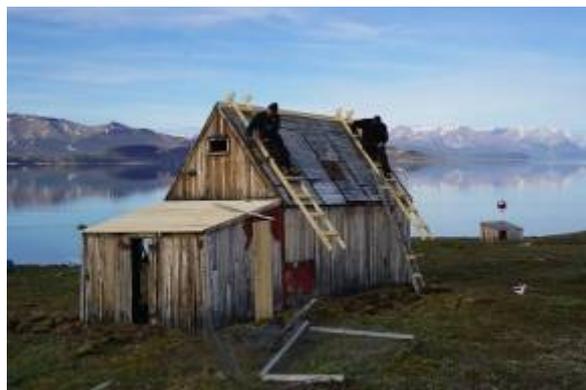
Incredibly, after 85 years there are still traces of the original red paint.

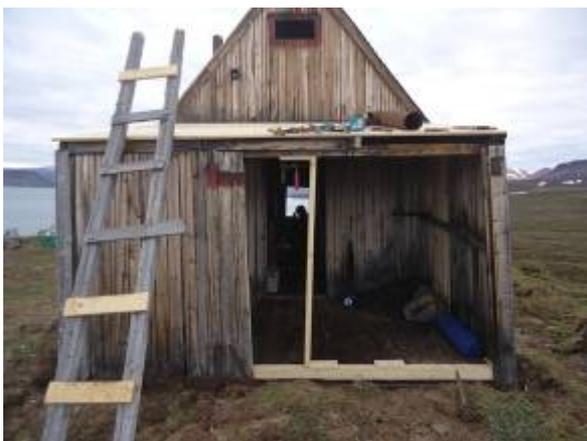
Believe or not – the new lath is in plumb!!

necessary to reinforce the original laths. Also, especially on the south side, the outside boards had rotten away from the ground with 5-30 cm.

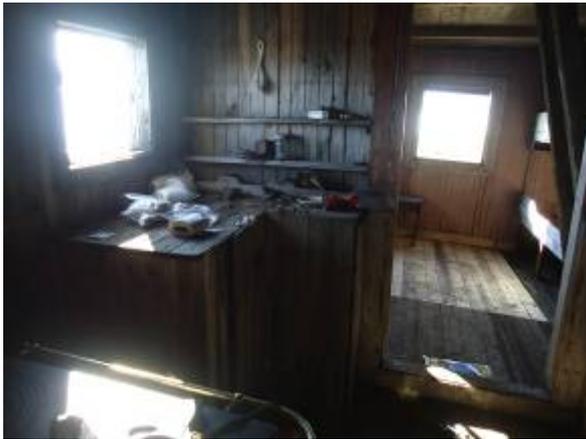
The bear had only made a small mess with the inventory.

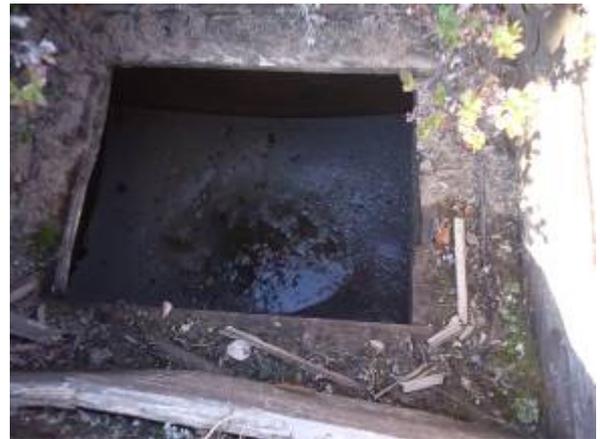
The summer fridge – probably 85 years old.

A little curiosity we found on the site was a simple but very effective summer fridge. It was dug down to the permafrost, the ground was made skidfast with boards and a lid was put on top.

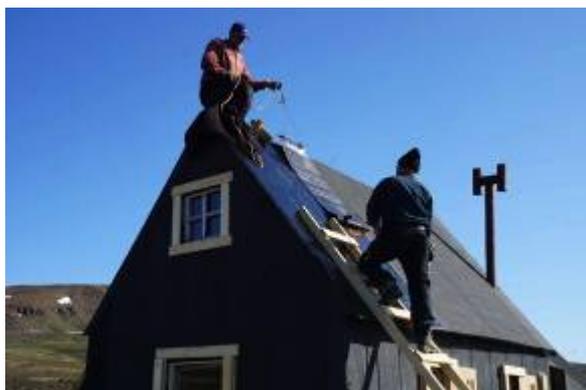
Finally it begins to take form.

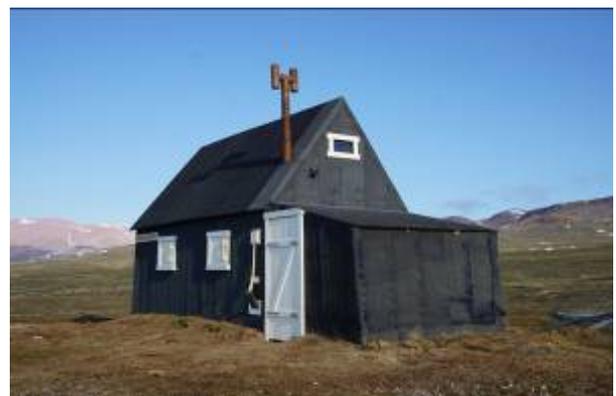
The final result was quite reasonable.

We worked on finishing the hut up until late afternoon August 9th. Outer felt was welded on everywhere, and, despite the flammable wood, only once it was necessary to remove the newly welded felt to reach some smouldering wood dust beneath.

were framed. New shutters were produced and fitted to all ground floor windows, and a holder for shovels was made and put next to the main entrance in the outhouse. The outer part of the stove pipe was dismantled and made secure by reinstalling.

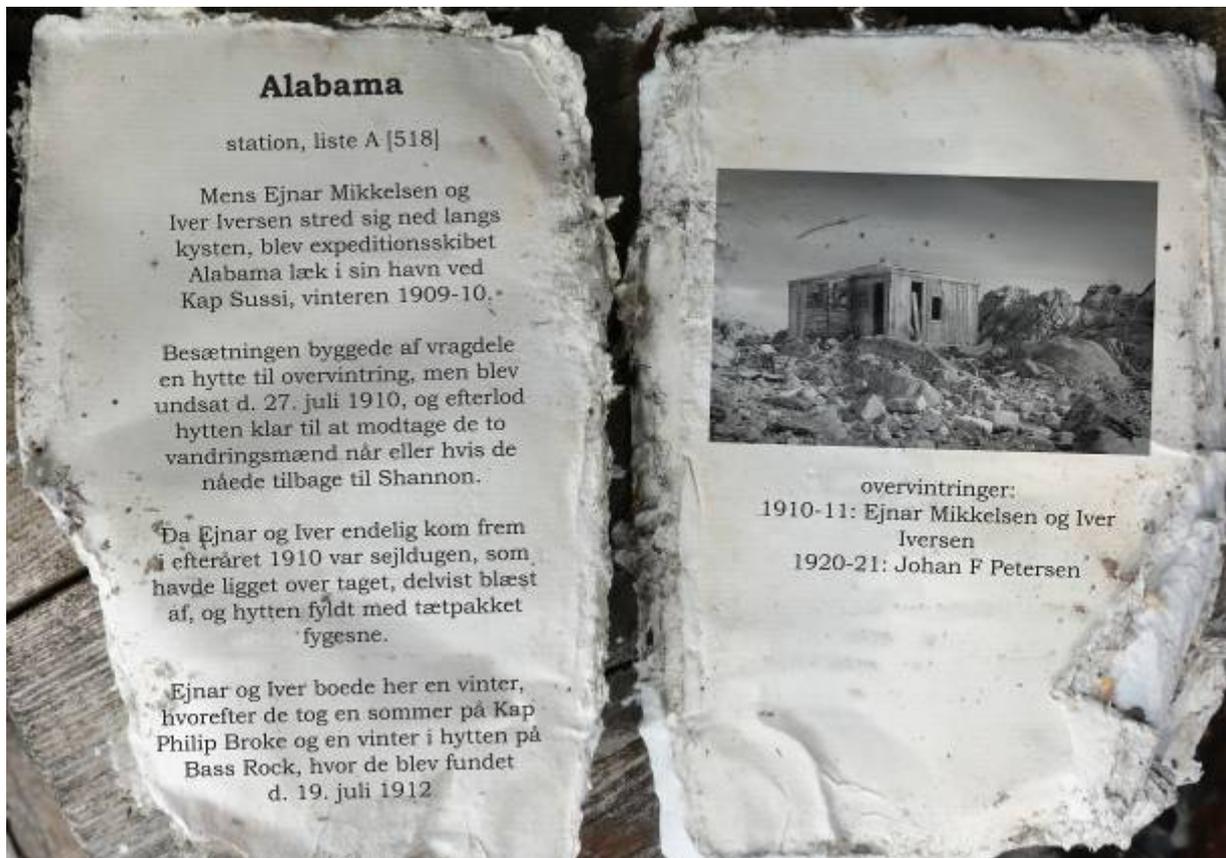
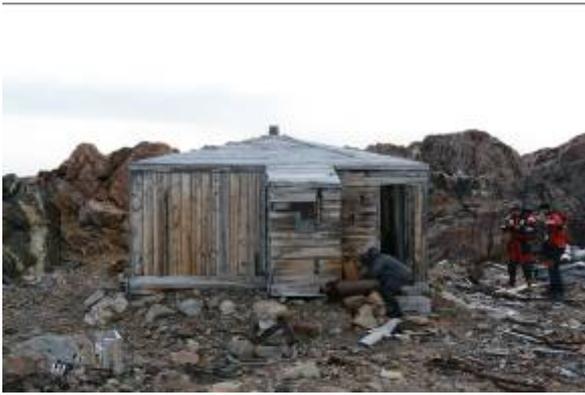
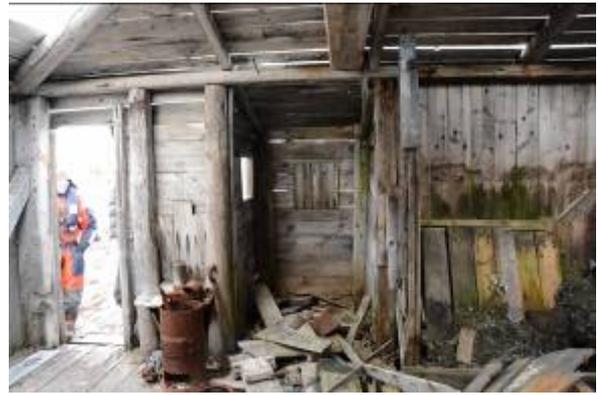
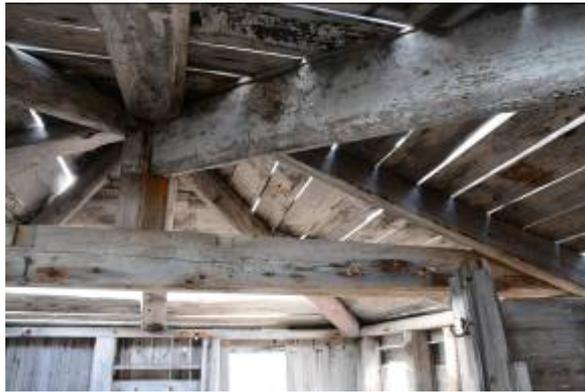
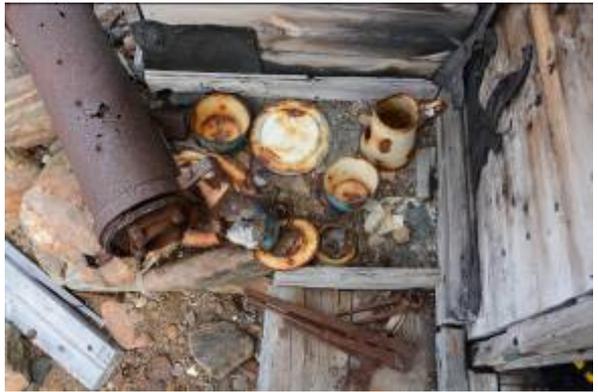
Alabamahuset outside and inside

museum in Nuuk. We immediately start to measure, register the condition of the house and photo-document. It is around loose objects, such as wooden parts and textiles, in the house that damp has accumulated, and it would be a good idea to empty the house for these objects, so the woodwork gets a chance to dry out.
