Field report from the journey to North-East Greenland 2016

Alabamahuset secured!

Field report for the "Alabama team" 2016

Field report for the "Ella Ø team" 2016

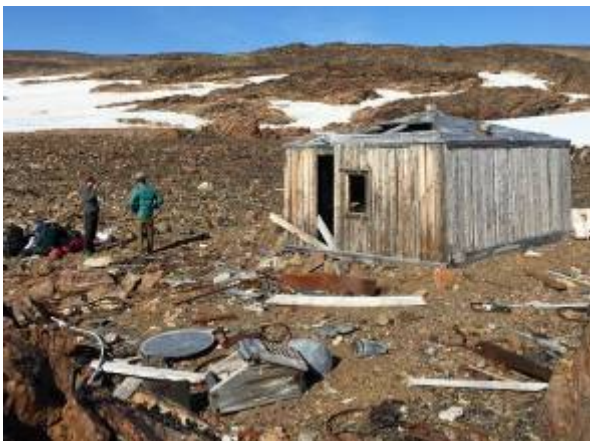
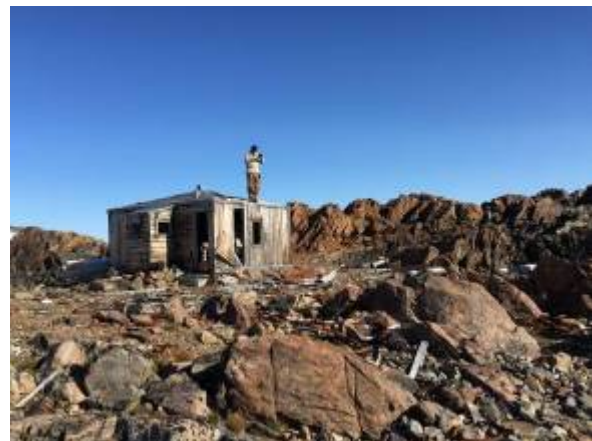
Arrival at Alabamahuset. We try to make an overview of the situation.

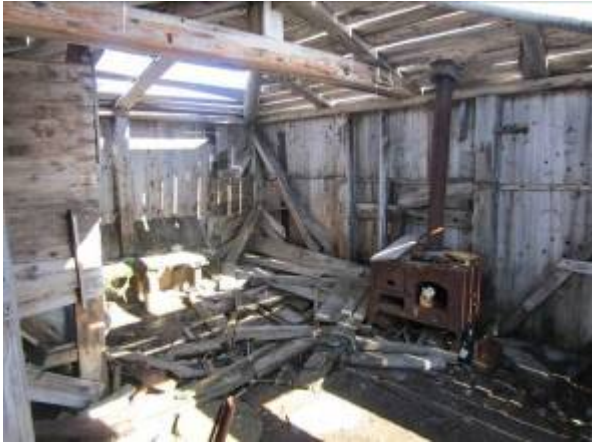
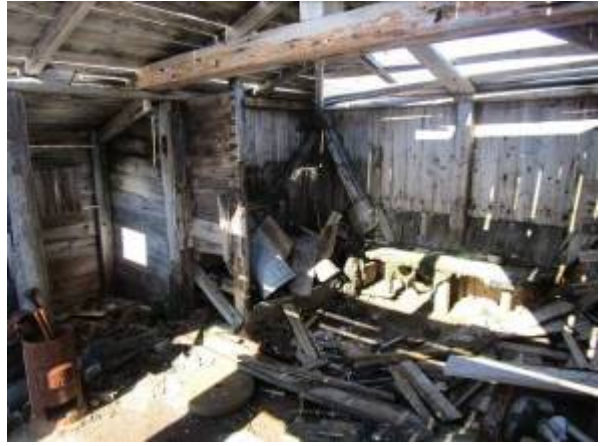
Alabamahuset inside upon arrival

The bottom layer on the floor can best be described as a 5-10 cm layer of composted clothes, books, and furniture mixed with some items that must have been placed on shelves, on the table, under the bed and in boxes standing around.

Our first priority was to be able to stay overnight in the hut because of the great risk of bear visitors in the area, so after having taken photos of the ground around the hut, our first task was to clear out everything from the hut. We made an effort to take everything out in the order and correlation in which it had fallen down over the years, and everything was placed in numbered piles. When boards, furniture, coal stoves and boxes under the beds had been carried outside, there was only the layer of compost on the floorboards left. This we put into rubbish bags, and it was later put into a wooden frame 20 m west of the hut with all the extra wood from the hut that we could not find any use for.

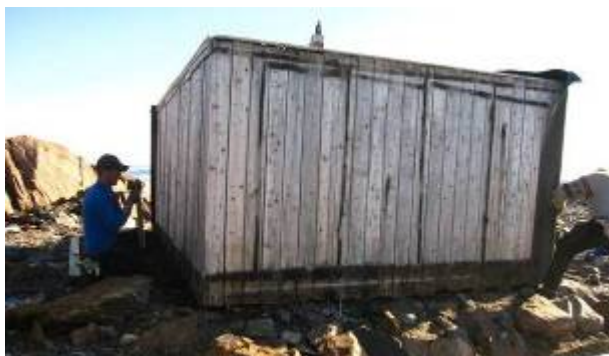
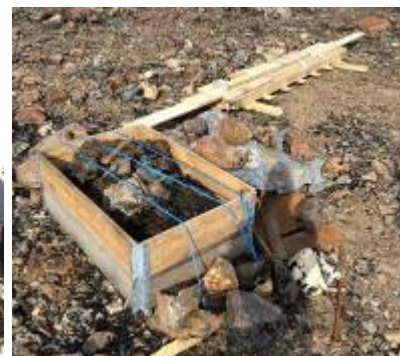
Inspection of the foundation and the lower planks outside the wall planks also had high priority. Originally, the hut was built on sand and grit, and then the same material was piled up the walls to prevent draught in the hut. This we removed to get an idea of

We removed all moisture binding material around the hut, made room for airing under the roofing felt of the walls and dug out to make a drop away from the hut. When boards, furniture, coal stoves and boxes under the beds had been carried outside, the only thing left was the layer of compost on the floorboards. We put this into rubbish bags, and it was later put into a wooden frame 20 m west of the hut with all the extra wood from the hut that we could not find any use for.

the need for extra support in case of rot. We were able to ascertain that the hut is built on three floors, where the lowermost was very damp and showed signs of incipient rot. Two deck planks, the one on the north wall and the one north of the porch on the west wall, showed much rotting, but are still connected. We assessed that the deck planks had no significance for the stability of the hut and that the authentic appearance of the hut was best maintained with the original deck planks, so these were kept for drying-up. We removed all moisture binding material around the hut, made room for airing under the roofing felt of the walls and dug out to make a drop away from the hut. Next, with the available materials and larger stones, we built a snow guard up the walls of the hut, which will help ventilate under the hut in the summer and quickly become sealed with snow in the winter.

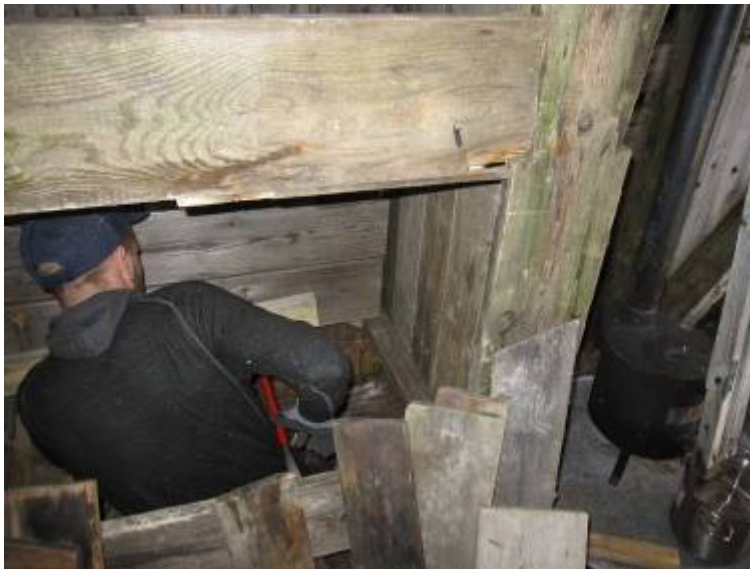
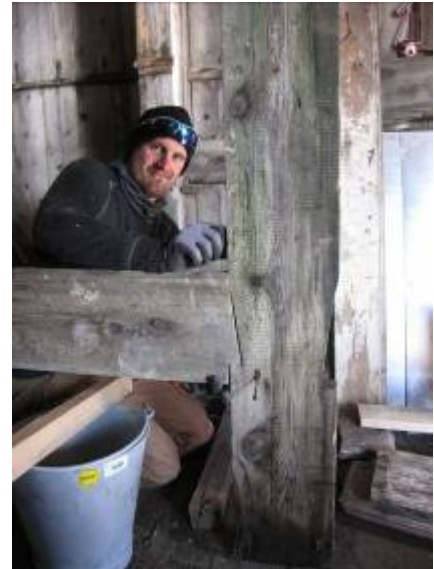
On the east wall, the freestanding pillar by the bunks' bearers was a mystery. The two east-facing bunks' bearers were attached in some characteristically recessed fenders. On the other side of the pillar there were identical fenders.

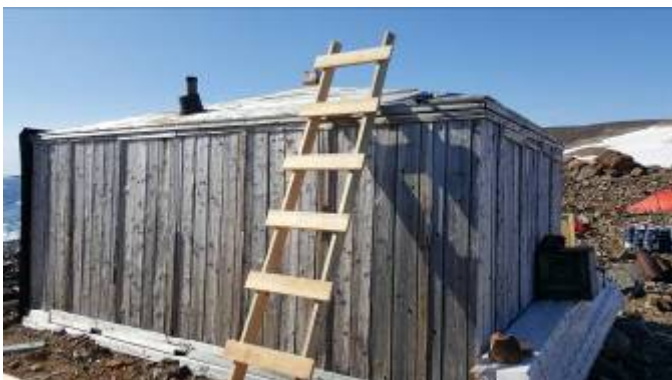
All of the roof boards were re-nailed so the roofing felt was not put on an unstable base.

The missing boards had blown less than 10 meters away from the hut and were reattached without any difficulties. A single extra jack rafter was installed out of necessity to scaffold the roof surface facing north. All the roof boards were re-nailed so the roofing felt was not put on an unstable base.

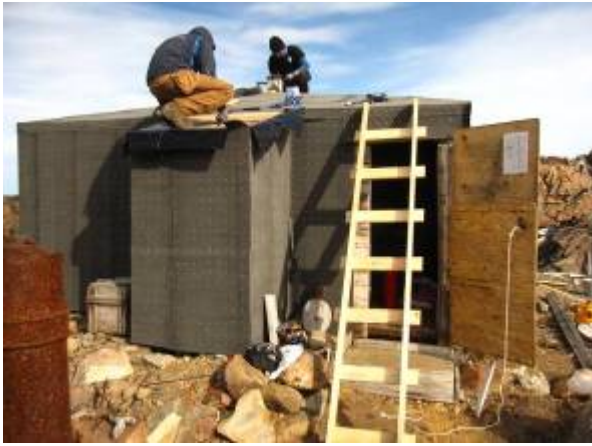
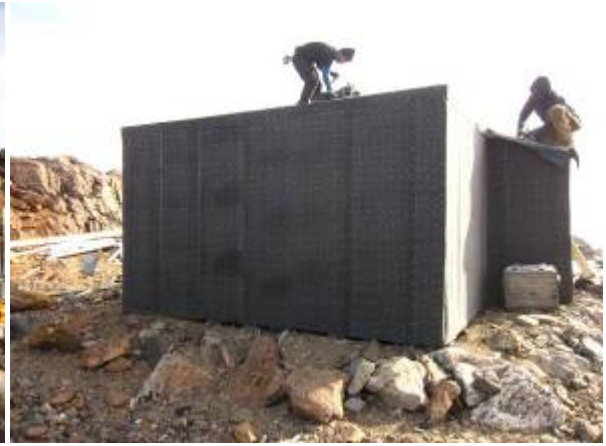
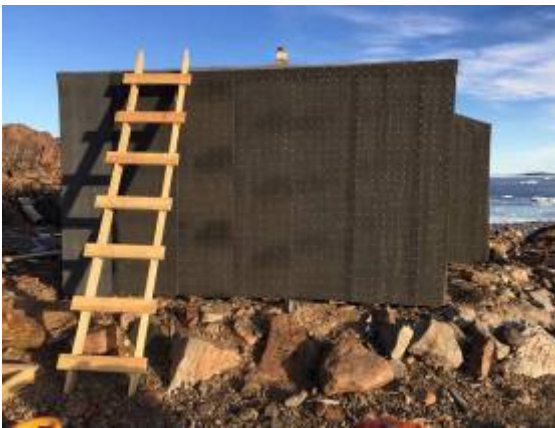
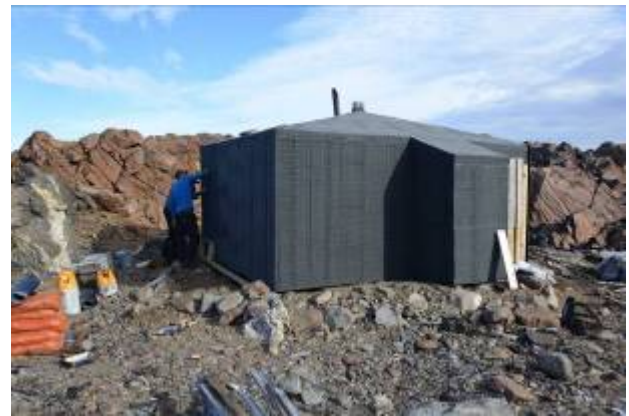
Walls and roof were covered with inner roofing felt, which was nailed on with 25 mm roofing nails. 18,000 roofing nails in total with 5 cm in between.

Lots of the nails had fallen out, and we found them around the house and put them back. Many wall planks were loose because of weathered iron nails. These were nailed back on. On the outside of the walls were old boards, fillets and window frames, which held in place roofing felt, zinc plate and sailcloth. These were measured, photographed and taken off with the hardwood wedges that we had brought. A few fillets were so thin, worn after a 100 years of wind, that they split and had to be glued, before they could be reinstalled.

Walls and roof were covered with inner roofing felt which was nailed on with 25 mm roofing nails; 18.000 in total with 5 cm in between. Next, in an increased state of fire readiness, the outer roofing felt was melted on with overlap considering water from above and the predominant wind directions (NE and SW). On the roofing felt of the walls the original fillets etc. were attached precisely where they had been installed previously. Outside, to the left of the door, a shovel holder with shovel was put up.

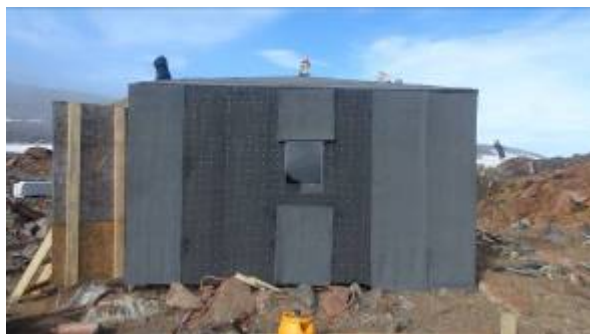
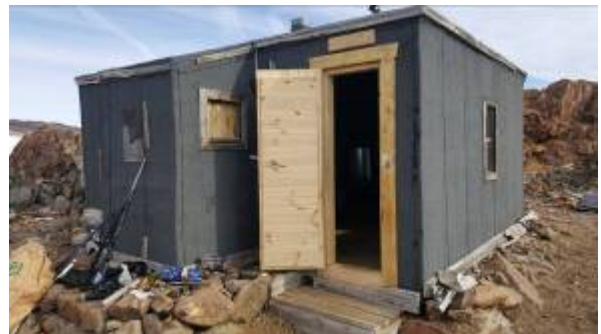
The outer roofing felt was melted on with overlaps considering water from above and the predominant wind directions (NE and SW).

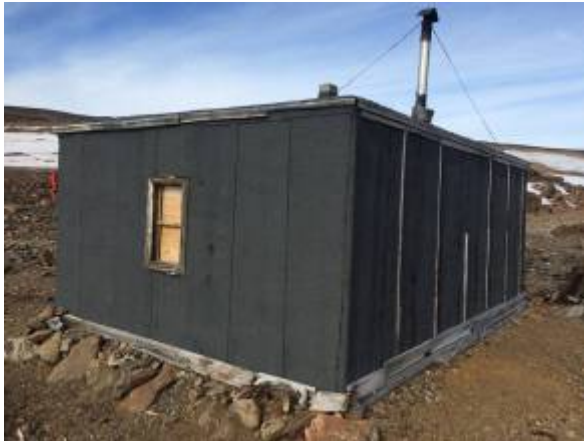
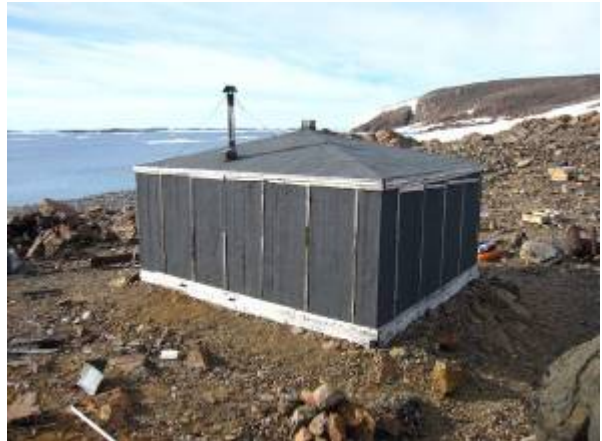
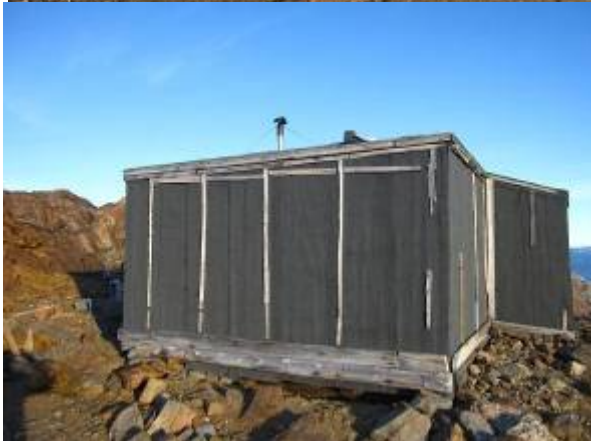
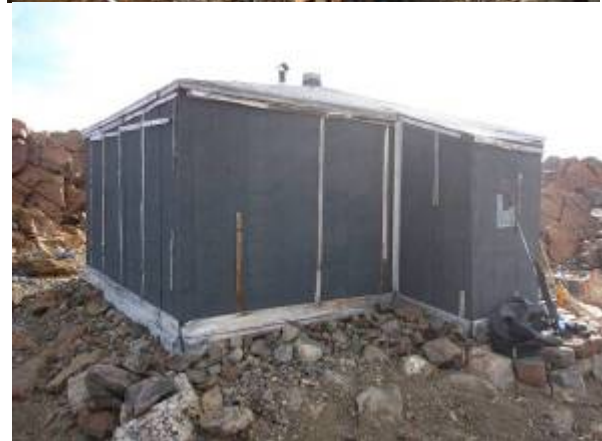
On the roofing felt of the walls the original fillets etc. were attached precisely where they had been installed previously.

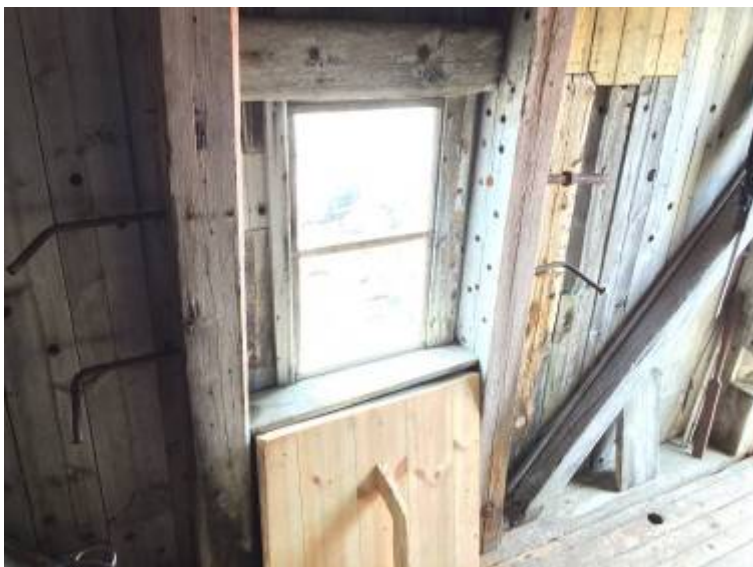
Because of the visits from the bears, we decided to produce shutters for the windows to improve the bearproofing of the hut. We installed the shutters on the inside to keep the original appearance outside.

We had visits from 5 polar bears during the 12 days we were renovating the hut. The bear alarms work as intentioned. Due to these visits, we decided to produce shutters for the windows to improve the bearproofing of the hut. We installed the shutters on the inside to keep the original appearance outside.

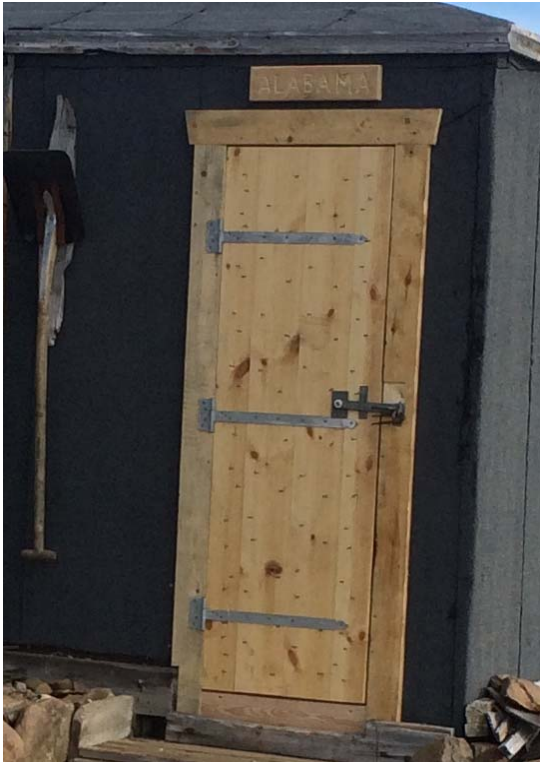
Unfortunately, the new, replicated sign and the new door did not reach us in time. Instead, a temporary sign and a solid door were produced from available materials.

By the entrance of the door we found handle and door spring, hinges and keyhole frames. However, we did not find any trace of a door. Its fate remains a mystery. We expected the door to be missing, and there had been taken measurements for and produced a ship door in teakwood similar to the door seen installed in original photos from 1910. Similarly, measurements had been taken, and an exact copy of the original Alabama-sign, seen installed over the door in original photos, had been produced. Door, sign and some lighter roofing felt for the roof (in a colour corresponding to the lighter sailcloth that originally covered the roof) unfortunately stranded in Reykjavik due to a stupid mistake by the Icelandic shipping company. Instead, a temporary sign and a solid door were produced from available materials and uniform roofing felt was used for the walls and roof. There is space available for the replicated sign above the new door, which has the same outer measurements as the teak door, so both sign and door will be easy to replace when the opportunity arises.

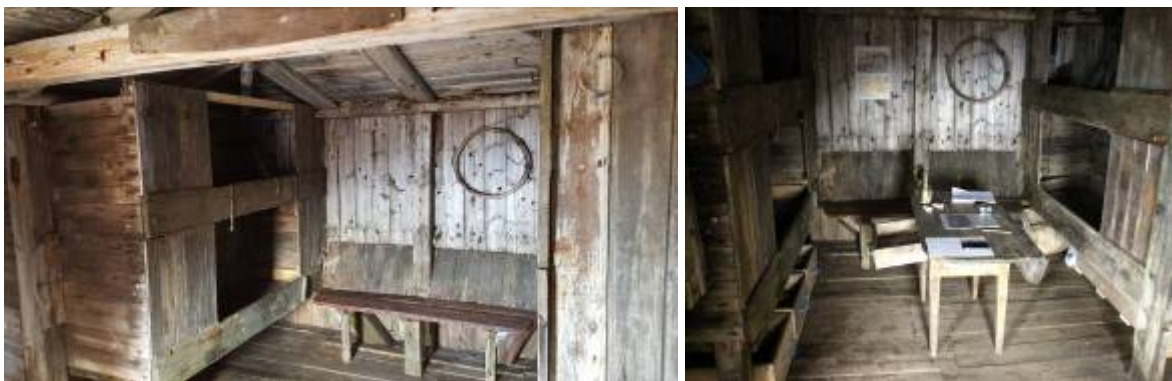
It was a big puzzle assembling the fixture and installing the things exactly like they had been, and it involved the work of comparing the position of each plank and board to nail holes.

As mentioned earlier, all the bunks, partitions and shelves were damaged when we arrived. It was a big puzzle assembling the fixture and installing the things exactly like they had been, and it involved the work of comparing the position of each plank and board to the nail holes. On the east wall, the freestanding pillar by the bunks' bearers was a mystery. The two east-facing bunks'

bearers were attached in some characteristically recessed fenders. On the other side of the pillar there were identical fenders. As we found some planks used for sealing the lower east-facing bunk, it became evident that the identical fenders marked the location of the last two bunks, which the house naturally had had when the six crew members were living there. The remaining wall fillets supported this theory. When Ejnar Mikkelsen and Iver Iversen returned, they had decided that they did not need six bunks. Therefore they removed two bunks and improved the remaining bunks with the materials and moved the stove to a better position.

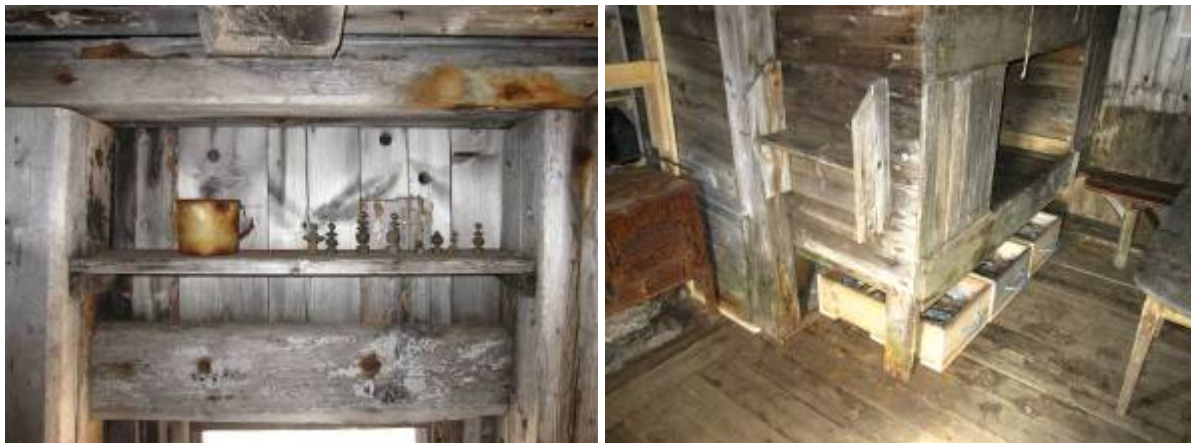
The last details are taking form.

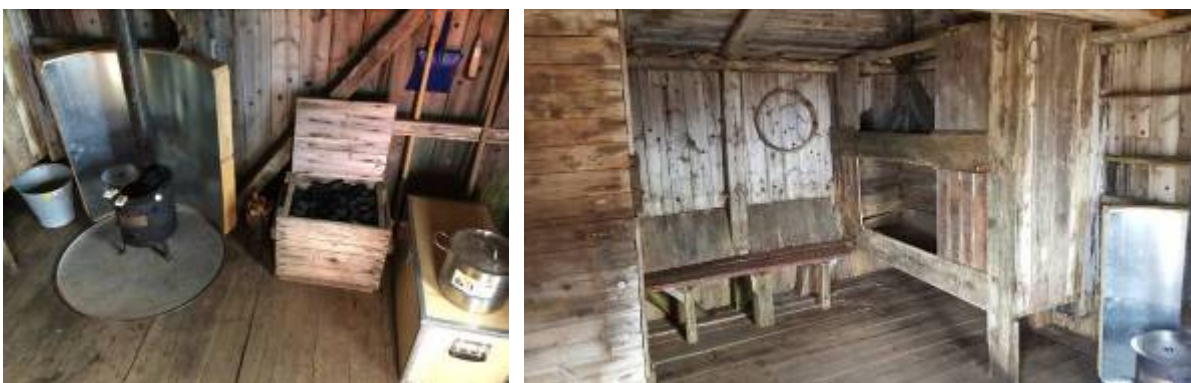
The round shape of the cover plate called for a similar round reflecting screen which was produced from the materials in which the Nanok stove had been packed.

returned from their expedition and found an empty hut, filled with snow, instead of a ship with a crew. We have blocked up the stove with rocks because the legs are unstable and loose in their sockets. We have set up a Nanok stove in the location where the old coal stove was. The place already had a feed through for the stovepipe and was chosen for the functional stove of the house by Ejnar and Iver. When we used the stove to dry up the hut, we realised the need for installing a reflecting screen against the wall and a cover plate on the floor. As a cover plate we used the end of the old water drum, visible next to the kitchen tent on the photos from 1910. The round shape of the cover plate also called for a round reflecting screen, which was produced from the materials in which the Nanok stove had been packed. The original feed through was a 250 mm pipe, which must have served as a kind of deck feed through on the ship. The stovepipe for the Nanok stove is 100 mm so this left some room for rain and snow to enter. To seal this hole, from the torn zinc plates lying around

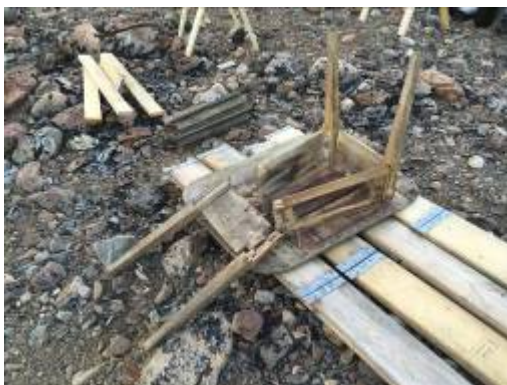
Captain's table before and after restoration.

In the middle of the pile of wood pieces on the floor, we had found the sad remains of a peg joined ship table with flap, drawer and grommets for wallmounted hooks on board the ship. It had been twisted many times. The pieces were many, and the damages extensive. After four days of gluing, fitting,

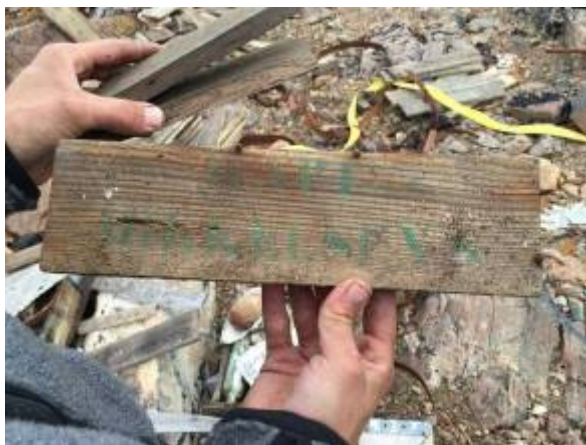
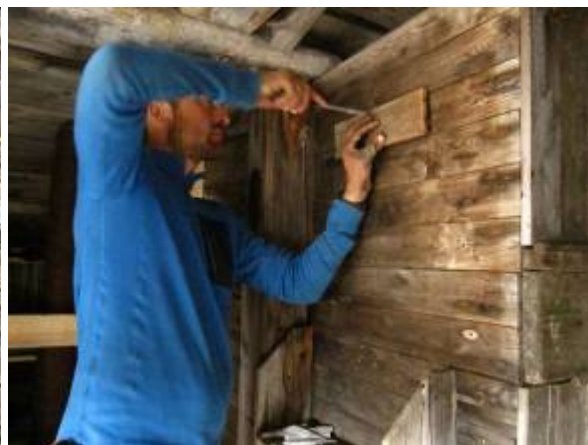
Bjørn attaches the "Kapt: Mikkelsen" sign to the wall. Captain Ejnar Mikkelsen was Bjørn's great-grandfather.

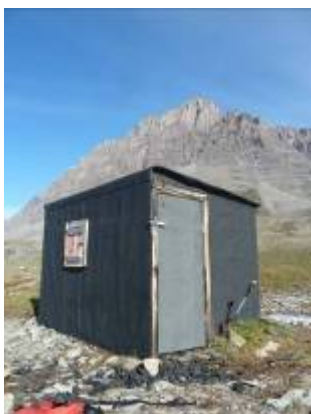
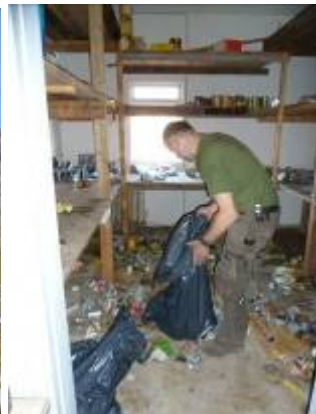
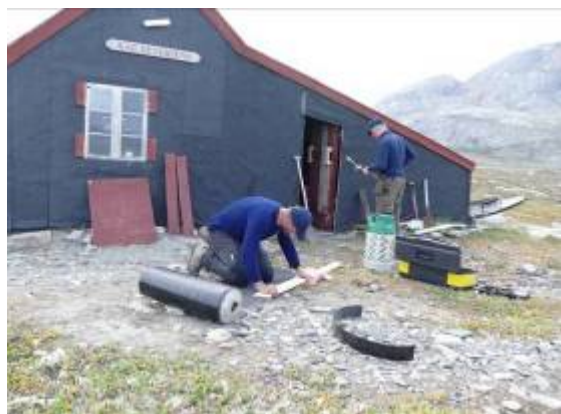
Left: Kongeborgen [224-2] has received a new door. Middle: Tidying damaged provisions in Nyhavn. Right: Reparation of roofing felt on Kap Peterséns.

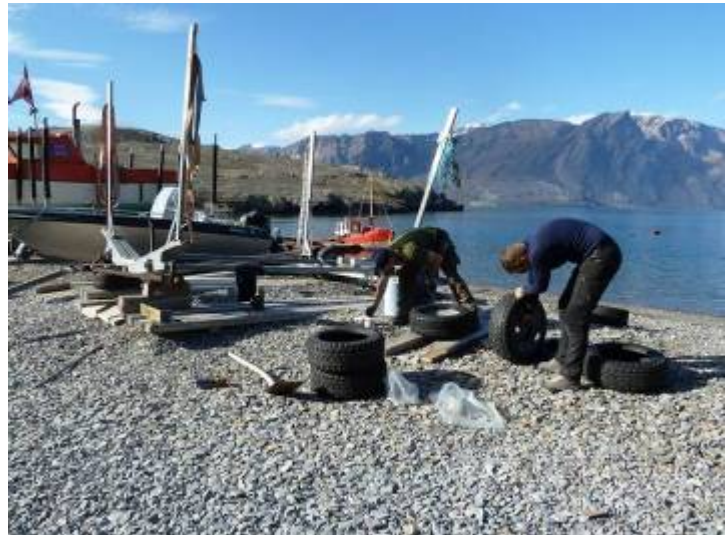
Renewing the old, rotten tires of "Agsut"s cradle.

Meanwhile we had also dealt with some other tasks at the station. We had renewed the old, rotten tires on the cradle for "Agsut" and mounted a new hp emergency motor on Brebøl-jollen. Furthermore, Jesper had exchanged the defect Eagle echo sounder in Brebøl-jollen with a new Lowrance Elite7 Ti echo sounder, which, despite Jesper's persistent effort and adjustments, only works at relatively low speed, as expected, unfortunately.

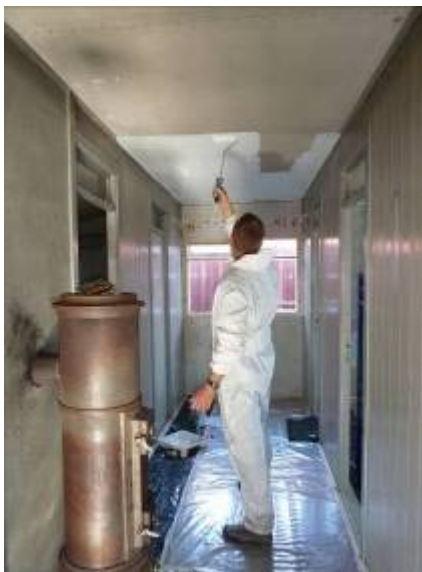
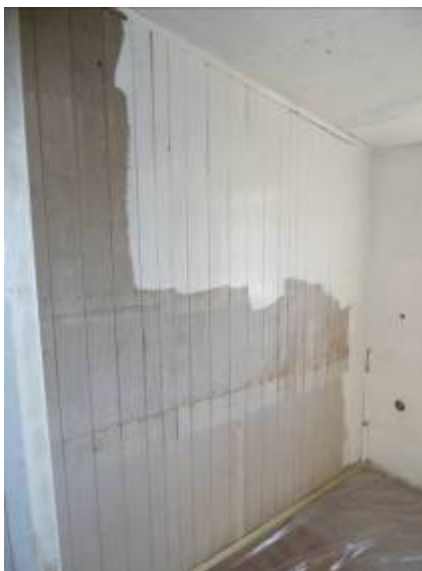
Tolvmandsbarakken was painted inside from floor to ceiling. It takes time, but it is worth the while. In the middle the central coal stove of the barracks can be seen.

we used custom-made linseed oil painting in authentic colours. When we arrived at Ella Ø, the barracks, besides a kitchen-dining area, also had five rooms, each furnished with a bunk bed. However, we soon realised that two of the rooms were too small to be properly functional. Therefore we took down the partition between these, so Tolvmandsbarakken now has four functional rooms, each with a double bunk bed. By 17 August we had got so far with painting and furnishing that we could move from Ørnereden into Tolvmandsbarakken. There was also lit a fire in the central coal stove and a nice warmth quickly spread through the entire house. The stove works well, by the way. It burns without

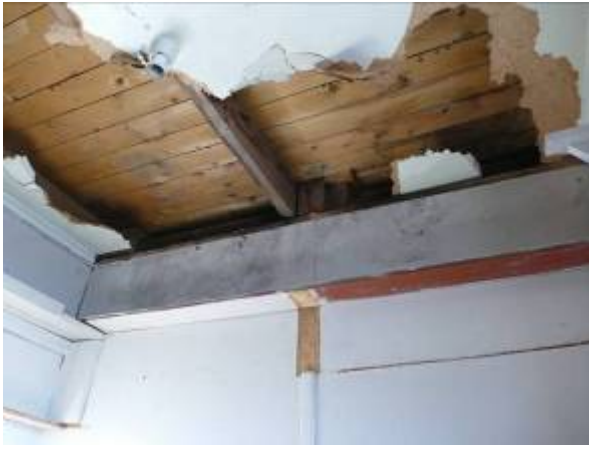
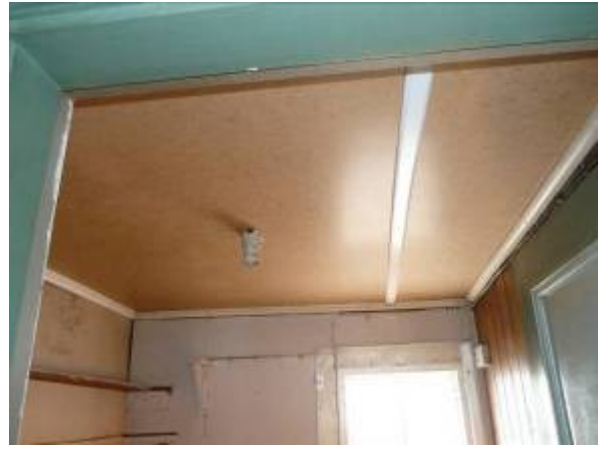
Left: In several of the rooms in Ørnereden the bear had destroyed the ceiling plates in 2013.

Right: New ceiling plates mounted and ready for painting.

In Ørnereden, Torben had renewed the masonite ceiling plates and fillets which the bear had torn down in the autumn 2013. Plates and fillets were finally painted with linseed oil paint in the authentic colour.

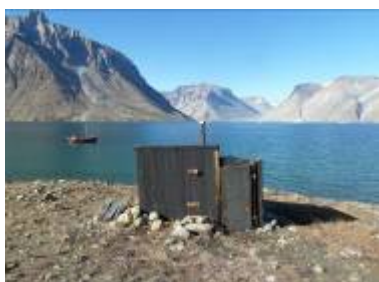
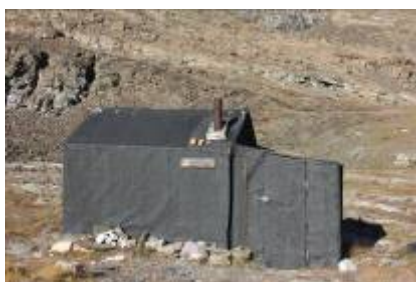
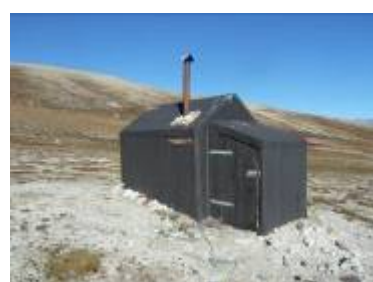
Rendalshytten [309], Renbughytten [325] and Kap Ovibos hytten [340] all in good condition.

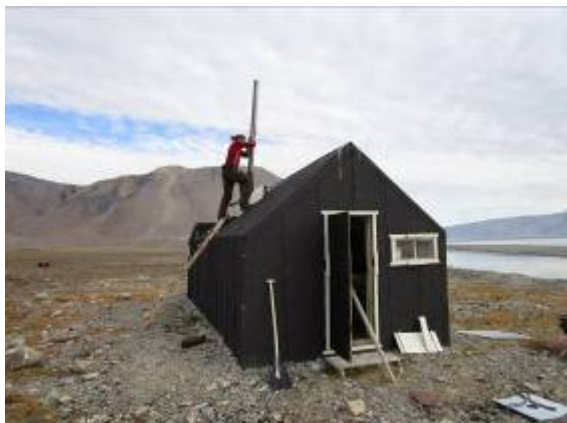
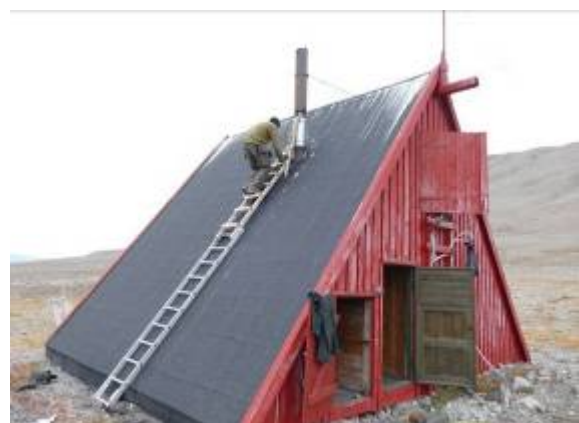
Left: New stovepipe on Strindberghuset [358-3]. Right: Emergency repair of stovepipe on Nordfjordhuset [358-2].

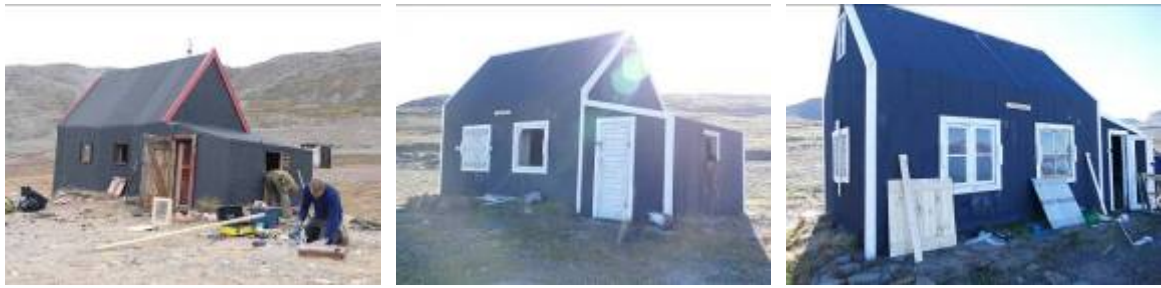
Left: Repairing Kap Humboldt [308]. Middle and right: Laplace [301] before and after.

The following morning we left Strindberg making for Kap Humboldt [308]. We arrived at 5pm and right away repaired the damages on the house, i.e. two shattered windows and missing roofing felt several places. Next morning we continued to Laplace station [301] in calm, sunny weather. No less than three windows and shutters of Laplace were destroyed by bear. Immediately we began our tasks and finished by 4pm. Considering the remaining time and tasks on Ella Ø, we decided to leave for Ella Ø straight away. In headwind we worked our way west through Sofia Sund and stopped by Arentz Hytten [304] and the Svedenborg [241] hut, which both appeared intact. After yet another nice and long day, we arrived at Ella Ø by 1am. The Siriusfupper were gone now. They had closed down their part of the station and left a few days earlier.

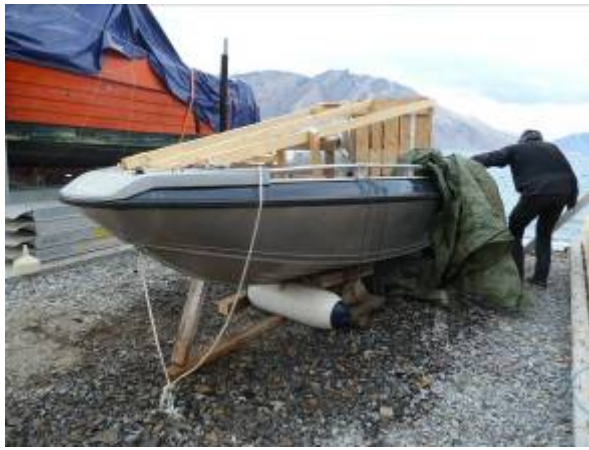
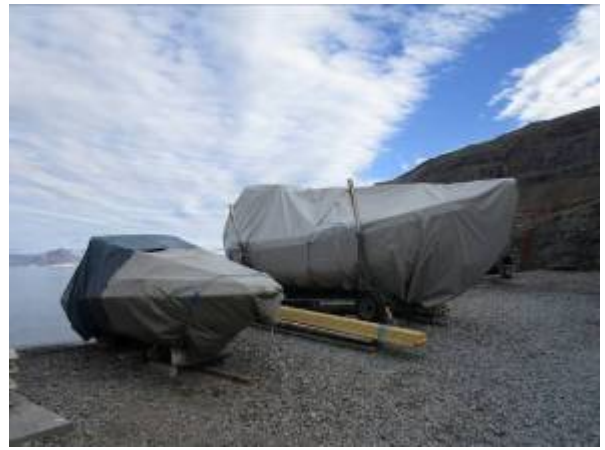
Lt: Preparing of Brebøl-jollen for winter. Rt: Brebøl-jollen and "Agsut" ready for overwintering.
