Field report from the journey to North-East Greenland 2019

Hvalrosodden – the hundred-year-old hut that was refitted and will not disappear!

Field report for the “Strindberg team” 2019

Field report for the “Hvalrosodden team” 2019

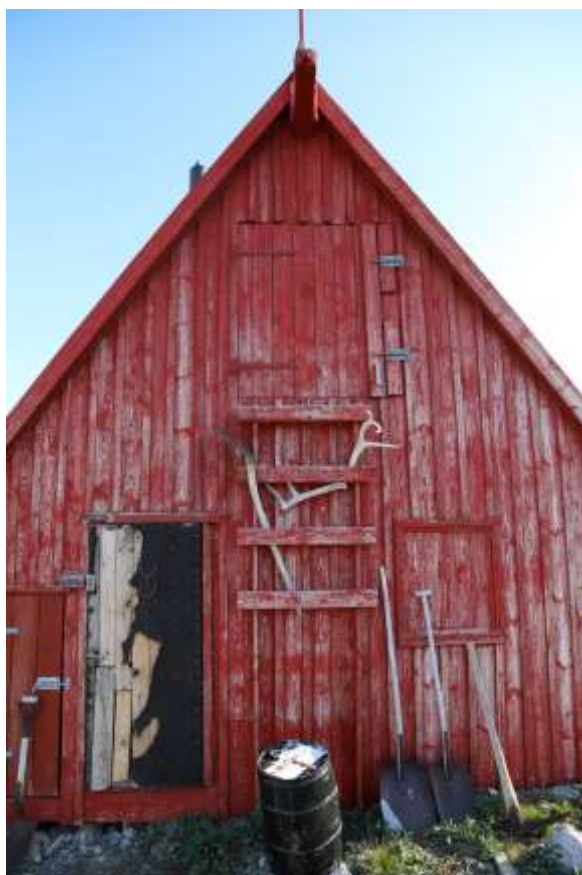
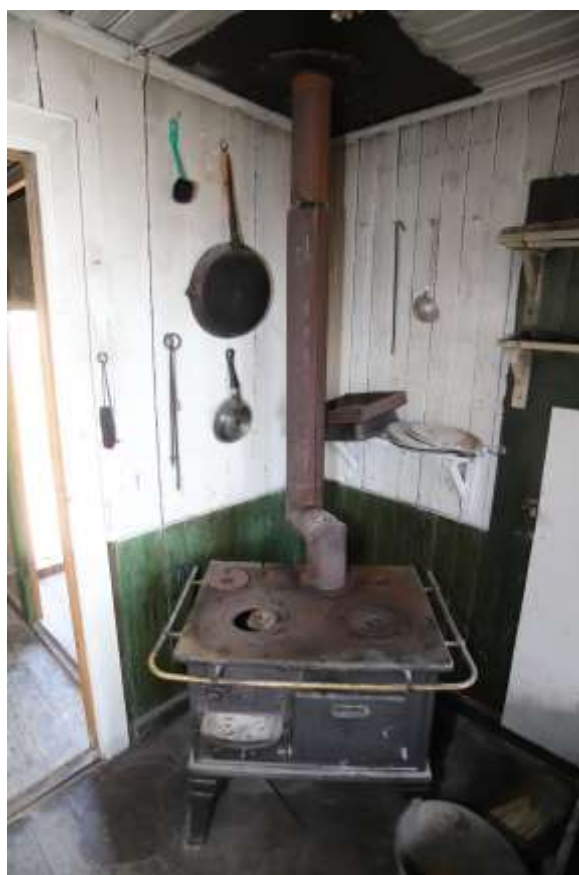
Outside, the wood was screaming for new paint, and the stovepipe was corroded in several places showing large holes. It is a wonder that the hut has not burnt down when guests have been using the coal stove. Many of the strips on the gable wood needed replacement, and both front door and porch door needed work to proof the hut against bear as well as drift snow and sands. Inside the hut needed a thorough clean-up and cleaning. At the same time, it was necessary to do a careful sorting of historical artefacts, which were mixed with the leftover from previous expeditions. In the common room of the hut, the walls, floors and inventory bore witness of many years’ usage of the coal stove. Porch, hallway and garret had been plagued by several years of drift sands. In the hallway the north-facing window had been covered, and the paint hung down in strips from the ceiling.

Condition before renovation.

The entire hut was cleared of inventory and stored-up effects. The bunks in the common room had been nailed thoroughly with very large nails to both walls and floor, and it took quite a while to unfasten them without damaging the original wood.

Having cleared the common room, irregularities and loose paint were scraped off the walls and ceiling, which were then washed down. After a day of drying, the ceiling and walls were painted. While preparing for the paint job, we realised that the original walls of the common room had been painted light green. Having brought along a dark green paint, we decided to give it a lighter tone to match the original light green colour as much as possible and create a brighter room.

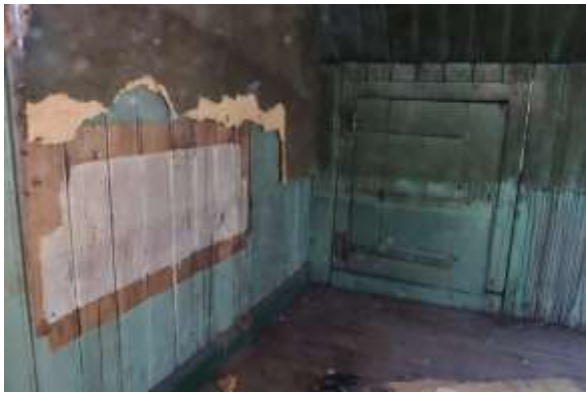
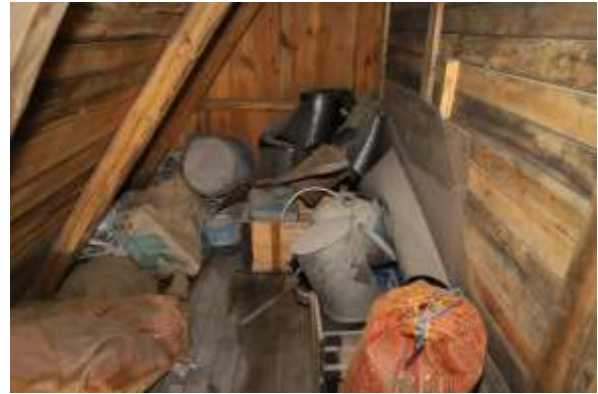
Before renovation. Left: Common room. Right: Porch.

From the materials of the old bunks, three new movable bunks were made. The solution was a compromise, where old fronts were reused and other parts were made from a mix of new and old. The old shelves and cabinets were thoroughly cleaned, and damages fixed, before they were reinstalled.

The two windows in the south gable and the covered window in the north gable were removed and replaced with new windows. These were made with puttied glass and according to traditional methods. The old shutters were replaced with new ones to make them bear-proof. Finally, the floor was scrubbed and scoured until the wood appeared once again.

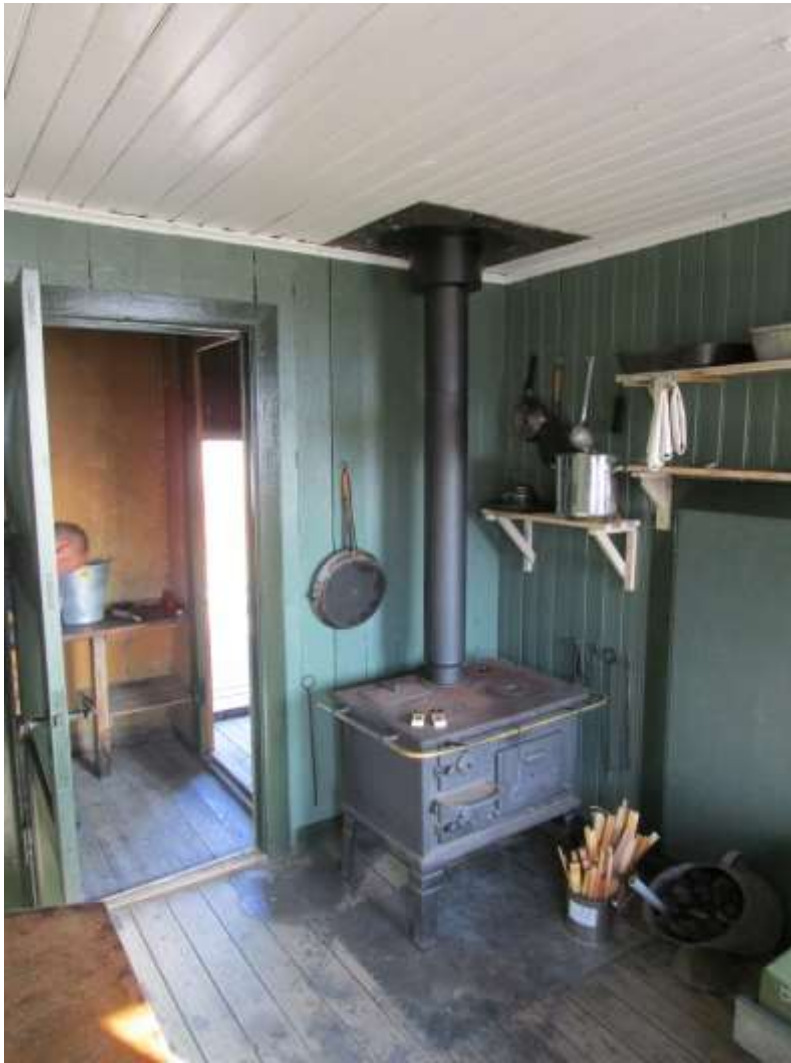
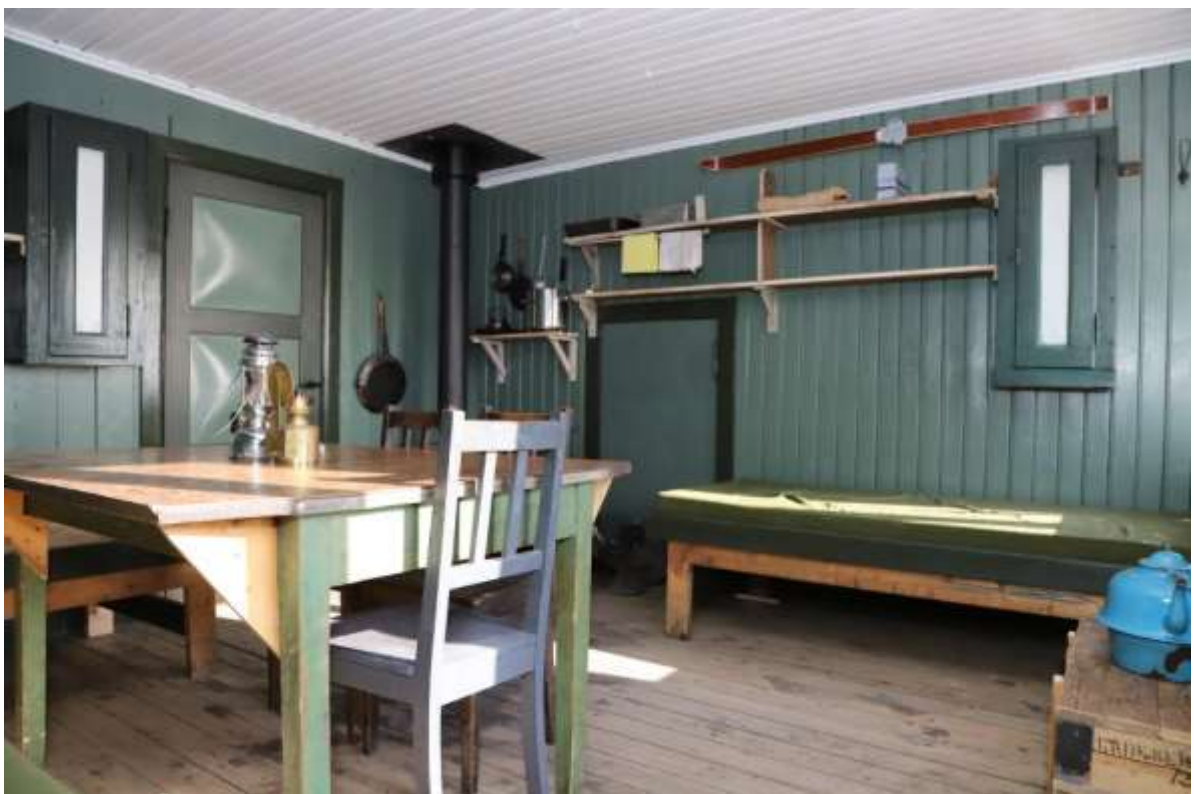
Nordfjordhuset after renovation.

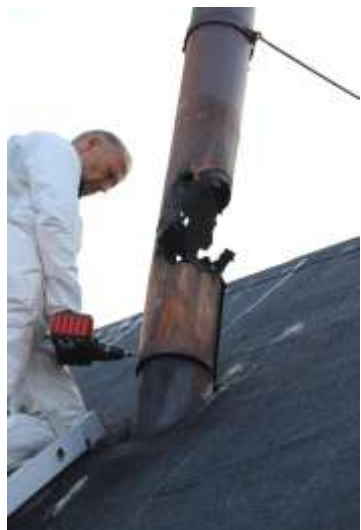
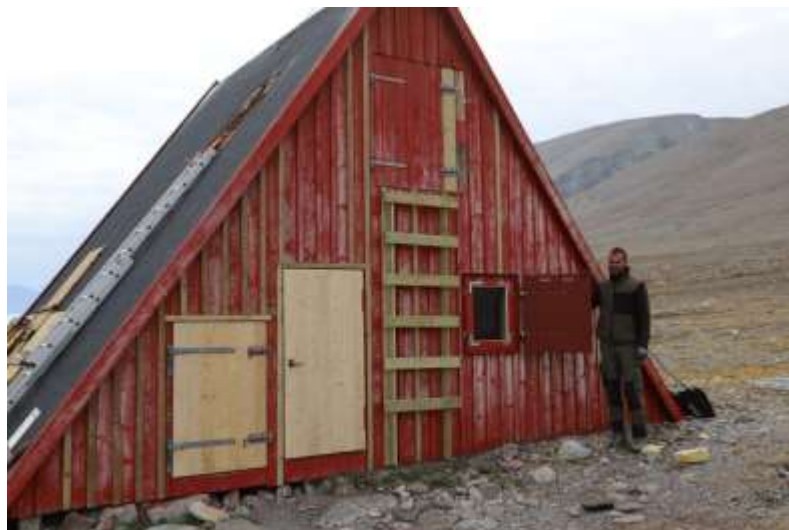
Outdoor renovation. Left: Jesper replacing the corroded stove pipe. Right: The wood was screaming for a new layer of paint.

Defect strips on both gables were replaced and then painted twice with Swedish red. Removing the old strips, it became apparent that the hut had also had a light green colour outside. However, in this case, we did not make a change of tone.

The front door, marked by previous bear visits, was repaired with new boards. These were installed on the old frame to show how the door looked originally. The door of the porch also received new boards and was sealed with wooden strips to reduce entry of drift sands and snow. Door of garret was dismantled, and bad boards were replaced. Hinges and barrel bolts were correctly remounted, so the door could be properly locked.

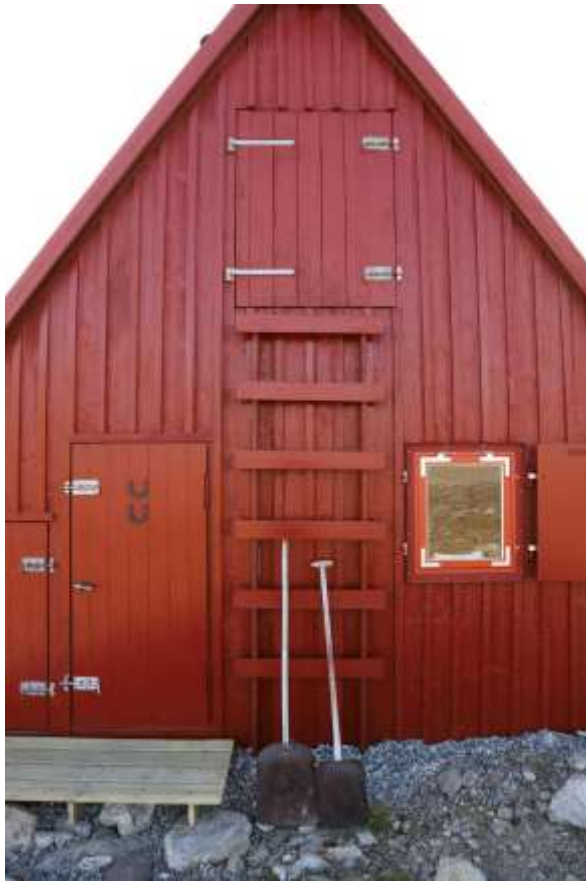
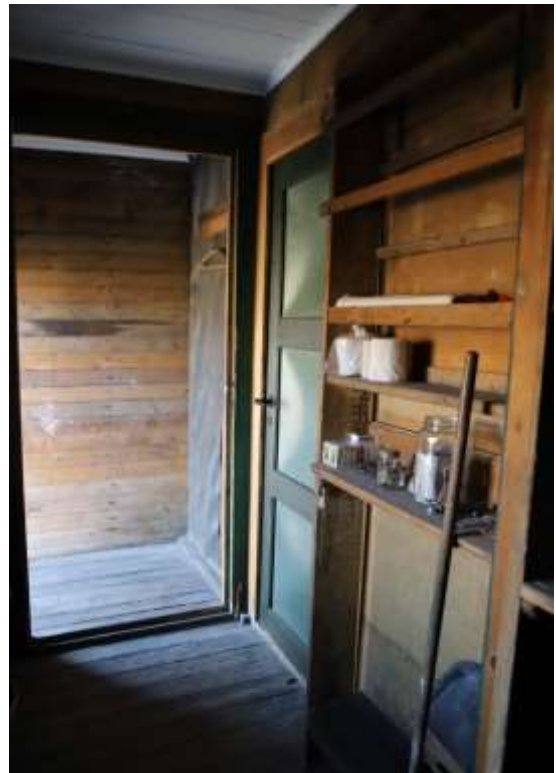
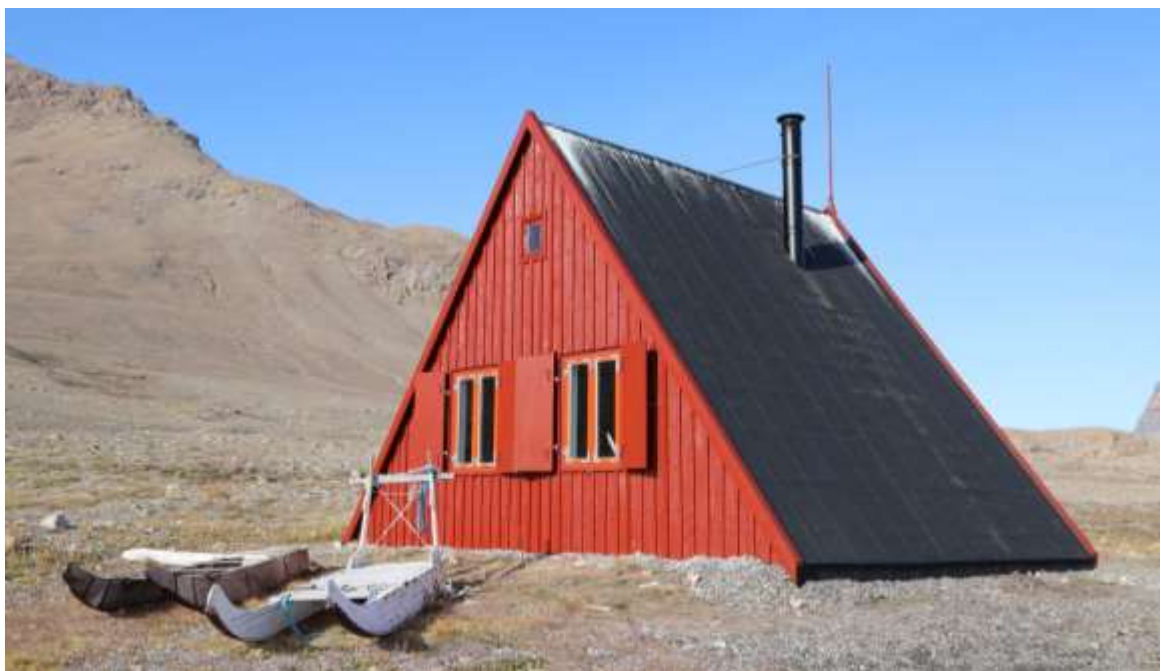
The newly renovated Nordfjordhus.

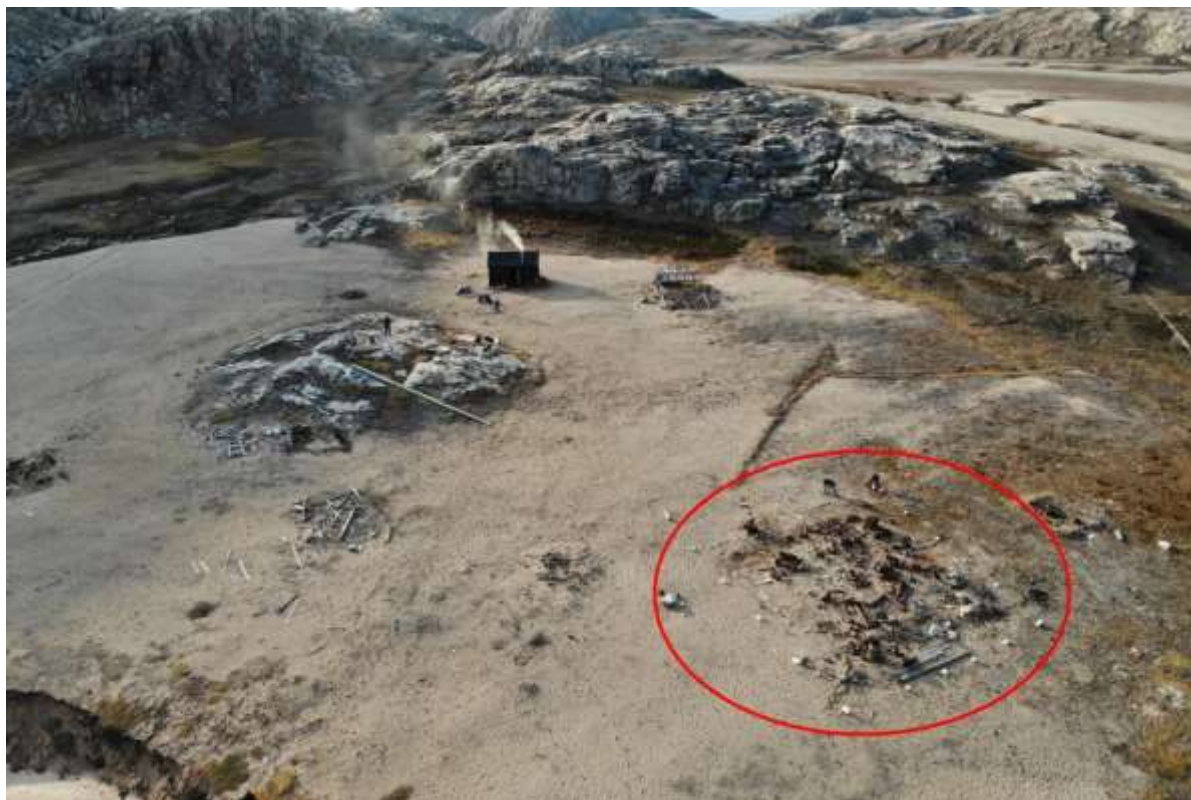
Eskimonæs [405]. The red circle marks the site of fire from the original Lauge Koch expedition hut that was burnt down by the Germans in World War II. The site contains many metal leftovers, and to better protect these against curious and light-fingered tourists, the ruin was marked as a "no-go"-zone with a square of white-painted rocks.

from the old expedition hut as a "no-go"-zone with a circle of rocks, painted in white paint. The following day, 17 August, we left Eskimonæs towards Loch Fyne. It was a grey day, but it cleared up as we were arriving at Loch Fyne [350], a lovely station and a fine location. After that we set course back north. After a short break at Breivik [404], we stopped at Elvsborg [407], which was also photographed and measured inside and out. Then quickly back to Daneborg and Sandodden, arriving around 20.30, just as the Saturday-mik at MarinBasis was beginning.

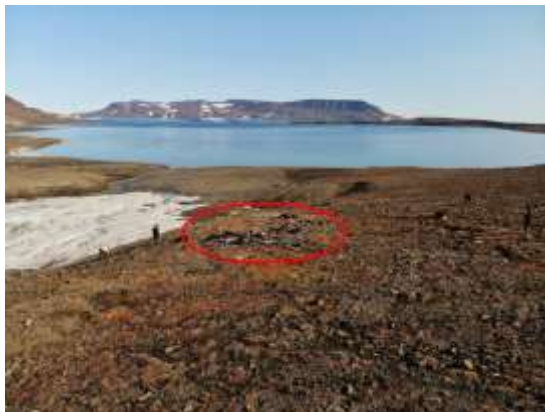
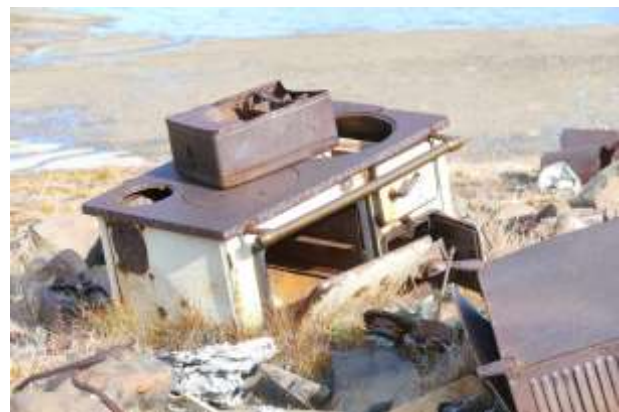
Hansa Bugt [457]. Left: The red circle marks the ruin of the "Alte Hütte" site. The ruin was marked as a "no-go" zone with white-painted rocks. Right: Leftovers at "Alte Hütte".

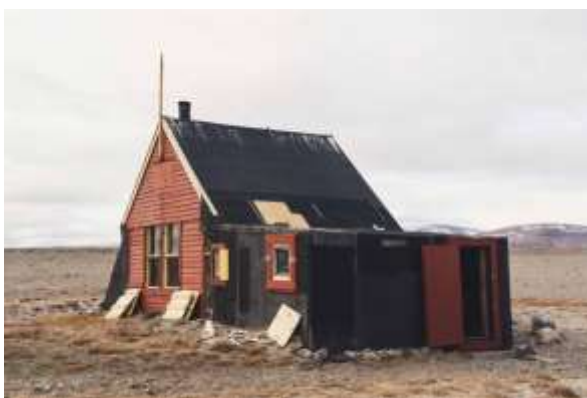
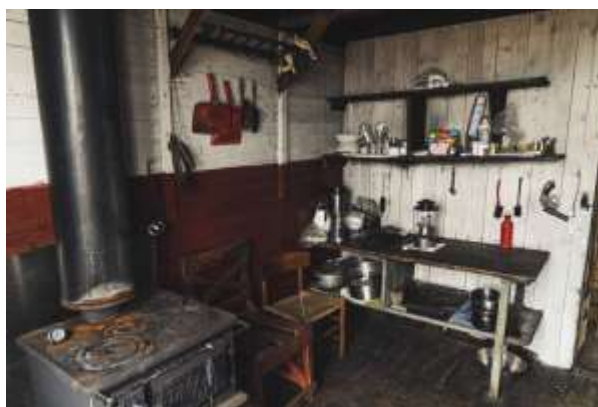
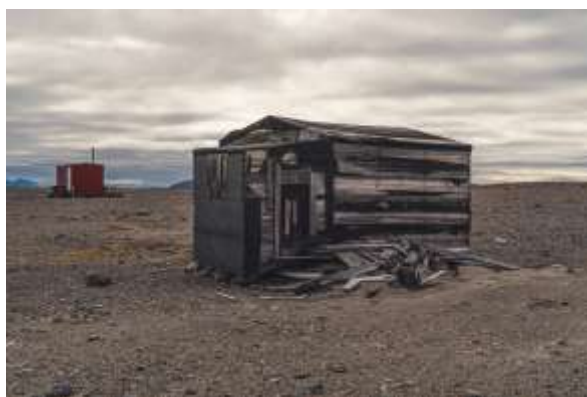
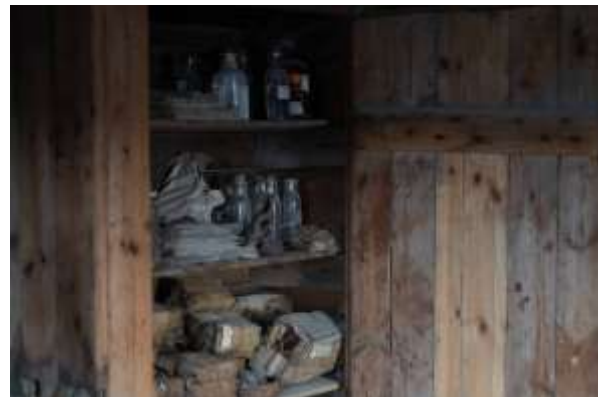
Having said our goodbyes, we went exploring in the fine old station. Even before we had left Denmark, we had heard a story (via Sirius) that a bear had been through the roof of the workshop and had had some fun there. The story was one hundred percent true. The bear had gorged itself on paint, tar and other delightful things. An emergency reparation of the roof had been done, but it was clear that a great deal of water had entered anyway. The workshop was swimming with a magnificent mixture of paint, nails, screws and water.

The small depot/coal storage to the left of the entrance was intact. Main room, kitchen and sleeping room were filthy and sooty, but otherwise in a good condition.

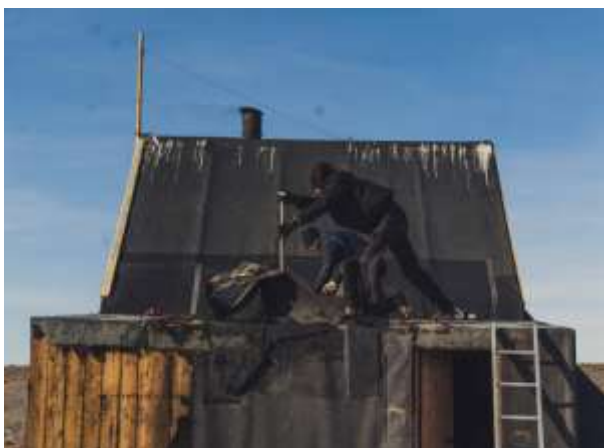
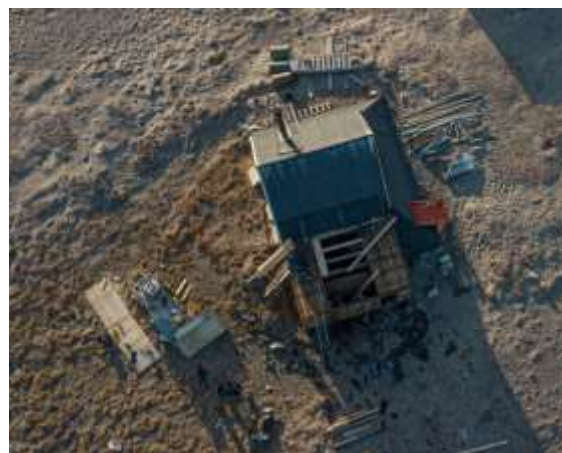
Renovation of the roof on the appertaining shed.

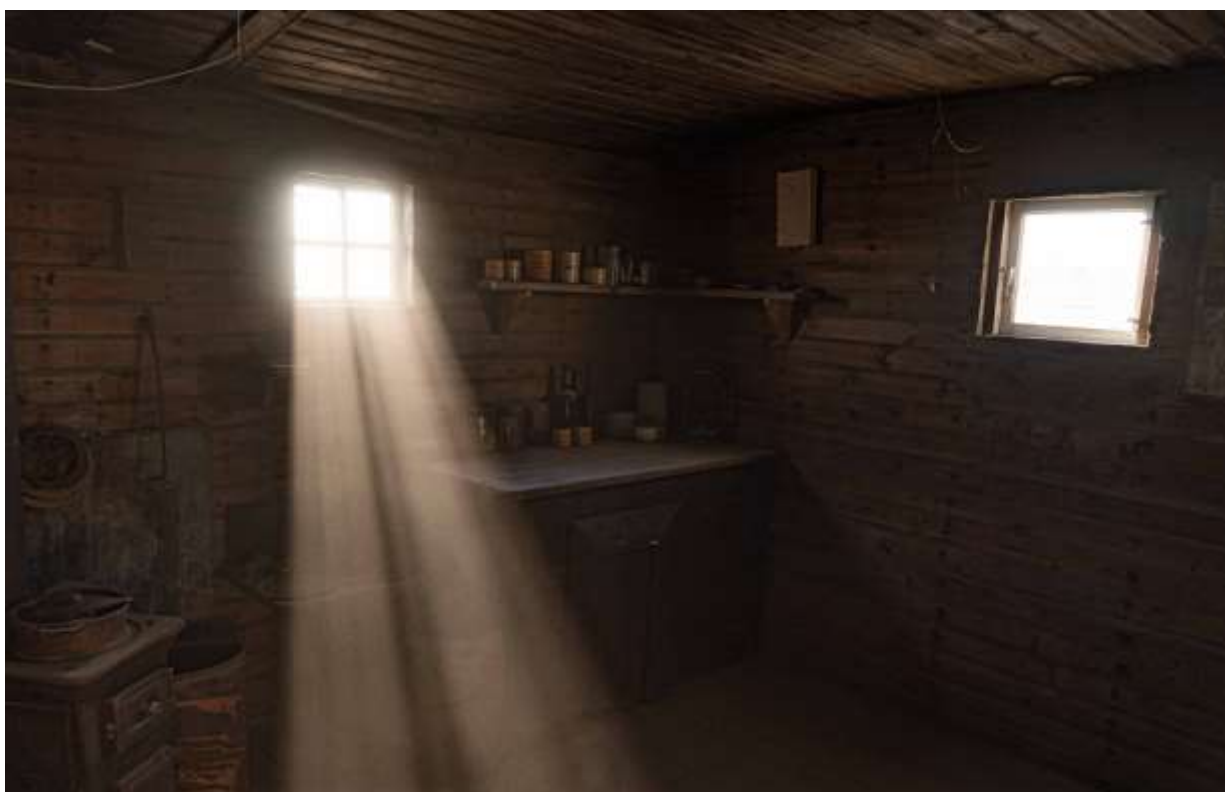
Atmosphere inside Alwin Pedersens hus after Nanok cleaning, clearing-up and gentle restoration. The interior of the hut is possibly in almost the same condition, as when the zoologist Alwin Pedersen left it in 1939, - that is, 80 years ago!

Alwin Pedersens small hut, located approx. 35 metres north of Hvalrosodden, was more and less in the same condition, as when Pedersen left it in 1939. The interior of the hut, including miscellaneous research equipment, was in a good state. The roof looked almost watertight. The exterior of the hut – except for a few boards here and there – was in good condition, too.

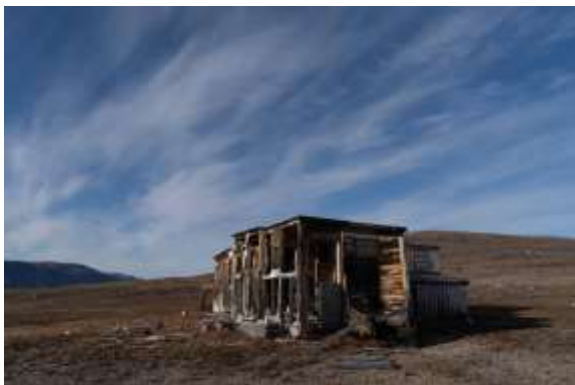
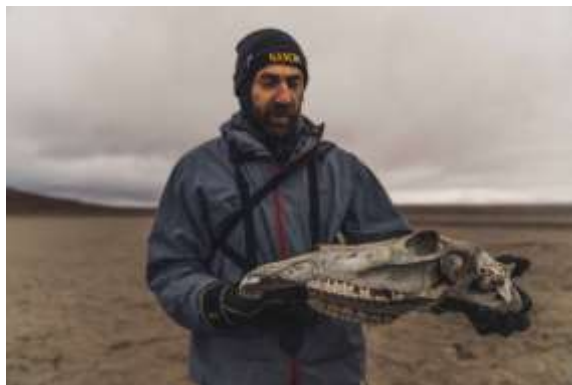
Left: Mørkefjord [641] station was used in the years 1938-41. Today the hut is in such a poor condition that it probably can't be renovated. Right.: Henrik with a horse cranium, possibly from "the 1912-13 Danish Expedition to Queen Louise Land and across North Greenland's Inland Ice," led by Johan Peter Koch.

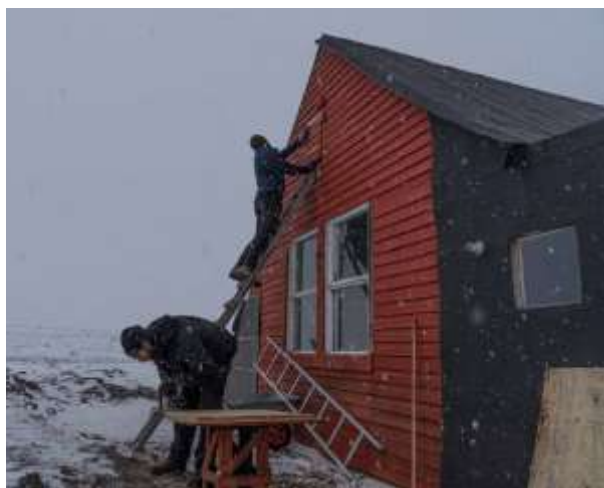
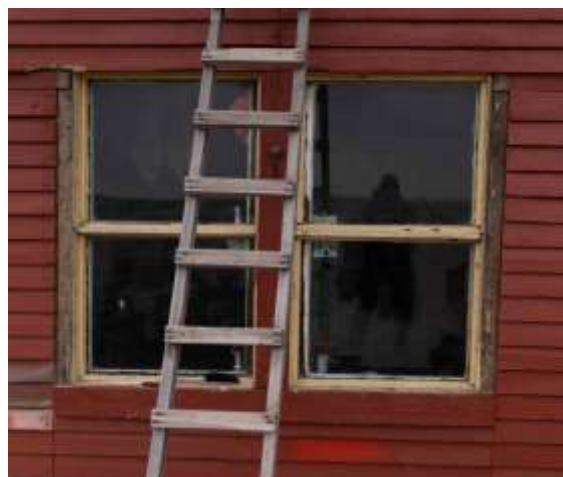
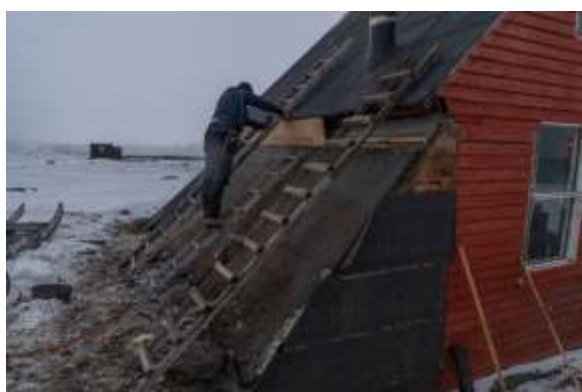
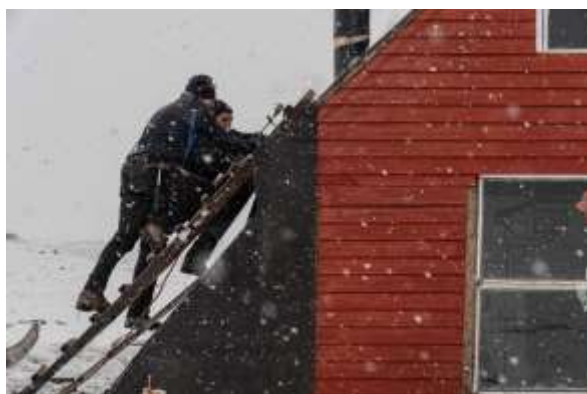
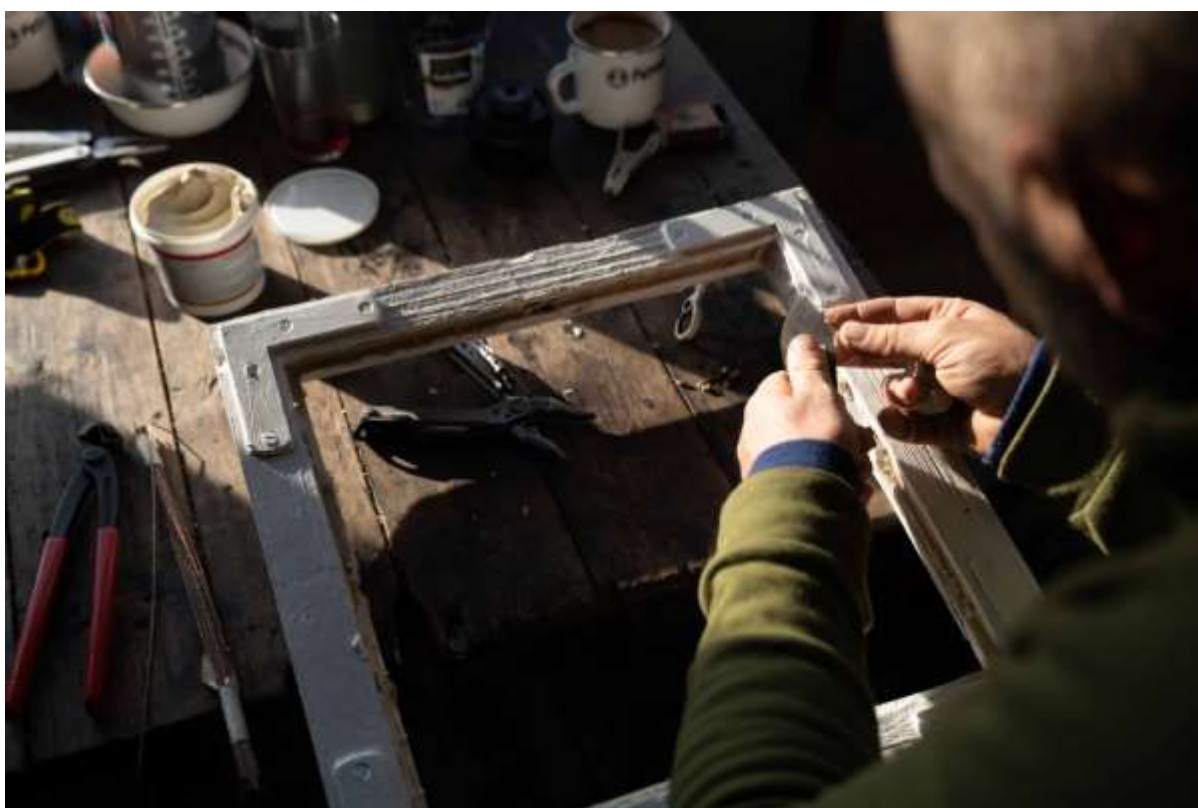
*Renovation of Hvalrosodden.
Top: Minus degrees and some days with wind and snow.
Below: Windows were taken off and repaired.*

As Alwin's hut now generally was done – a little window painting was still due as well as construction of and mounting shutters – we began the work on Hvalrosodden. Again, we removed old roofing felt and nails to get an overview of the damages to the roof construction. We stripped most of the roof from the part of the building that covers the workshop and were quickly able to establish that new rafters were needed.

Both melting on roofing felt and painting outside with linoil produced some challenges, as the weather shifted. But we went at it with a will, and two days before return journey, we managed to burn on the last roofing felt. Each piece and scrap of the outer felt was utilised. We wanted to use some of the old felt, which was already in "Odden", when we arrived, but it turned out to be completely porous and broke, when we attempted to roll it out.

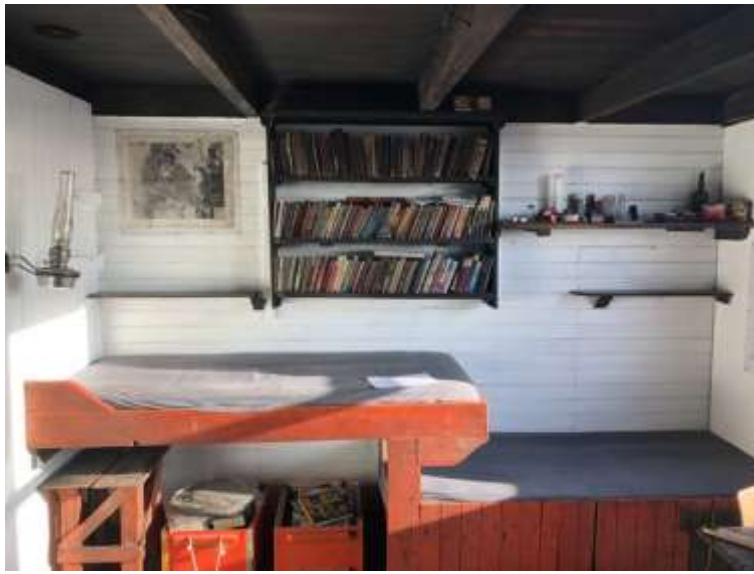
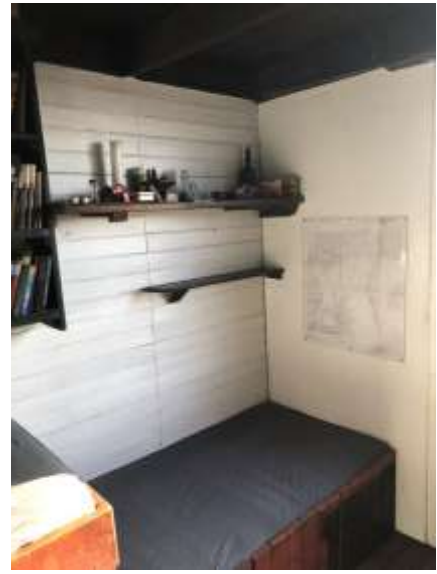
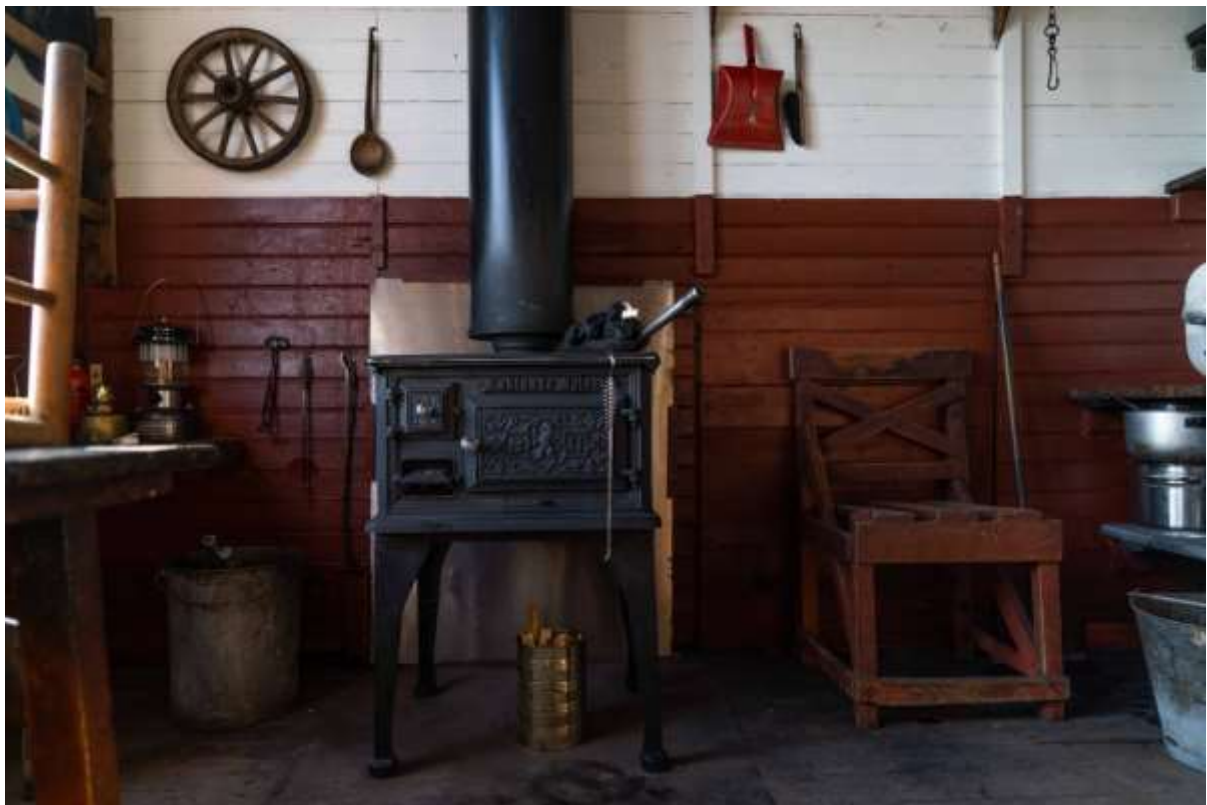
Hvalrosodden indoor after renovation. A living room with lots of atmosphere and history.

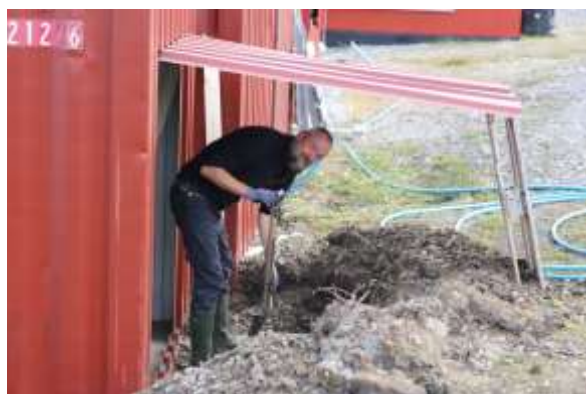
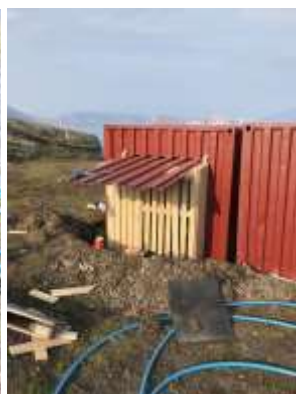
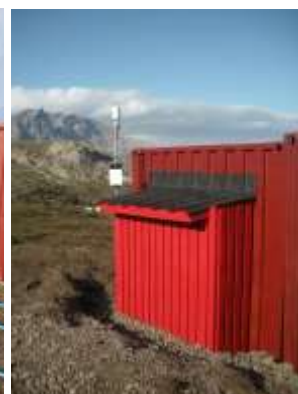
Left: Who needs a fitness centre, when you can dig earth? Middle: Container opened with angle grinder and used as roof for the extension. Right: Extension on the 'boat house'. Newly attached felt, drainage system and grout ought to keep it snow-proof. In addition, weather station with solar cells mounted.

At the same time, instruments for monitoring hydrographic conditions in the sea were assembled and programmed for start. One instrument was placed off Tolvmandsbarakken at 11 m depth (72°52.716N; 025°06.542W). The instruments are 6 m below surface and can be seen with the naked eye. A 30 m line has been put at right angles to land so it can be drained easily.

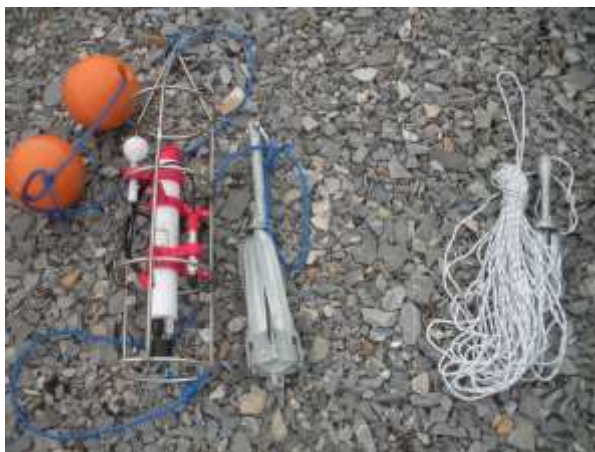
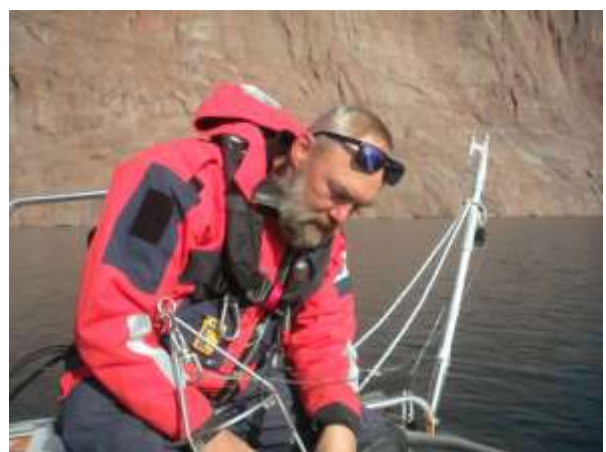
Left.: Example of underwater buoy measuring light, temperature, pressure, salinity and chlorophyll all year round on the three localities. Right: Søren prepares CTD for oceanographic testing along the sections throughout the fjord.

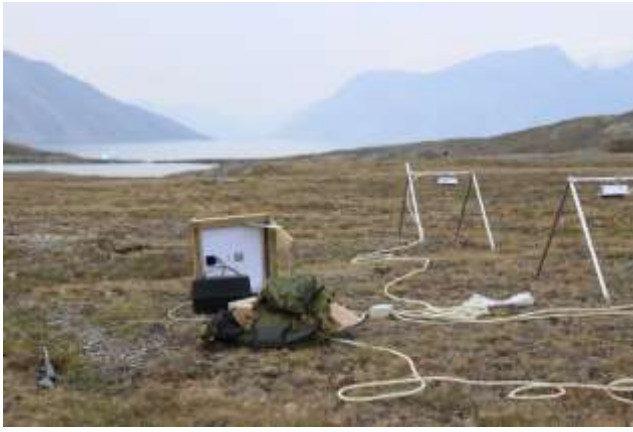
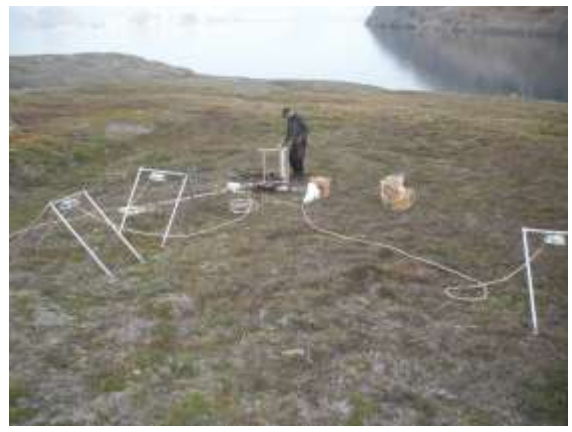
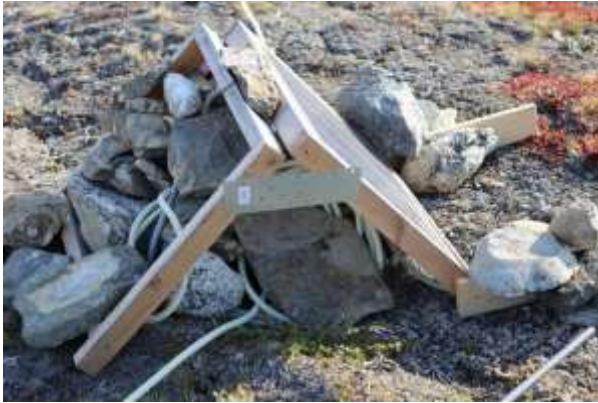
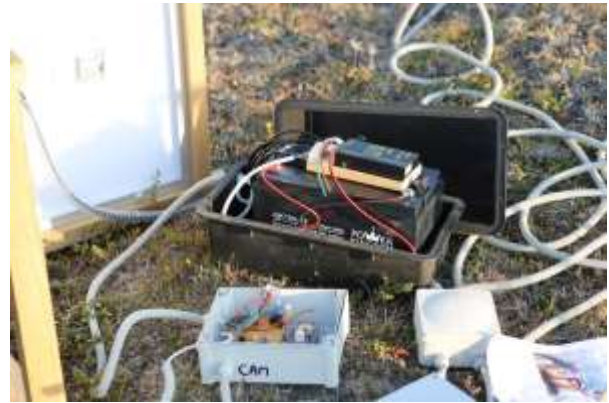
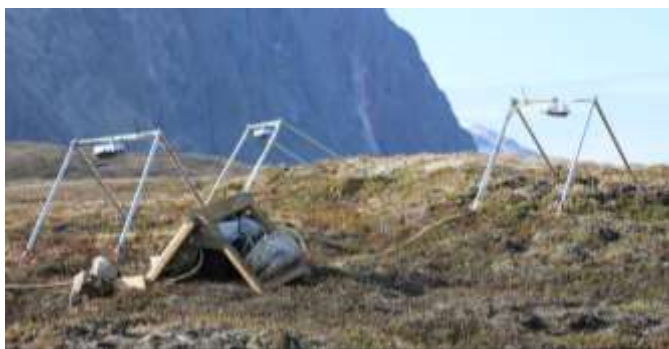
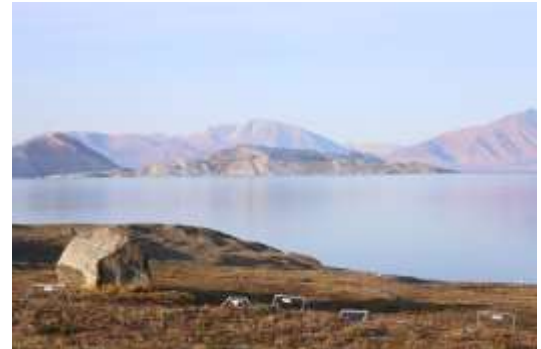
Toke's automatic cameras for monitoring of plants and insects on land.

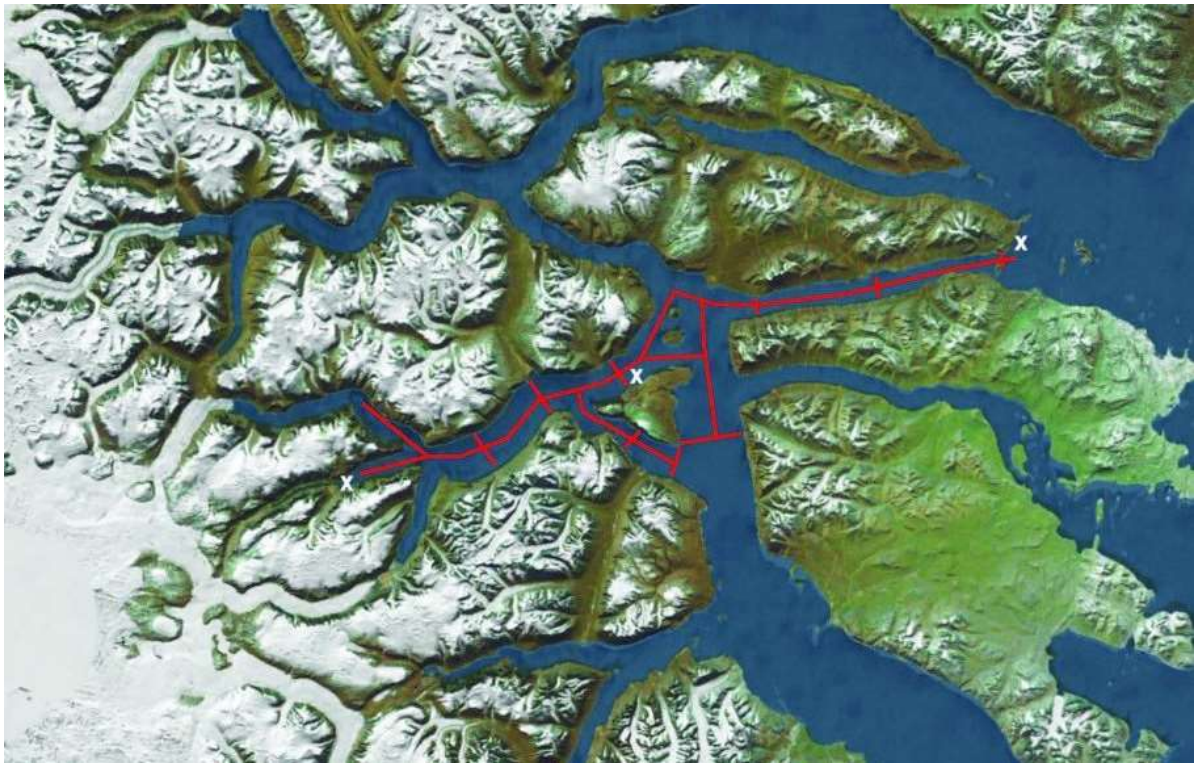
Map of the Ella Ø area. Oceanographic sections and samples (pressure, salt, temperature, chlorophyll and water isotopes) made from the Ella Ø fjords inmost branches to the outer coast. The map shows the sections and the route. Samples were made in 30 localities, and a total of 396 miles was sailed. In addition, 3 underwater buoys (white x's) were put out. They will measure until next year, with a plan of put out new instruments.

The oceanographic measurements reach from the Inland Ice to the Greenland Sea with several measuring stations across the fjord system. The aim of the project is to get basic knowledge on oceanographic conditions (e.g. temperature, salinity, tide, light, chlorophyll, turbidity, water isotope and mixing processes) in connecting fjords between the sea and the Inland Ice. Finally, we try to understand the local fjord wind, and how sea and atmosphere interact in these Greenlandic fjords. The Ella Ø wind system acts differently than other fjords (Young Sund and Nuuk Fjord), which we have studied through time – why, is still unclear. We established a weather station on Ella Ø, but there should be installed more weather stations along the fjord from the Inland Ice to the outer coast to really understand this fjord wind.
