Field report from the journey to North-East Greenland 2020

Sandodden – back to the future.

Field report for “team Sandodden” 2020

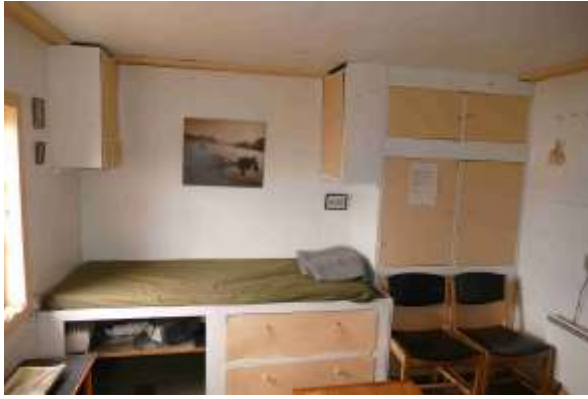
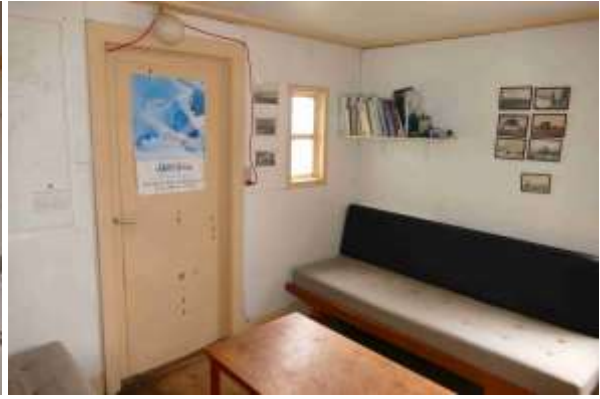
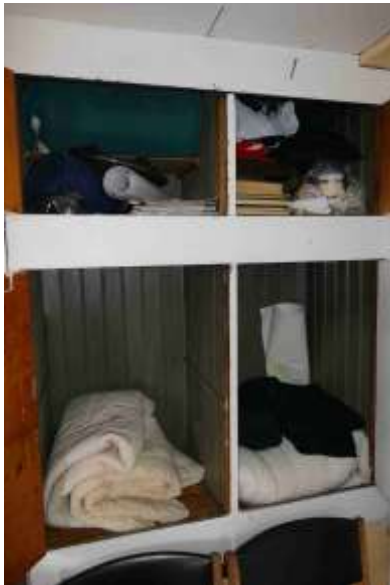
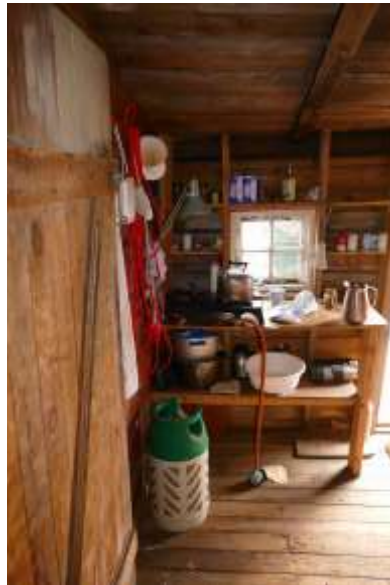
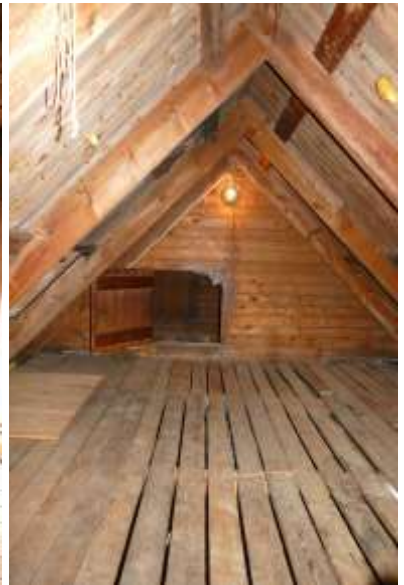
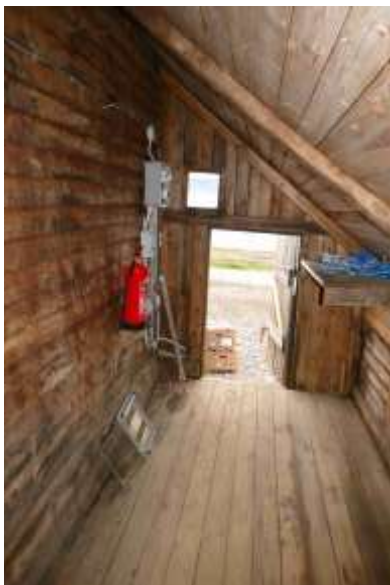
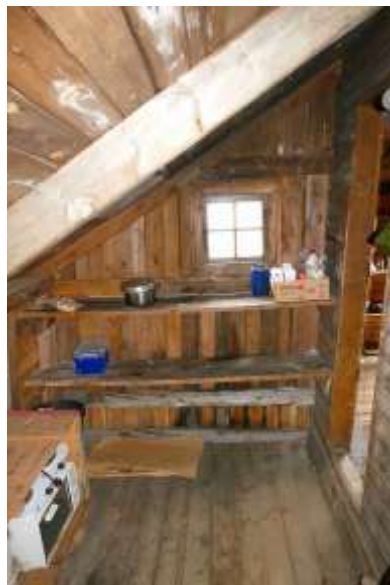
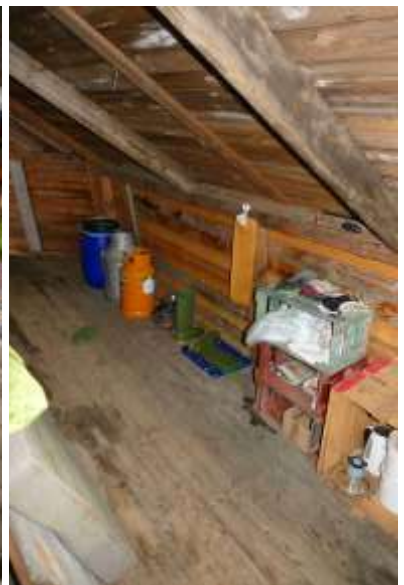
Sandodden as encountered upon arrival. Top row: living room. Middle row from left: cabinet in living room full of left things, porch/kitchen and attic. Bottom row: weather porch

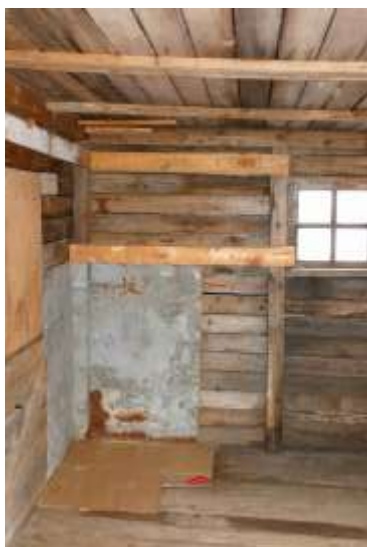
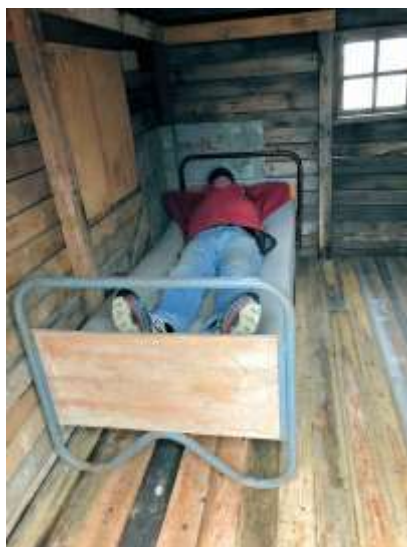
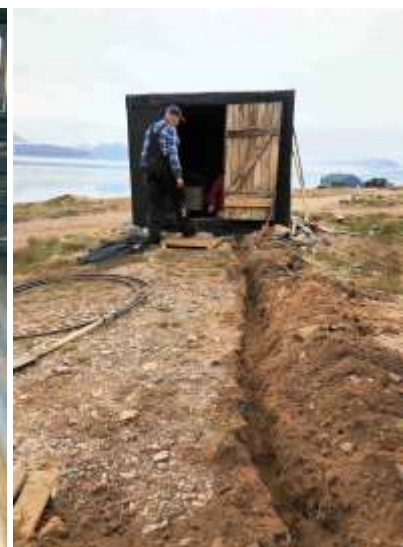
Left: Skindskuret inside upon arrival. Middle: New floor of Skindskuret, and the bed in the new "simple room" is tested. Right: Asger digs down electric cable and ground spear near Skindskuret.

living room in Sandodden soon would be cleared and, hence, out of function during the restoration process. This was resolved by making two temporary bed spaces in the porch and a new more permanent bed space in Skindskuret, where a new floor was put on top of the existing one. In addition, the first day was used removing the existing floor of the attic of Sandodden, prepare materials and tools for our projects as well as build up a scaffolding on the northside of the house.

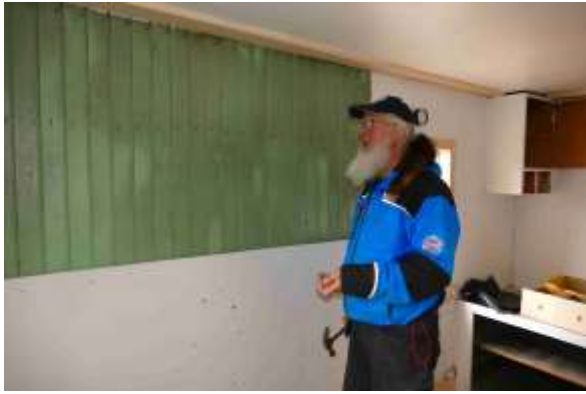
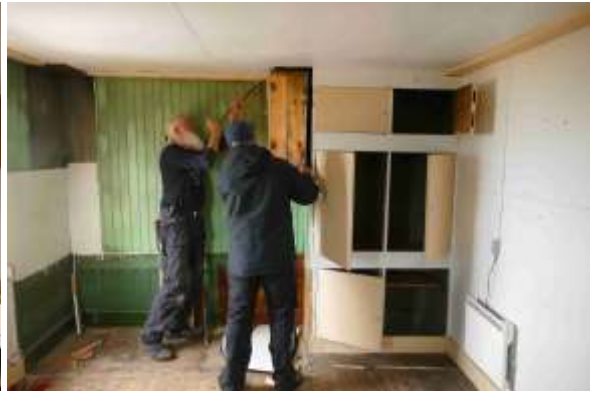
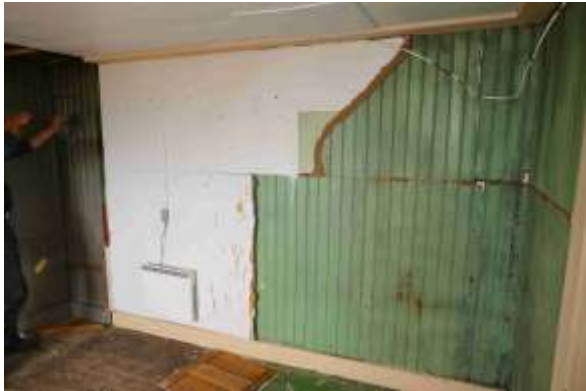
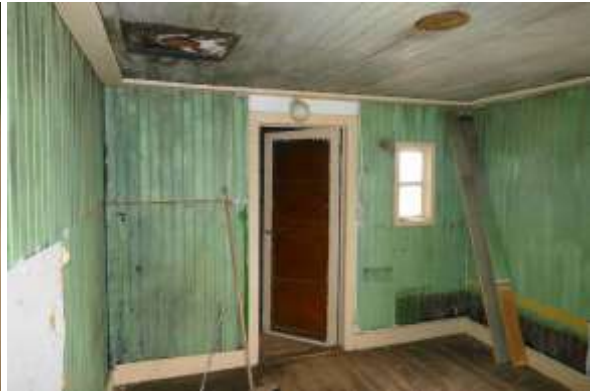
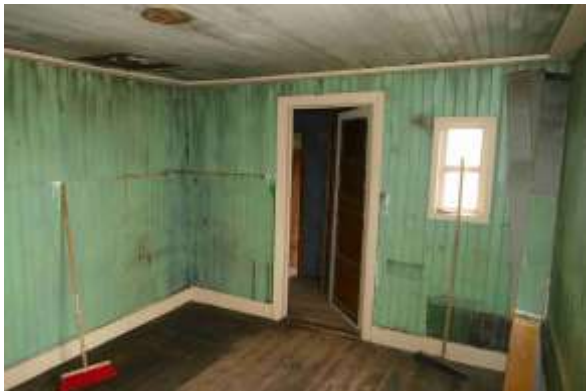
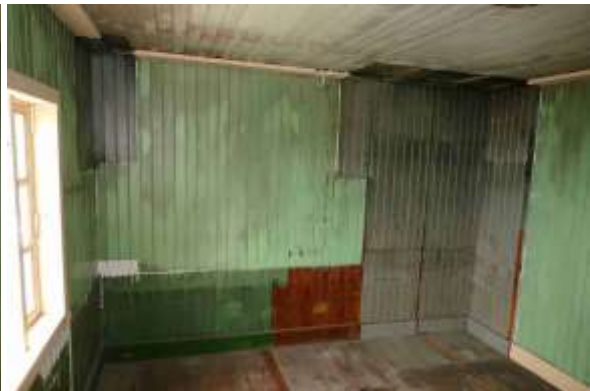
Removal of masonite cladding and stationary cabinets/bunks in the living room. Behind the masonite the fine, old panel walls reappear – with different layers of paint.

Ultimately everything was stripped to the original panels, which appeared to have been painted in many different colours and shades. Mostly green nuances, though. Then cleaning and sanding of all walls, ceiling and floor. All woodwork was seemingly in a good condition, without any signs of dry-rot. Having finished the demolition, we now could begin the actual rebuilding.

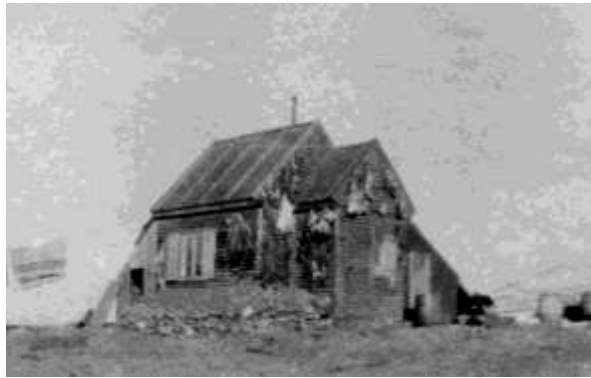
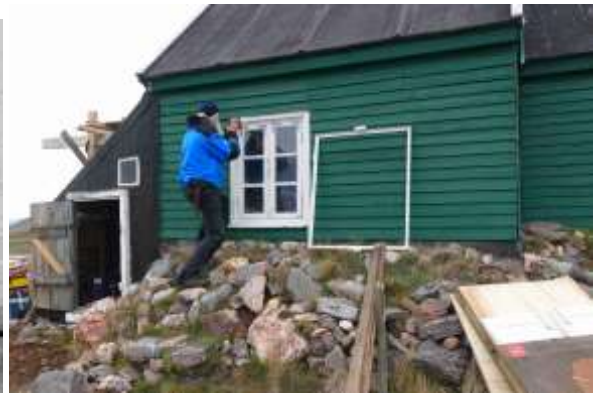
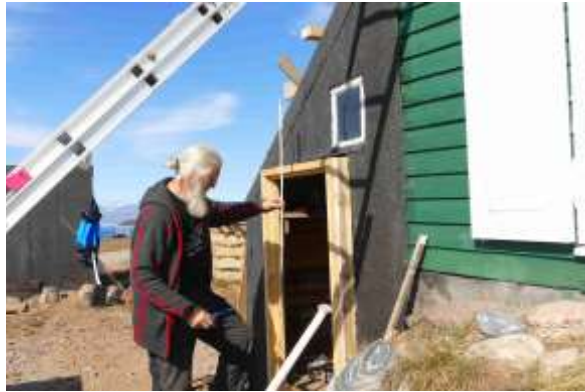
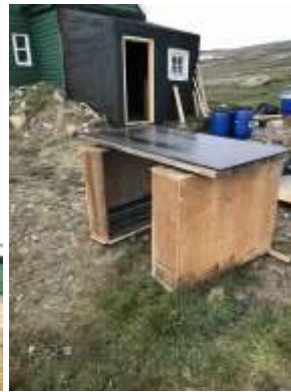
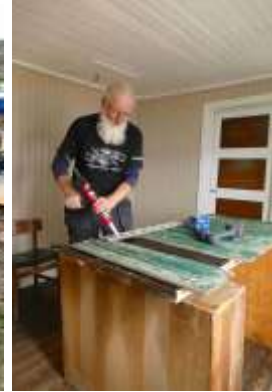
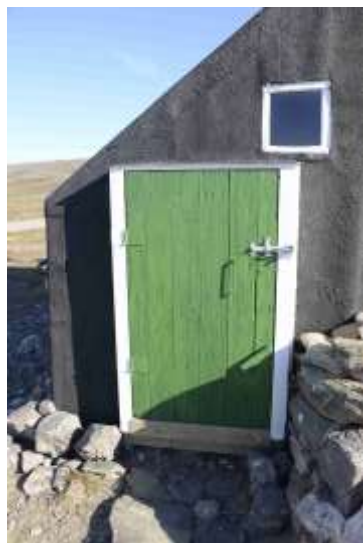
Restoration of windows and doors. Top row left: Sandodden approx. 1923. Notice that the house then had “French” shutters on the large window. Right: Goffi mounting the new shutters. Middle row: Assembly of the original material onto the new, reinforced door frames and doors. Bottom row: The final result. Sandodden’s large window has shutters again. Sandodden’s roofing felt-covered porch to the right was built in 1939 by Eli Knudsen.

authentic appearance as much as possible, which was solved by disassembling the existing doors and then mounting these onto the new door frames and a new door, which was cladded with original materials. Inside, the new door frames have built-in angle iron to reinforce them against a potential bear visit. The result was new durable and close-fitting doors, which from the outside look exactly like the original doors.

The large living room window was fortified with a new steel frame, and onto this was attached premade shutters similar to the ones Sandodden had originally. The existing window, which had been glued shut for several years, was reopened and restored with real window glass replacing the scratched plexiglass that had been installed at some point in time. Now there is a clear view once

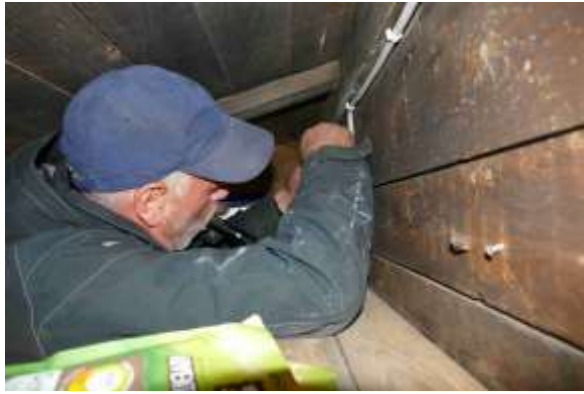
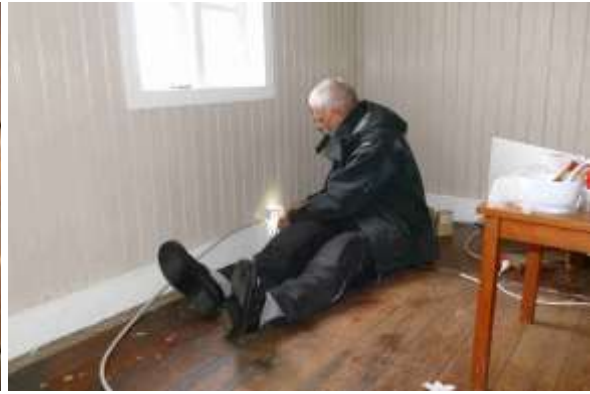
Asger made a completely new electrical installation in the entire Sandodden. A major task.

With a professional background as an engineer and an electrician, Asger was the right person to take care of the much needed and extensive restoration of the electrical installations. Prior to the work, Asger had developed a plan covering

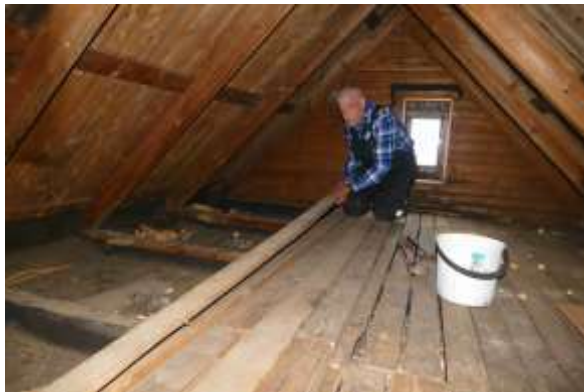
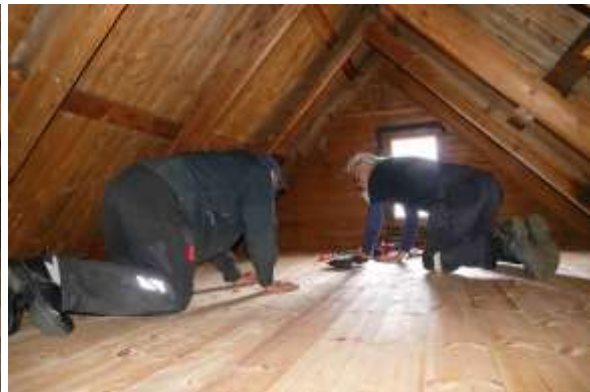
In the attic the old flooring is removed and replaced with an entirely new plank flooring.

Having removed the impractical old flooring and installed new electrical cables, a new plank flooring was laid on top of a layer of isolating glass wool. The result is a functional attic with two bed spaces, electrical installations and electric heating.

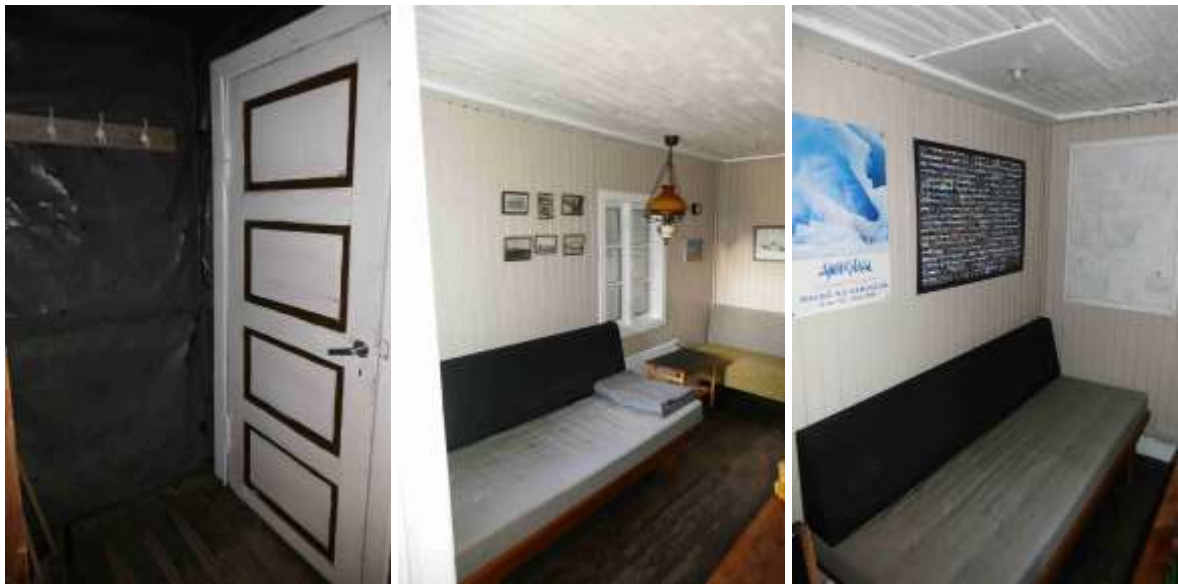
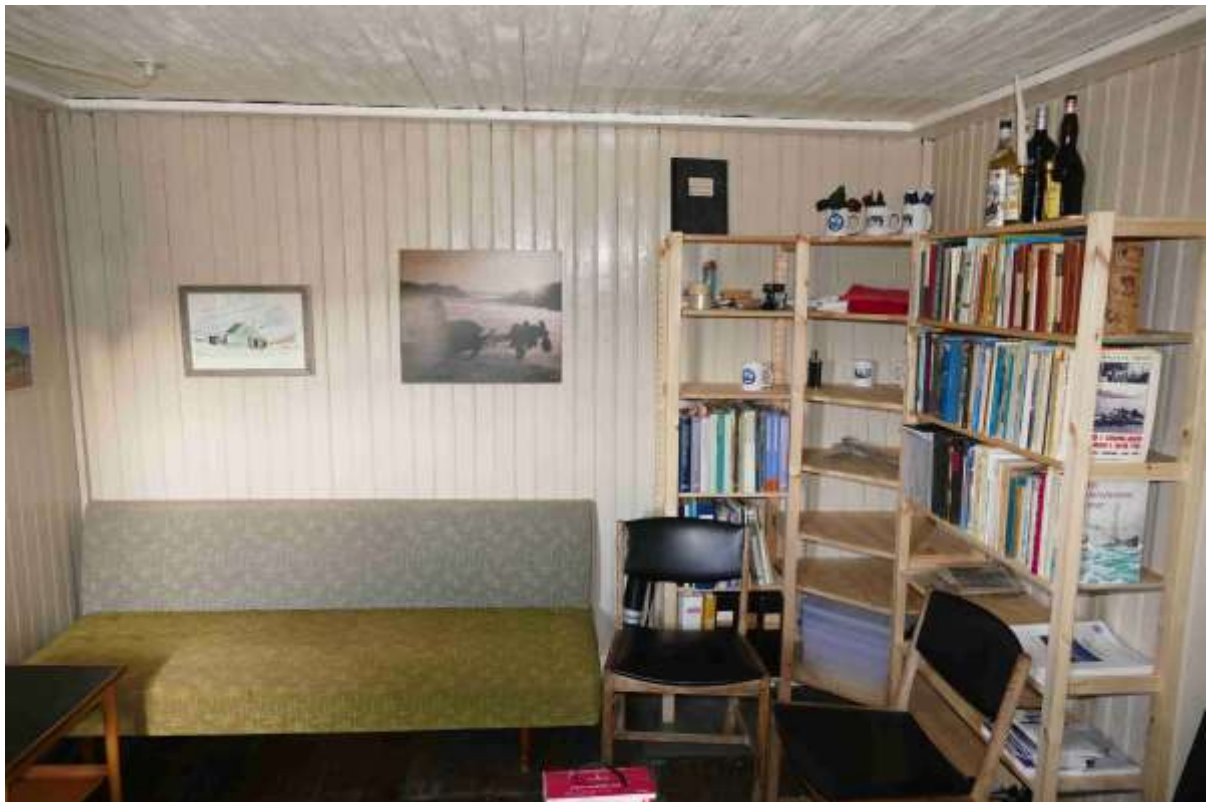
The living room freshly painted and decorated. The wall and ceiling panels are visible again. Similarly, the old, fine panelled door. New items in the living room are a spare daybed as well as a new shelving system. Among other things, the shelving system contains a fine, newly donated book collection of Greenland and Polar literature.

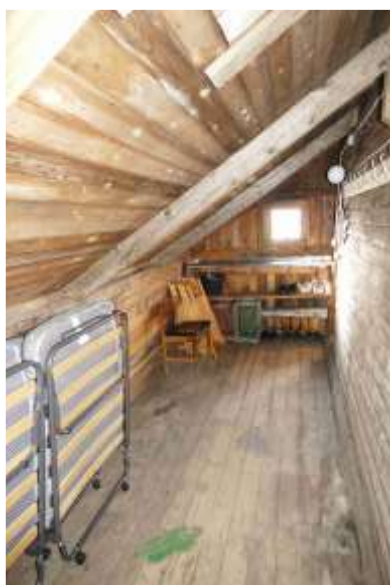
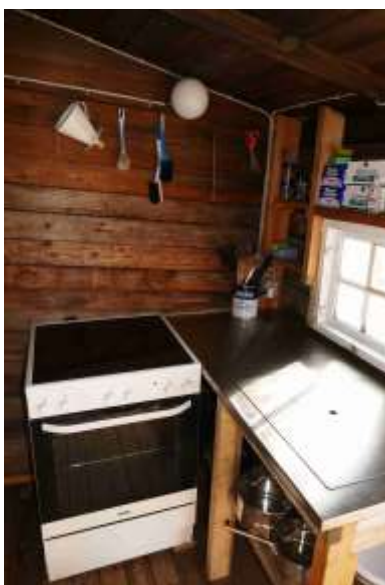
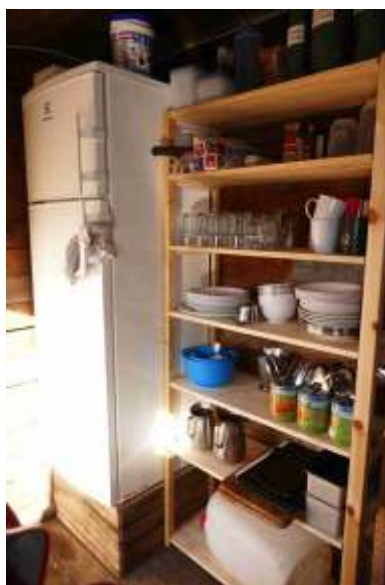
Left: Two new foldable camp bed have been placed in the porch. Right: The newly decorated kitchen in the porch has received a new steel tabletop, a new electric stove and fridge/freezer.

It has been decided to modernise the adjacent south porch, which serves as a kitchen. The modernisation consists of the installation of a new prefabricated tabletop incl. steel sink as well as electric stove and fridge/freezer. Up until now, it has often been necessary to discard fresh provisions due to the lack of a fridge or freezer. The upgrade of the kitchen makes it much more

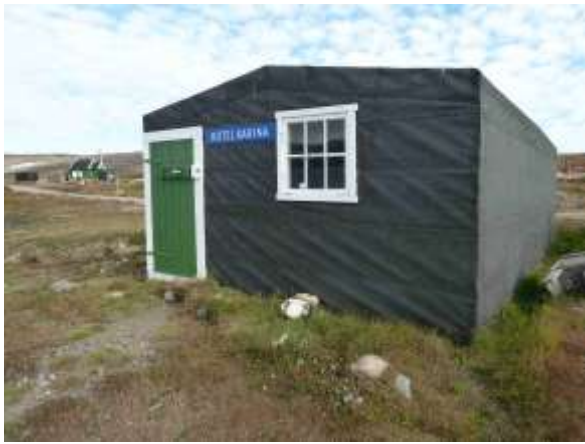
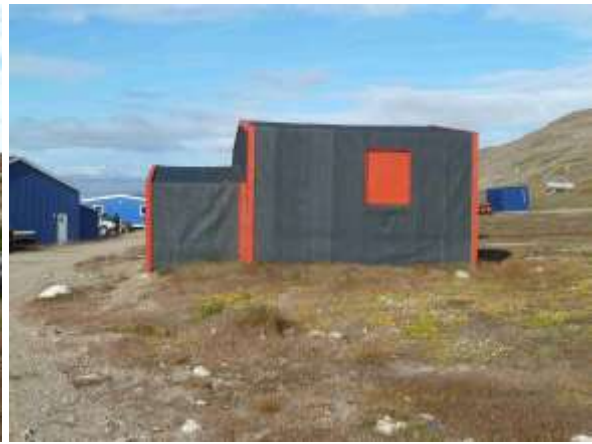
Sandodden's other houses: Hotel Karina, Skindskuret, and Sorte Skur as well as the tomb crosses and Building 9 all had a long time needed new layer of paint. Above: Hotel Karina (left) and Building 9.

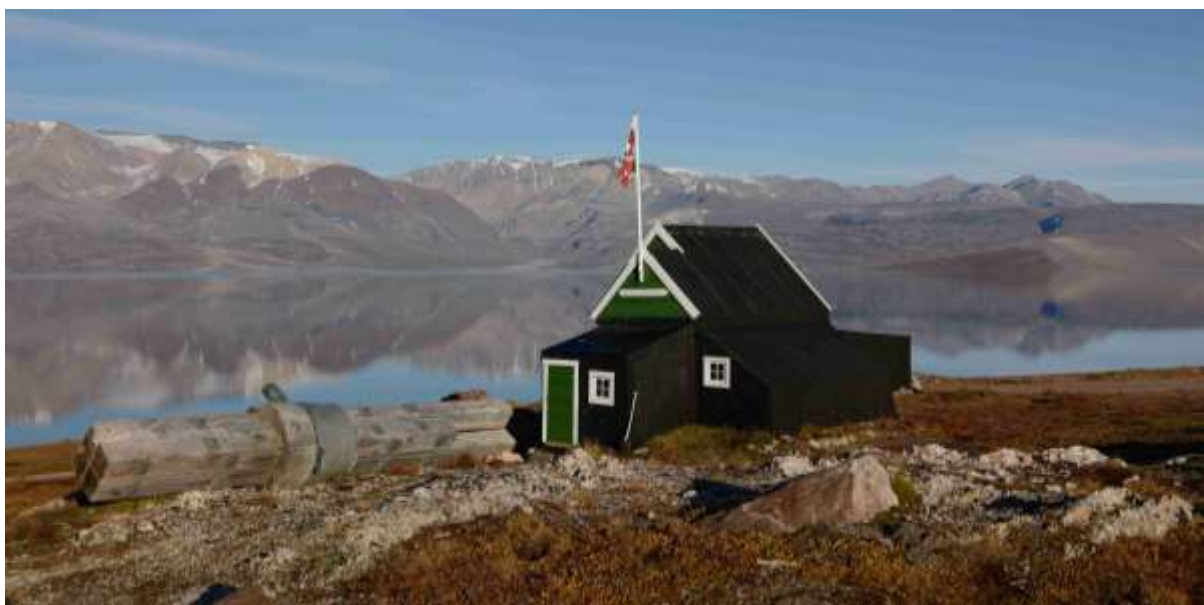
Sandodden shortly before departure. Restored and freshly painted inside and outside.

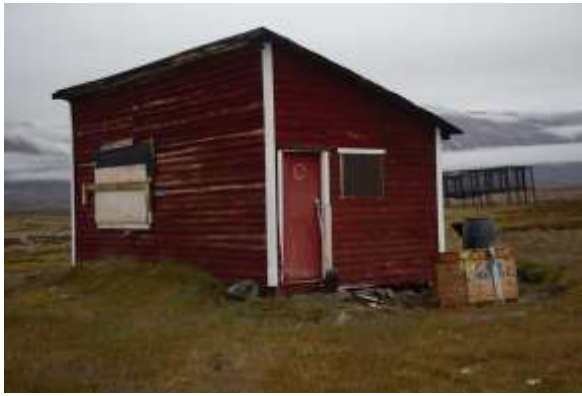
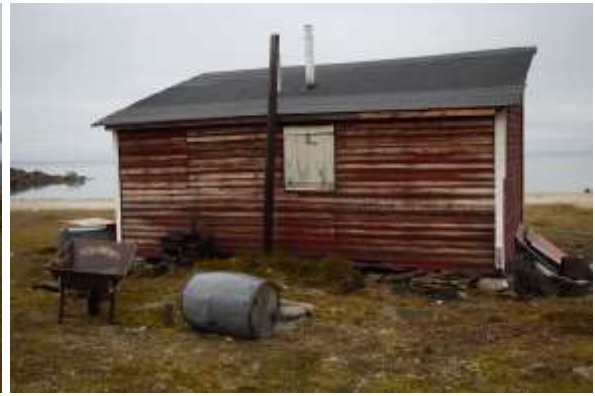
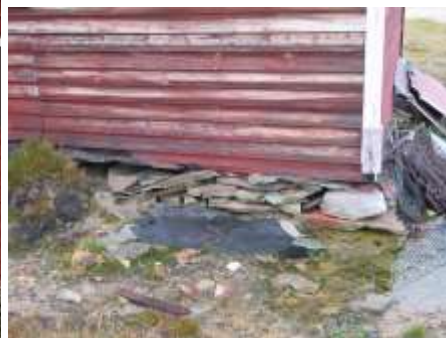
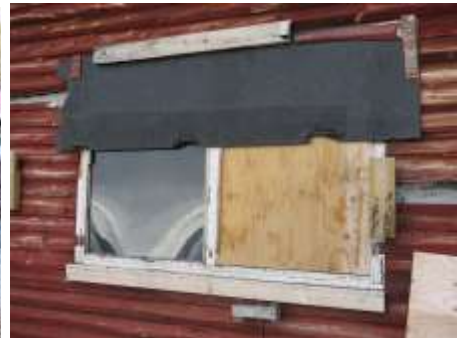
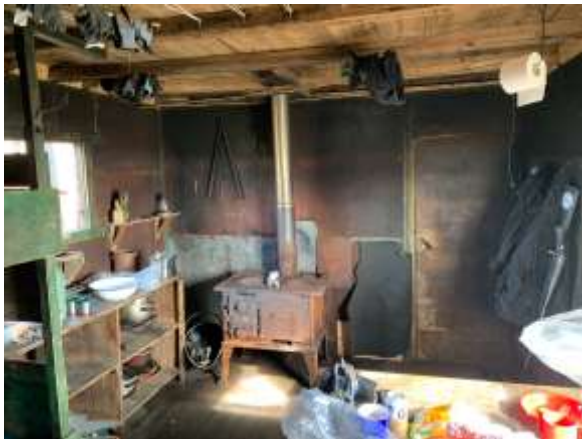
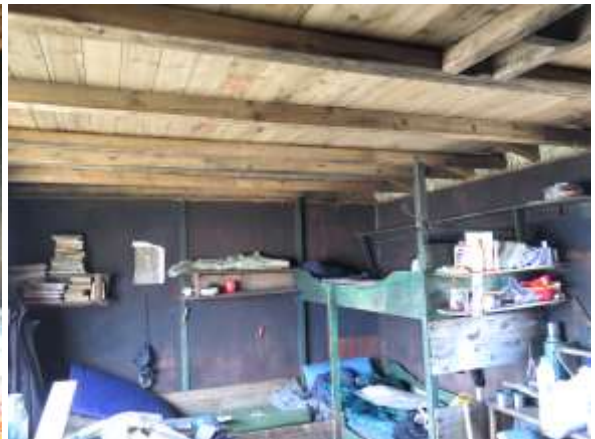
Photos from Hamna on our arrival 9 august 2020. A house in need of “tender, loving care”!

The first, and one of the most important tasks, is to visually document the condition of the house before the restorations begins. So we gradually approached the hut and soon realized that the hut was in a worse condition than expected.

Around the hut was scattered various things left behind by visitors, materials from scanty repairs, broken glass and much more. And even worse, the hut almost stood in a small lake, due to the recent period’s continuing rain. It was obvious that the lower part of the hut was much damaged by beginning decay. The windows and shutters were all provisionally repaired with materials available, and likewise, fascia boards and especially large parts of the hut’s covering was

filled with holes, destroyed or in extreme need of proofing. The outer door was tight, although our first encounter on entering, was a dead bird lying on the floor. Besides the common mess, the living room in particular, was marked by a leaking pipe passage by the stove, through which precipitation had come in and ruined the old coal stove, now both rusty and cracked. Unique for Hamna is a ventilating shaft in the middle of the living room,

which now unfortunately had collapsed, causing a constant dripping on the soaked-through floor. Worse still, the hut moved when we walked on the floor, and it turned out that most of the foundation had collapsed. Especially the backwall and the middle had no laying up. And last, but not the least, all the ceiling sheets had been removed, because drift snow and rain from leaks had ruined them. We had been informed that

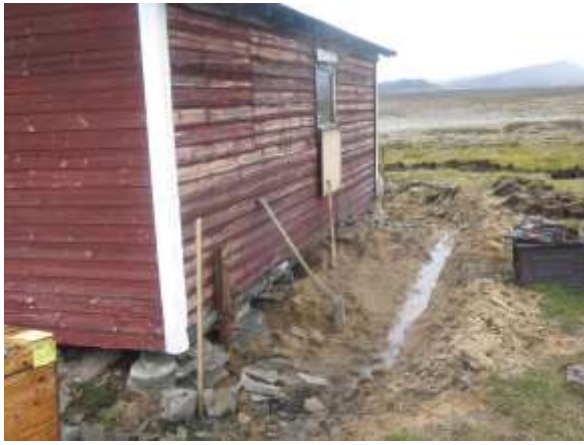
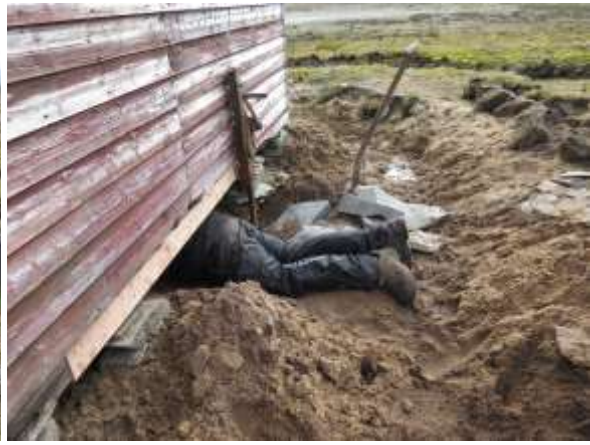
Restoration of Hamna. Left: Draining and laying up. Right: The center of the hut is laid up.

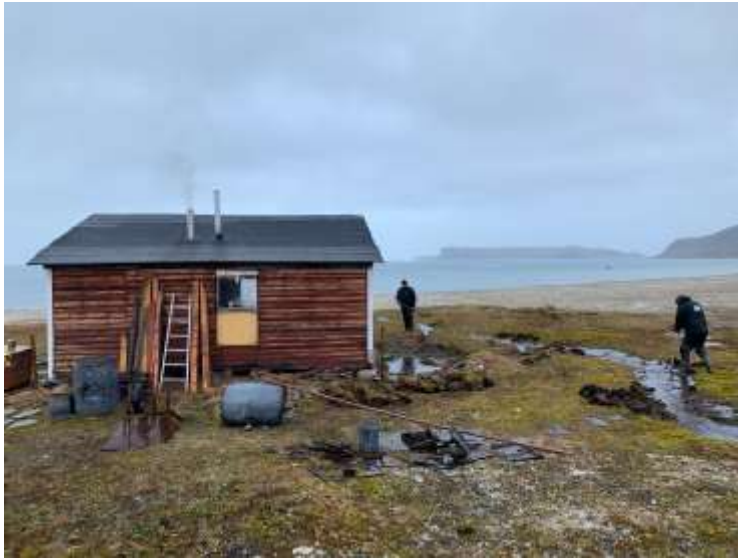
Left: Draining of the surroundings. Right: Weatherproofing of roof against rain and drift snow.

The future existence of the hut seem to rest upon the necessity of diverting rain water, and for this reason we made quite an effort of digging drain canals and lay down stones, where the wind and the rain had removed materials around the hut.

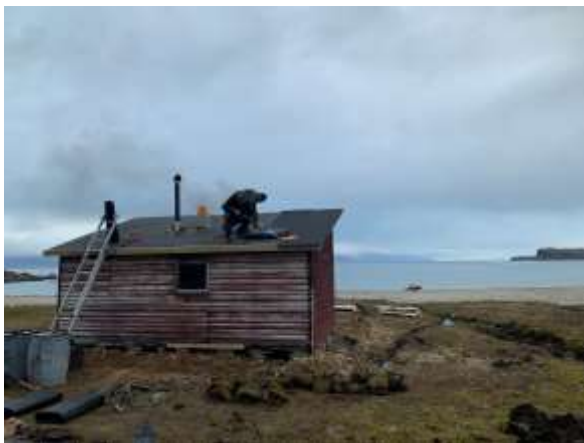
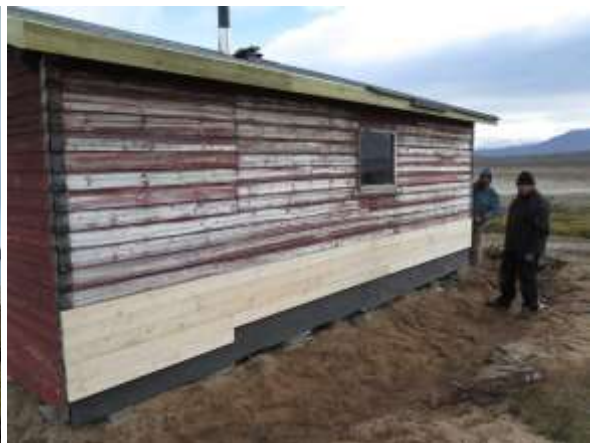
Left: Mounting new roofing felt. Right: New boarding on the back.

The weather improved from day to day, the mood as well and the work proceeded more easily. As the hut got stabilized, we began to repair the roof. The roof surface was cut, new fascia and barge boards mounted. Initially it was planned only to put on new roofing felt but we chose instead to clean the roof surface, mount new pipe passages,

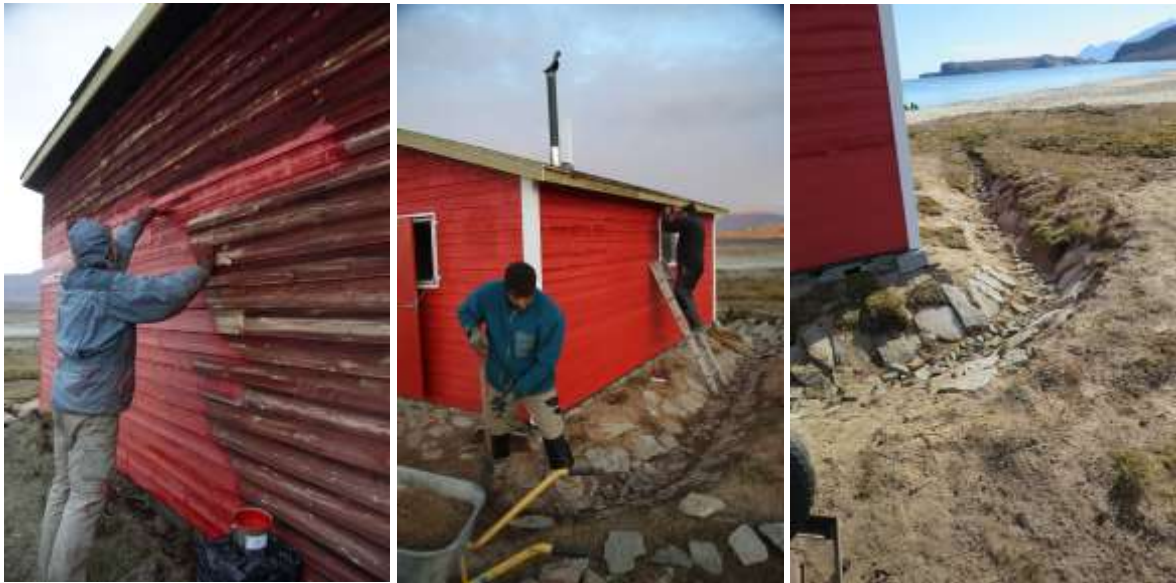
Left: Painting the outer covering. Center: Finishing the ditches. Right: Part of a new drainage.

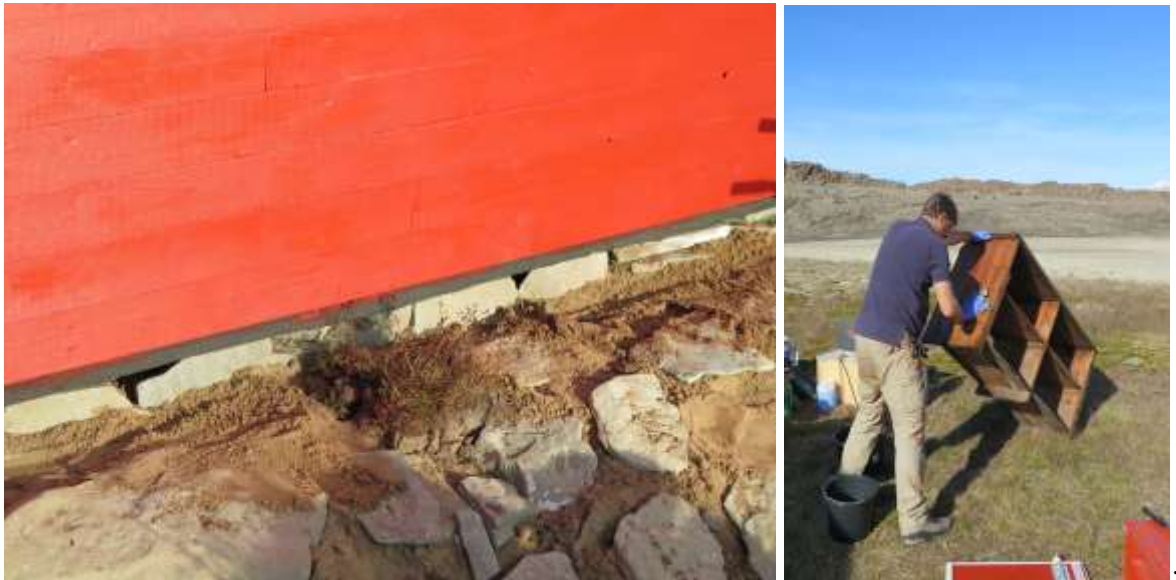
Left: New foundation and water diversion. Right: Cleaning the furniture.

The weather was still unstable, rainy and with heavy wind but nonetheless, the work with drainage, digging, establishing a new foundation, and stabilizing the hut, started to show good results. Storm, current and especially the ice had challenged "Agsut"'s anchoring outside Hamna several times. We therefore chose to navigate her through the passage to Noret, and after an exciting trip, she was anchored at a good, shielded location.

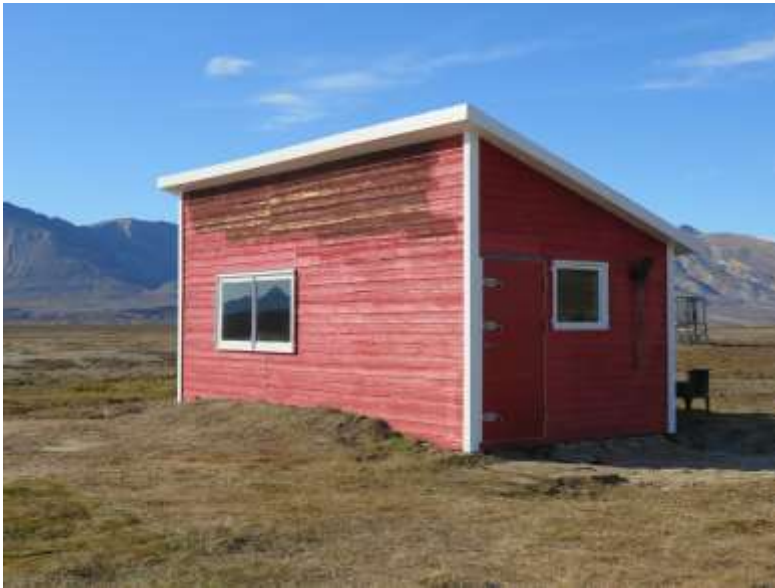
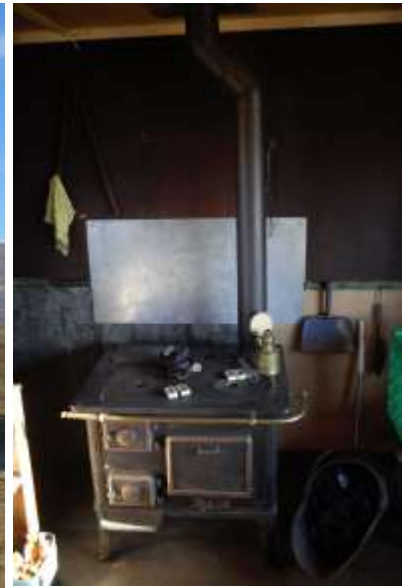
Left: Hamna after restoration – only the last part of the front needs painting. Right: The new coal stove.

Indoors the stove was replaced, and the hut prepared for mounting the ceiling sheets brought along. The new windows were installed and as the weather now was fantastic, most of the ruined

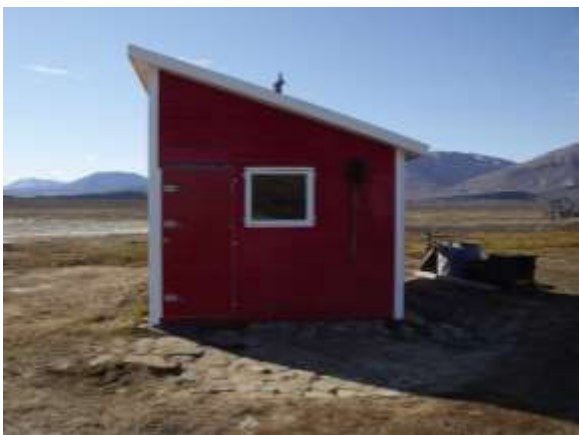
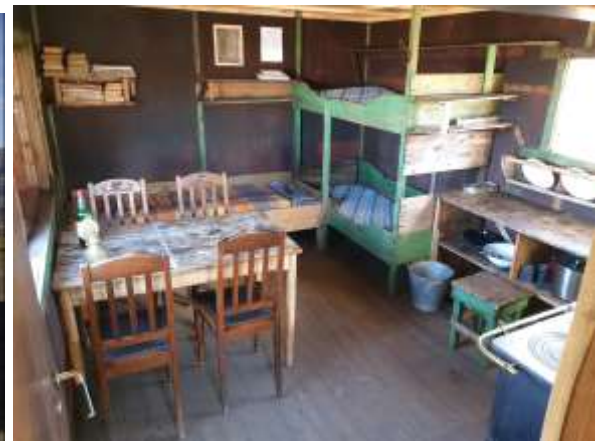
Left: New outer coating, cover, and drainage. Right: The living room after renovation.

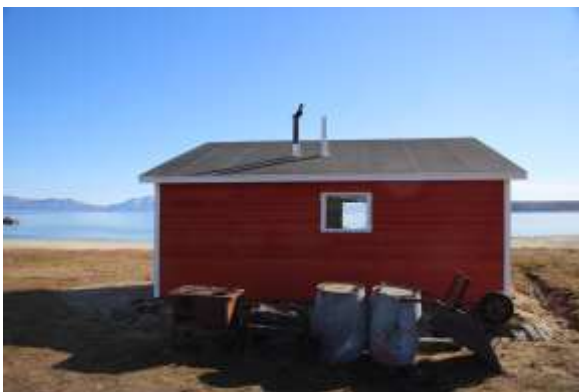
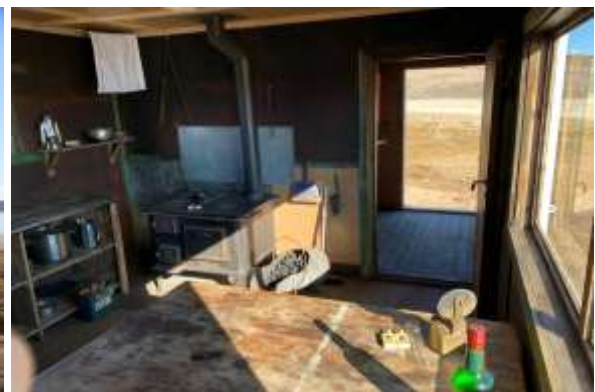
Left: Historic materials. Right: Furniture and coal stove after renovation.

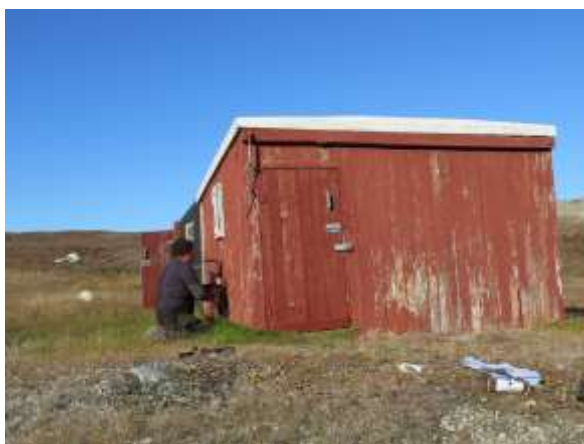
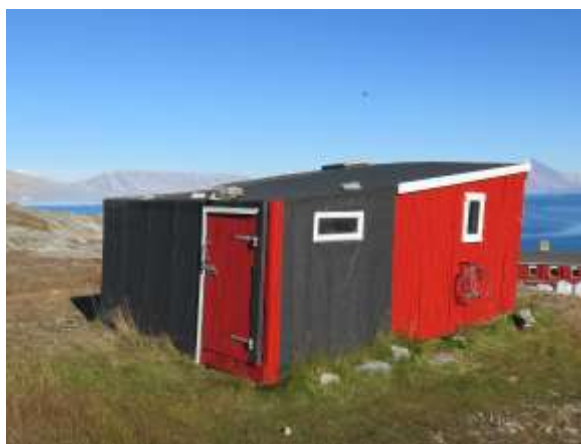
Restoration on Ella Ø. Left: Generatorhuset before – and after.

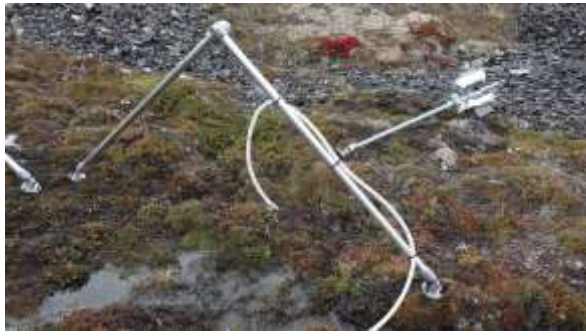
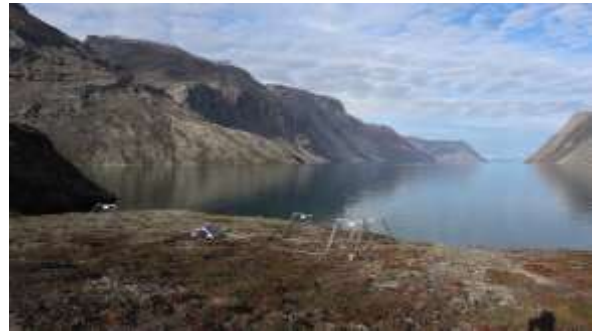
Left: Camera systems damaged by polar bear. Right: Newly installed camera system in Röhss fjord.

When opportunity arose, Simon and Toke took the boat into Röhss Fjord to erect a cluster of cameras at a location where we expect warmer summers and colder winters. The erection was prepared before departure, so within 3-4 hours we could bid farewell and so long. Next year we therefore hope to obtain the first comparable photo data and climatic data for two localities on the same altitude and thereby discover how huge the differences are in the climatic conditions and as such in living conditions for animals and plants. On a long view it will bring a better understanding of, how vulnerable the Arctic fauna and flora are with regard to climatic changes.

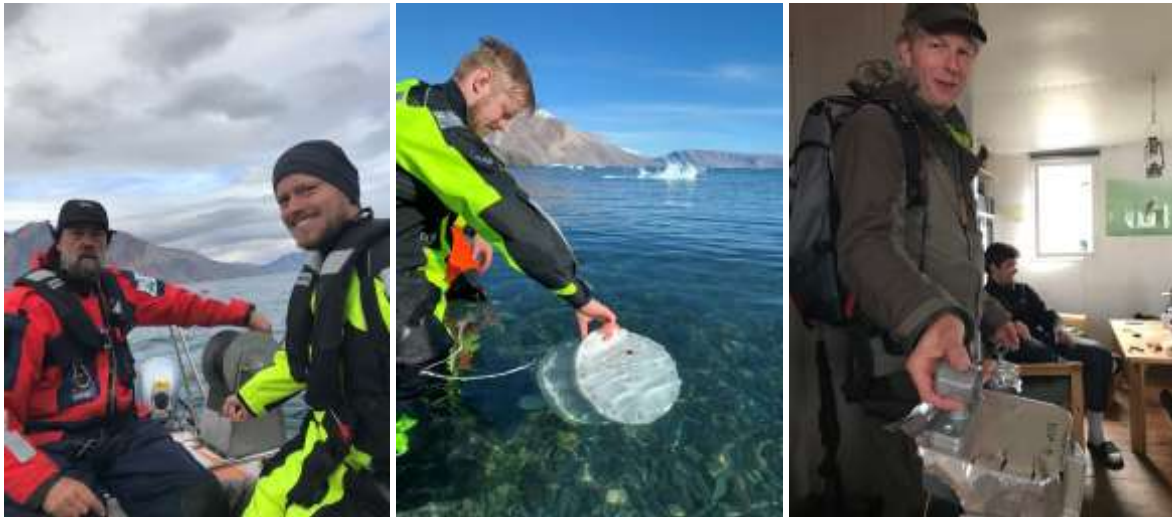
Left: Søren and Jens: Doing CTD measuring and water samples (photo: Lucas)

However, this was in no way to lower our spirit! Every hour with decent weather was spent on
