Field Report from the journey to North-East Greenland 2025

35th Field Season

Introduction

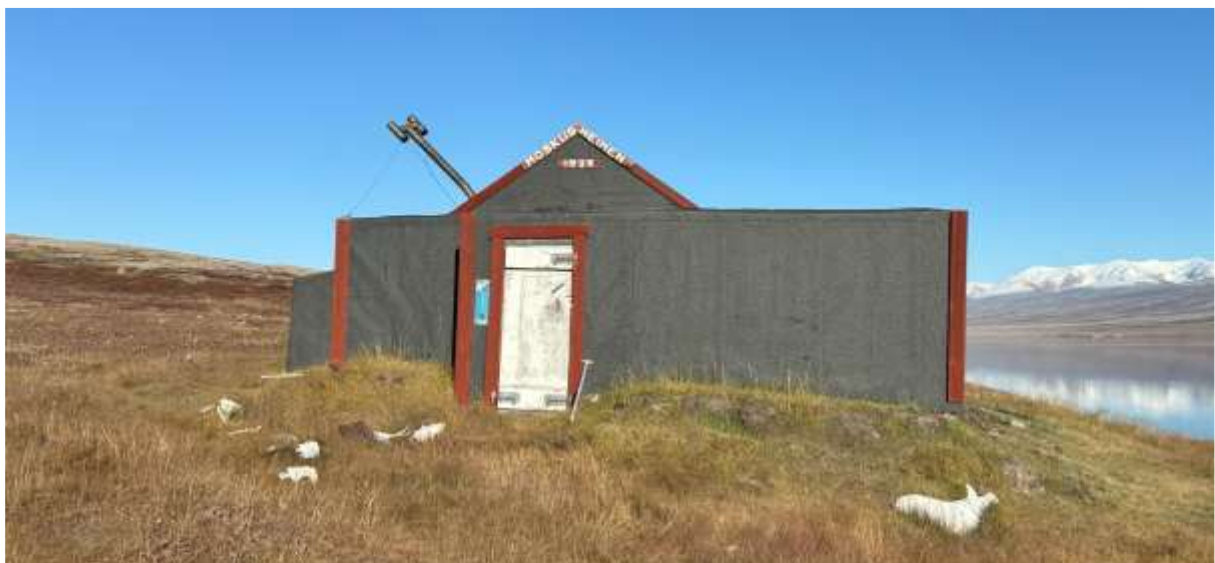
Moskusheimen on a summer day in 2024 – before renovation and with a collapsed chimney.

The next three days were spent on renovation. A complete chimney pipe system was installed, as the old pipes and fittings were broken and weathered. Afterwards, the stove worked perfectly. All doors and cabinet doors were removed and straightened. All cabin and Tilly lamps were prepared for upcoming visitors. In the bedroom and living room/kitchen, the walls were washed down and painted with "Daneborg Grøn" linseed oil paint to match the original colour.

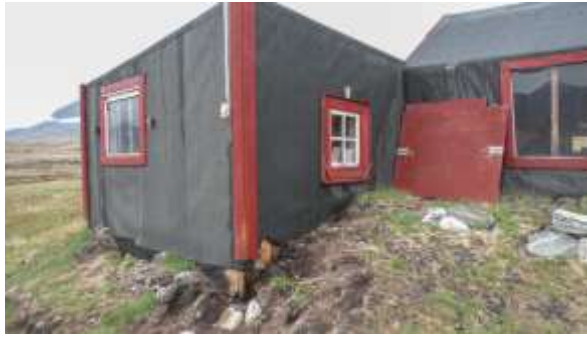
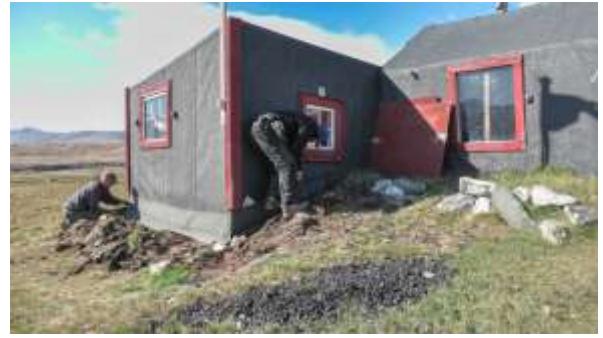
Outside, the foundation was dug free so that new roofing felt could be installed before covering it again.

Outside, we dug out around the east, north, and west sides of the station to install new roofing felt before covering it again with stones and turf. The drying rack just outside the station was also straightened, so it should last for many years to come. We also separated newer wood from the old/historic timber.

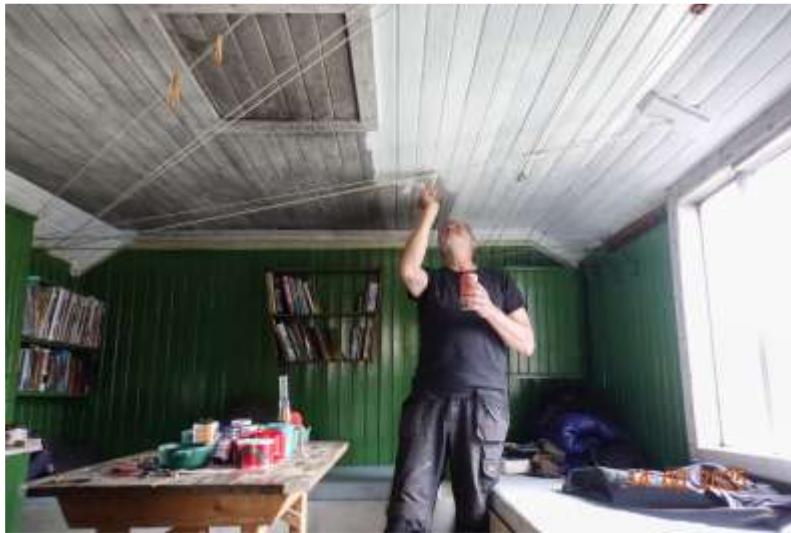
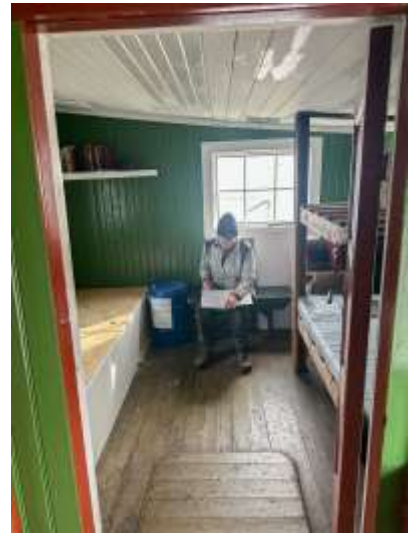
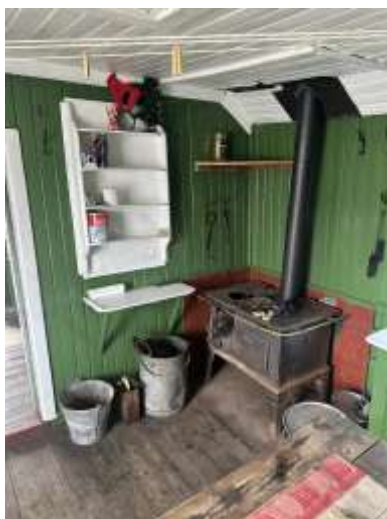
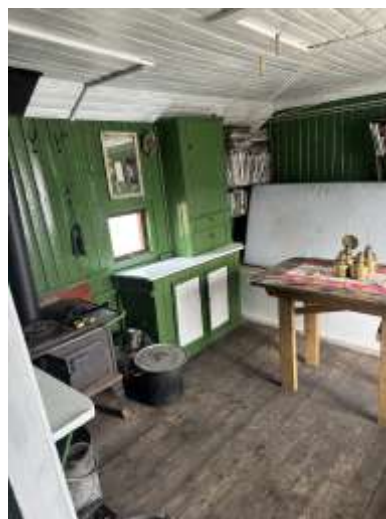
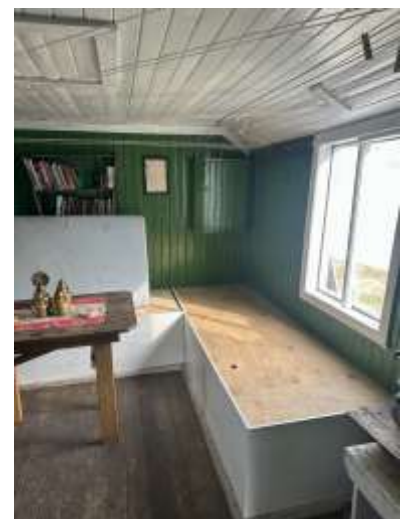
In the bedroom and living room/kitchen, the walls were washed and then painted with green linseed oil paint to match the original color. The ceiling also received a fresh coat of white paint.

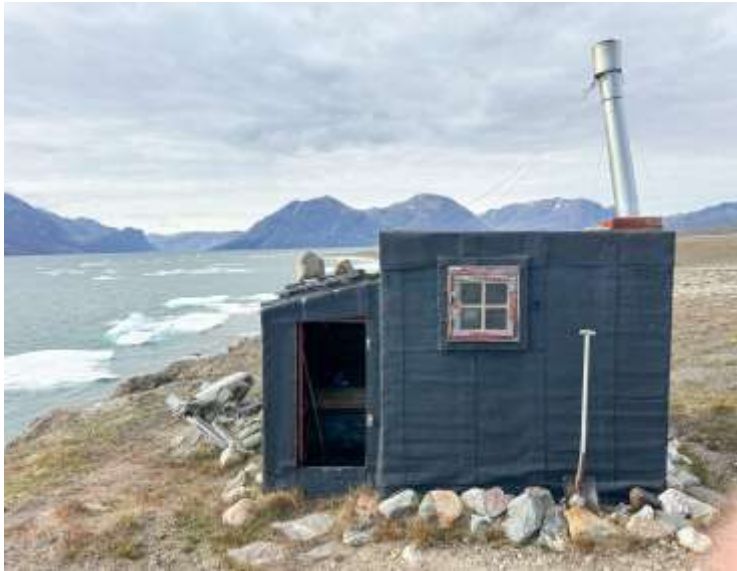
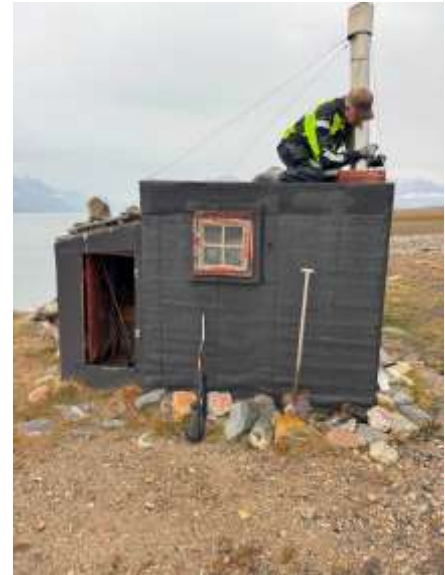
At Pashytten [433], the chimney was secured with wires and straightened.

The following day, late afternoon, we sailed to Pashytten [433], where we secured the chimney and took inventory of the equipment in the cabin. From there, we sailed to Fiskerhytten [438-4]. Here, we found that more than just a few pieces of roofing felt were needed. Both the north and south sides required new roofing felt. We used the materials we had on hand and sailed back to Daneborg after midnight to pick up more

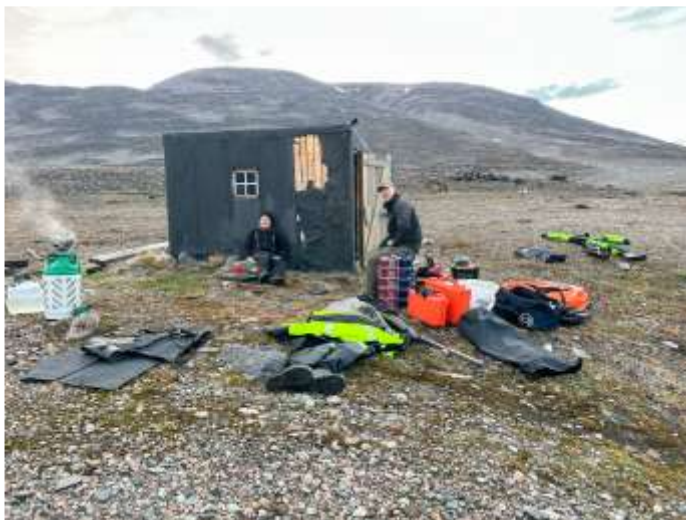
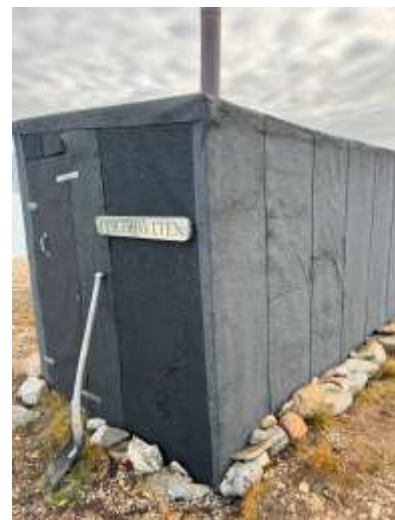
From left: Fiskerhytten [438-4], Djævlekløfthytten [427], and Lerbugthytten [434].

After changing the propeller and packing the materials, we sailed back to Fiskerhytten, where we completed the roofing felt installation and adjusted the door and window. The cabin is now in good condition for use by the Zackenberg team. On the way back, we stopped at Djævlekløfthytten [427] just to confirm that it is still usable.

On August 8th, the wind dropped to 5–8 m/s, so late in the morning we sailed to Lerbugthytten [434]. We made the hut usable for travellers, repaired the stove and chimney pipes, but the hut is in a state of decay and is a project in itself if it is to be preserved for the future.

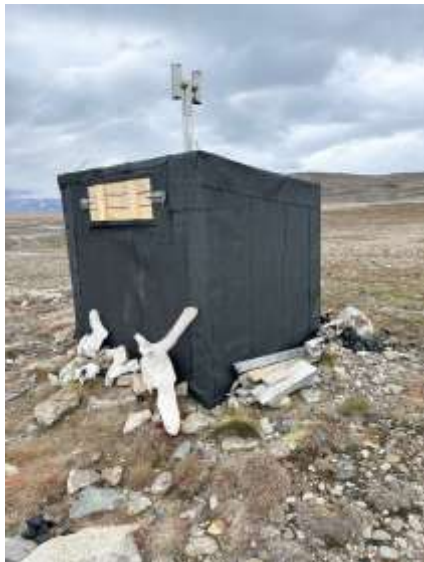
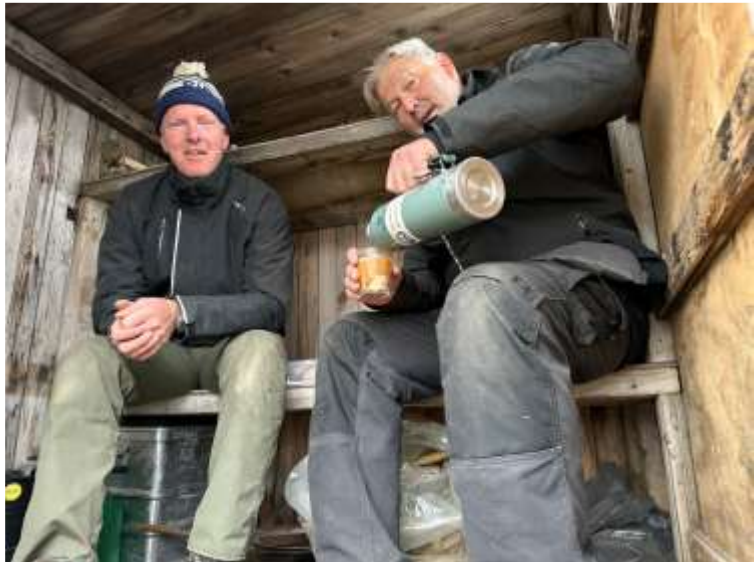
Kap Berghaus hytten [423] ude og inde. En kop kaffe efter færdigt arbejde. Birger (t.v.) og Leif.

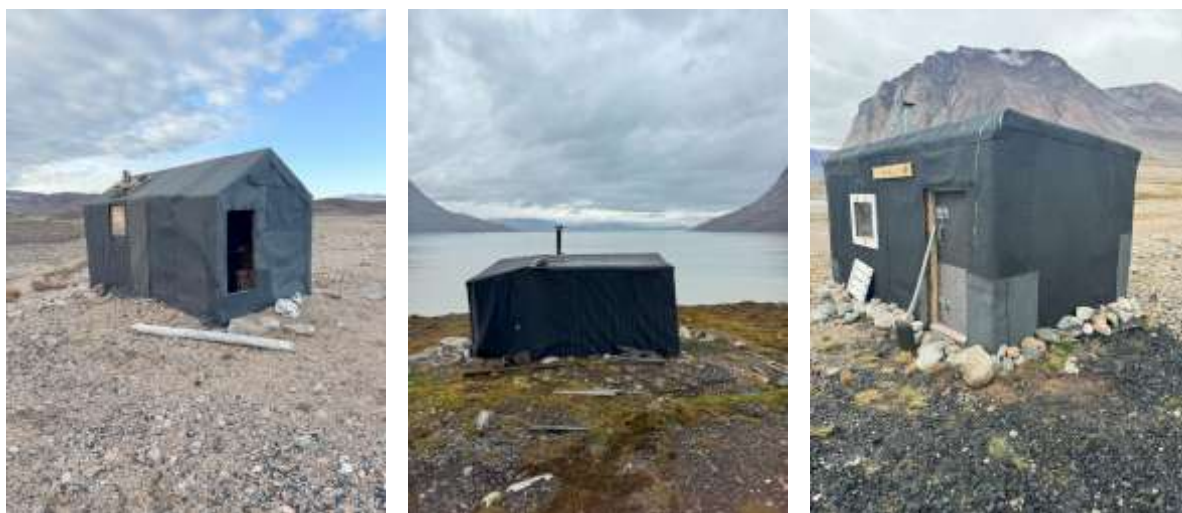
From left: Djævalekløfhytten [427], Lerbughytten [434] og Bjørnnesstua [437].

On the morning of August 13th, we once again sailed toward Moskusheimen. On the way, we stopped at Bjørnnesstua [437]. Here, we carried out some minor repairs and welded roofing felt. The hut will now be of good use to Sirius and other travellers going forward.

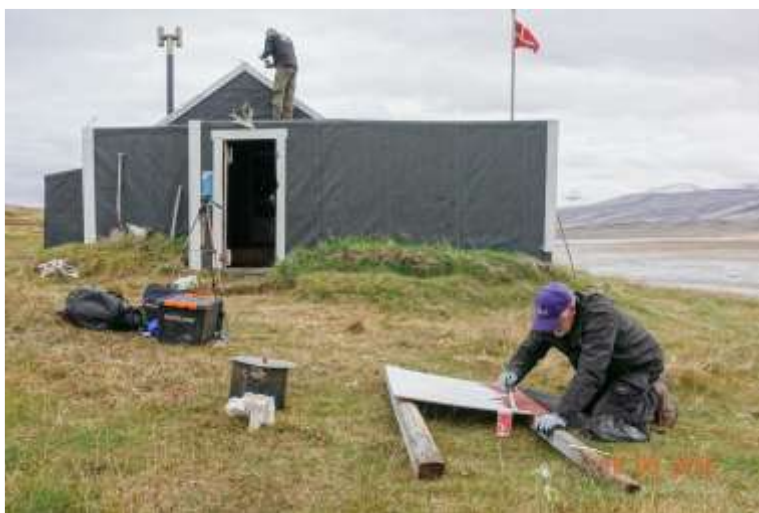
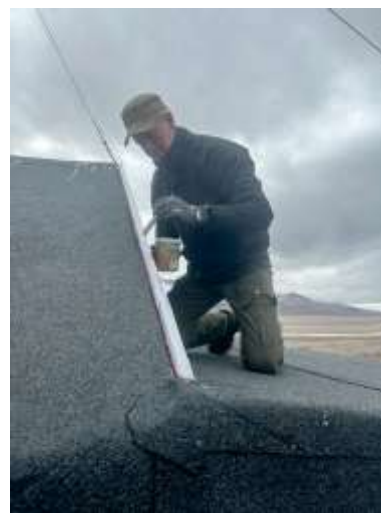
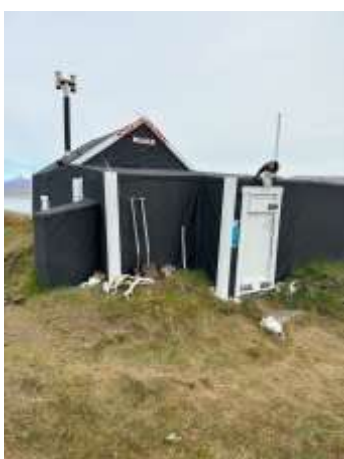
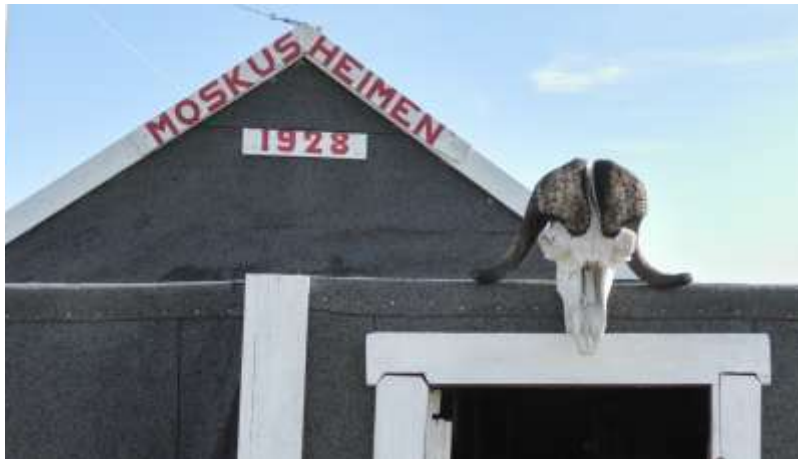
Moskusheimen – restored to its original colours, with the original name board renovated.

In addition, a tøndebuk (barrel stand) was fabricated, and we filled gravel/soil into a gap between the north wall and the surrounding terrain.

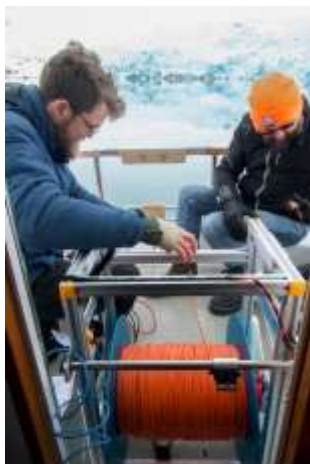
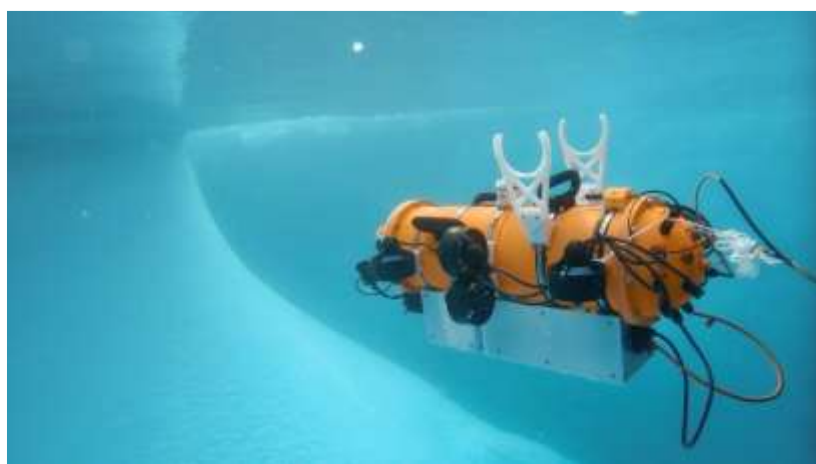
Claus and Nicklas are adjusting the winch with the optical cable (left). Underwater robot on its way around an iceberg (right).

The next day, we planned to deploy the underwater robot at the deepest location. Here, we combined filming and measurements. We had some beginner difficulties with the winch, where the wire guide caused some tangles. After disassembly and appointing Søren as wire guide together with Claus, things went smoothly. Nicklas skilfully controlled the robot all the way up to the glacier and began diving while filming and measuring. We reached down to 120 meters, where there were plenty of small fish. Very turbid water began to flow out from the glacier, and we could see crystals in the polarized camera. We continued diving, but suddenly the alarm for “leak” sounded, and we had to rush the robot up again. It turned out that water had entered through the fibre optic cable, which had been damaged, and we had to return to prepare for the next mission. Despite the leak, the dive was a success, and we learned a lot about how to optimize the dives.

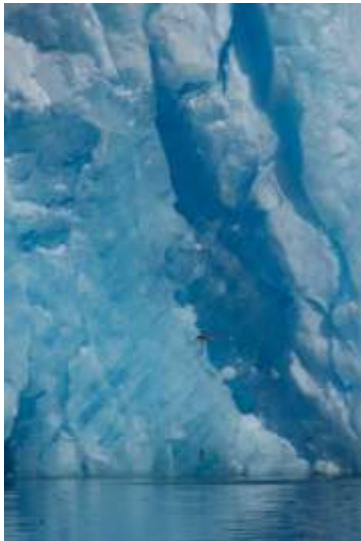
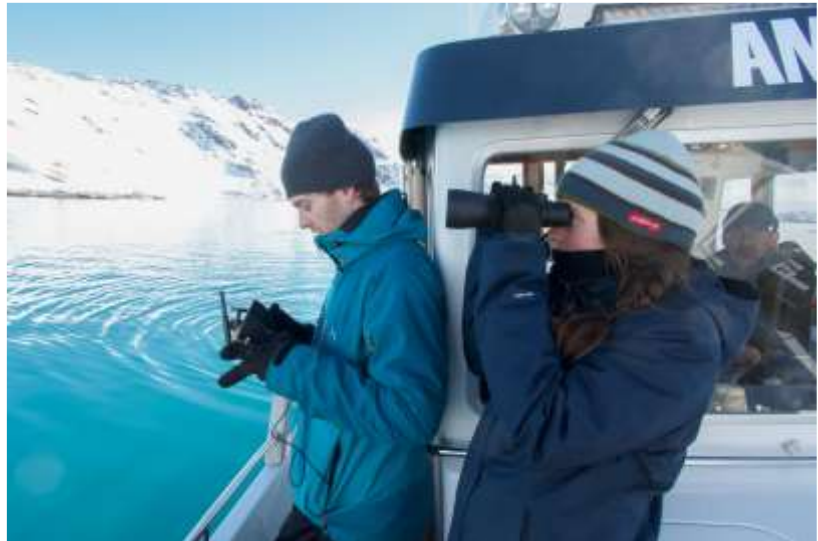
Drone lowers measuring instrument along the glacier wall (left). Ebbe controls the drone while Fleur directs it the right way (right).

Both systems were tested in Qaqortoq from March 12 to 28, where the upper 150 meters of the water column were below the freezing point for freshwater. Fleur, Ebbe, Nicklas, Claus, Lars, Caspar, and Søren flew from Copenhagen to Nuuk and onward to Narsarsuaq, where we got a boat ride to Qaqortoq. Here, we rented a house from 60N, where we stayed while working on the glacier-fjord processes. It worked very well, and we felt very welcome in the town—it was truly a pleasure. We had sent equipment ahead by ship and located it the same day we arrived. The following day was spent unpacking, testing, and charging a lot of lithium batteries needed for the newly developed instruments. After a few days, Nanna also arrived.

The first trip to measure with our drone helicopter took place the following day. After a little over two hours of sailing from Qaqortoq, we reached the glacier and found that the point near the glacier was a suitable place to go ashore. The drone helicopter was too large to take off and land from the boat. Here, Ebbe could get the drone helicopter ashore and then jump back into the boat, after which we sailed around the point and out in front of the glacier at a safe distance. Along the way, we sent up our drone so it could fly along. Meanwhile, Fleur kept an eye on the drone through binoculars and told Ebbe where to fly. We measured at four locations already on the first day and found that the water in front of the glacier was about 180 meters deep. The temperature was close to -1°C , and we could see ice crystals in the polarized camera system we had developed. There was high spirits on the sailing back – the instruments worked.

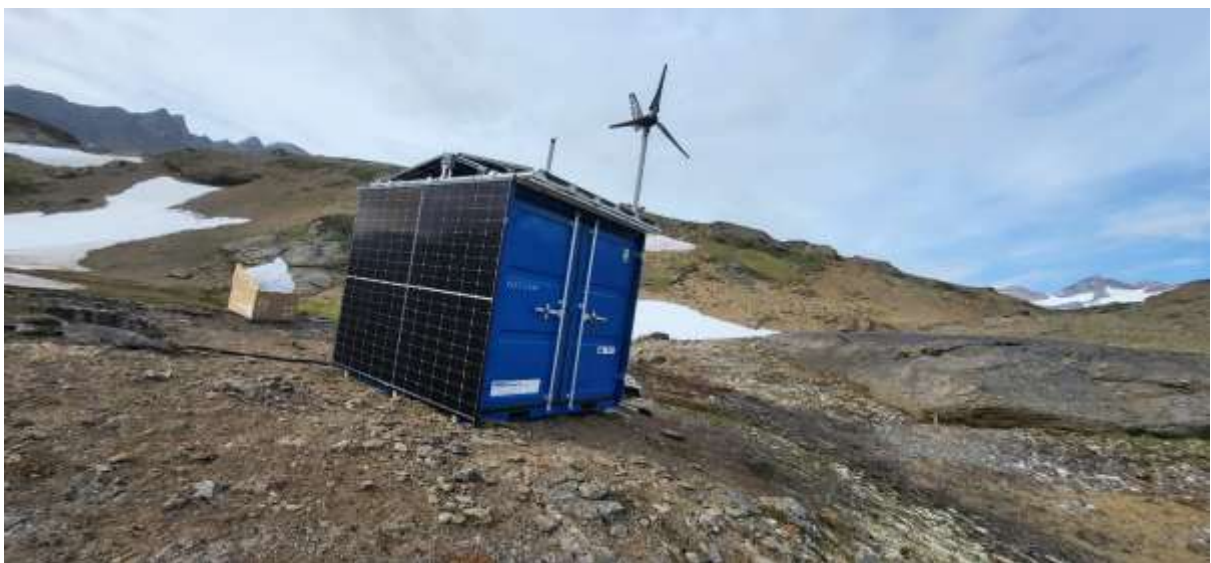
The GIOS station at the field team's departure. There are still several tasks that need to be completed.

- Install side rails of the correct length and fully secure the side-mounted solar panels
- Repair the wind turbine mast section with damaged threads
- Confirm stable communication between the PC and the tower
- Find a solution to the deep discharge issue – ensure the tower shuts down when the batteries are running low
- Check the surrounding area for the last missing solar panel
- Secure the container to prevent it from sliding further down the small hill
- Check instrument calibrations during future visits
- Collect, analyze, and archive old SD card data; check for usable measurements
- Install a wooden storage box at the back of the site for storing tools and spare parts.

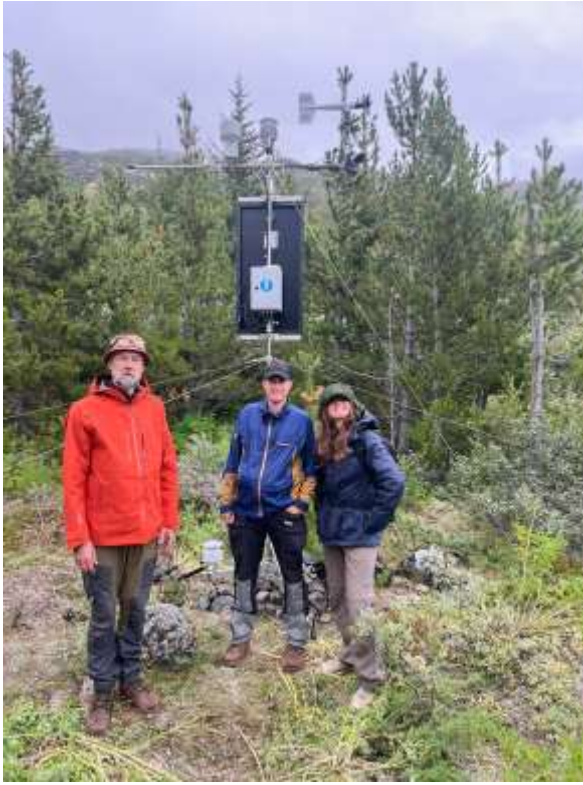
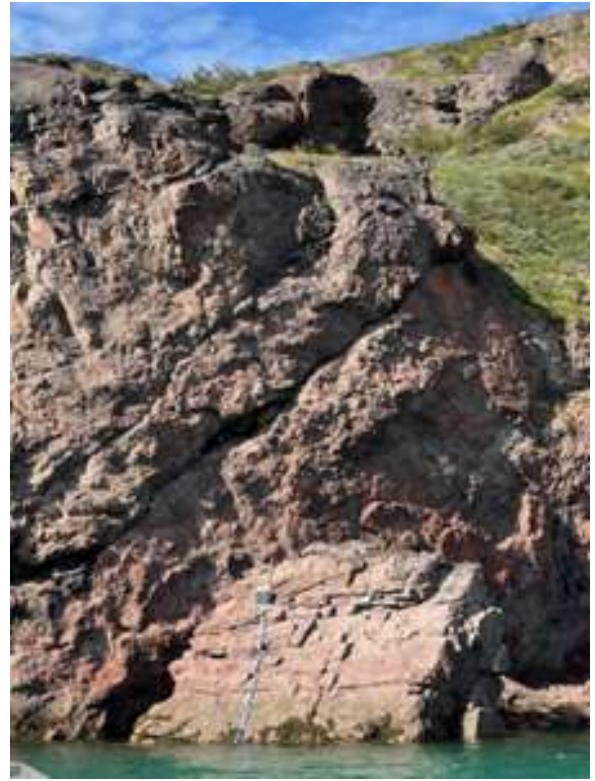
Søren, Esdoorn, and Fleur at the new weather station (left). New marine station near Narsarsuaq (right).

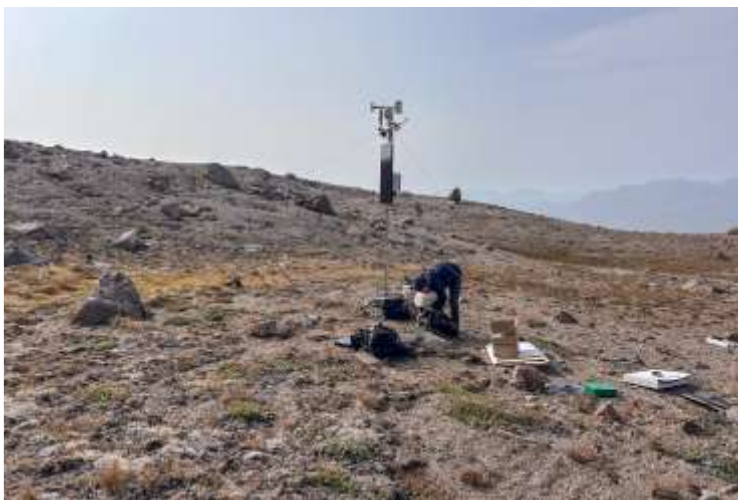
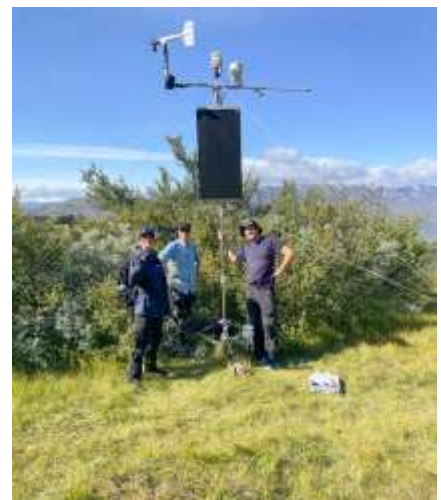
New weather station at 800 m altitude (left) and at 200 m altitude (right). We also installed a weather station at 400 m altitude.

Between August 9 and 25, we (Fleur, Esdoorn, Simon, and Søren) installed four weather stations

in the Narsarsuaq area to capture the variability in weather conditions along a climate gradient from sea level up to 800 meters altitude. Data from the weather stations will be used to characterize living conditions for animals and plants from the valley to the mountain summit in the area. Additionally, together with our marine underwater buoy, the data will help improve local weather forecasts, tidal predictions, and other oceanographic conditions. The instruments transmit data in real time and are part of the Greenland Integrated Observing System (GIOS)

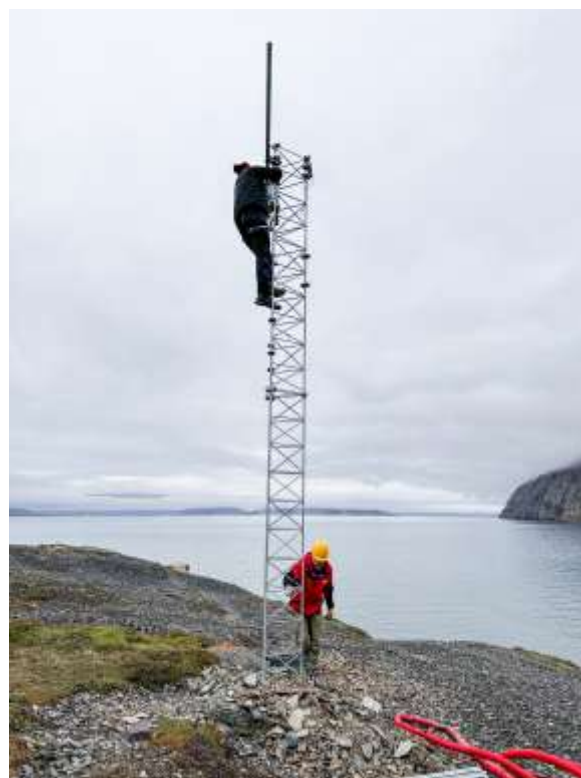
The atmospheric mast has been cleared of equipment and is almost ready to be taken down.

The following two days were spent dismantling the meteorology mast and preparing ship mik. The GIOS meteorology mast is being replaced by the cheaper GIOS-lite masts, several of which are installed at various locations in the fjords around Ella Ø. Johan and Lau carefully and thoroughly removed all the instruments, ensuring everything was taken down without any problem. Finally, with help from Sirius and Axel, we laid the mast down before it was disassembled and prepared for shipment home. Simultaneously, Egon packed the waste that had been stored at the back of the storage area onto pallets and labelled it for

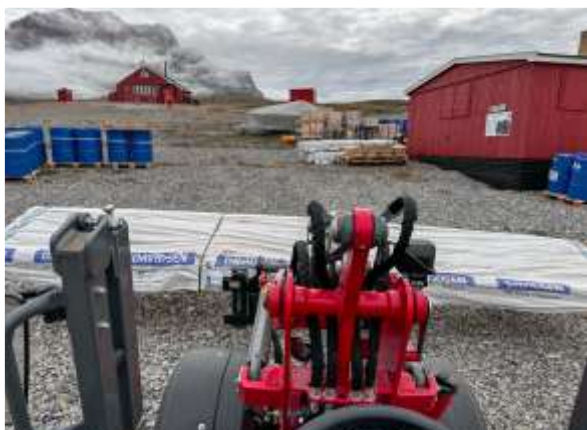
Ship mik – timber for Kap Hedlund (left). Lau and Johan are working on the GIOS container in Ulvedalen (right).

Already on the day of ship mik, Johan and Lau went up to Ulvedalen to inspect the container and see what tools and equipment were available there. In the days that followed, they hiked up to the container daily to carry out mounting and installation work. The first task was the battery

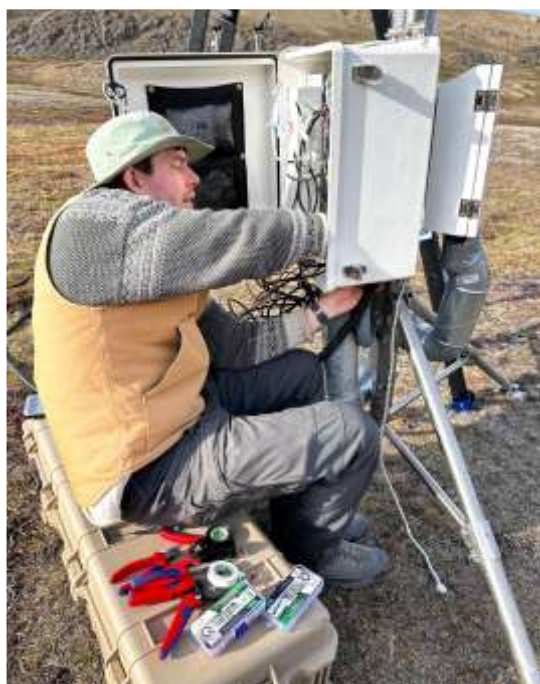
Johan working on the installation.

pack consisting of 16 batteries, each with a capacity of 165 Ah.

Each battery weighs 54 kg, so getting them into the container was quite a heavy lift. Once in place, the batteries were connected to the pre-installed electrical system inside the container. In the following days, solar panels were mounted on the roof and the south-facing side of the container. Wind turbines were also installed, allowing the batteries to be charged in both windy and sunny conditions. After that, the focus shifted to installing the rest of the equipment, including an atmospheric mast that measures wind speed, wind direction, precipitation, CO₂ fluxes, PAR (light), humidity, and air, surface, and soil temperature. Meanwhile, on Ella Ø, Egon began rebuilding the solar power system that supplies electricity to the sockets in the Tolvmåndsbarakken and the Fjøsset. For the past two years, it has been necessary to disconnect wires on individual units to shut the system down. This is both inconvenient and

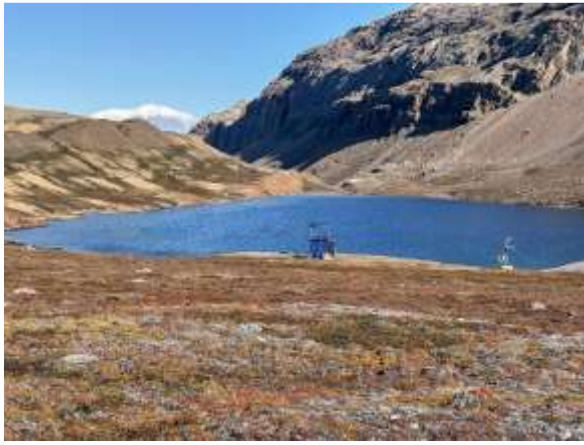
The site in Ulvedalen – in the background, the lake where the GIOS-lite lake installation is mounted (left). The fully rebuilt GIOS container on Ella Ø (right).

wears out the wire terminals over time. Therefore, we decided to rebuild the system so that it can now be turned on and off simply by flipping two switches. Ebbe had drawn up the wiring connections and prepared an instruction manual, as well as purchased the necessary components, allowing Egon to carry out the rebuild following the guide and electrical diagram.

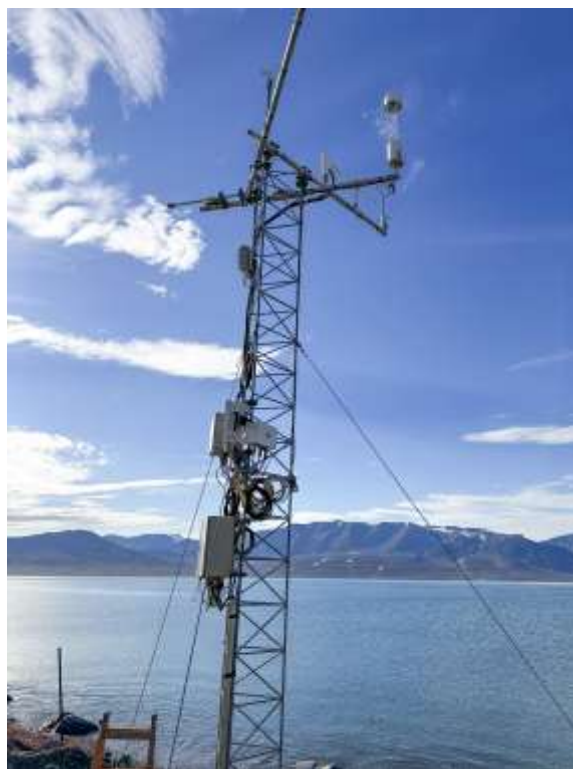
The atmospheric mast at Daneborg.

Once Bjørn had started up the atmospheric instruments, they needed to be calibrated. Help was available from Marin Basis, as Henry Henson from Ecoscience at Aarhus University was both able to climb the mast and had expertise in calibration. This was successfully done, and we got the container operational, so it is hoped that it will be able to send data home to the researchers during the upcoming winter.
